## DEPARTMENT OF TRANSPORTATION

### Federal Aviation Administration

**[Docket No. FAA-2013-0822; Directorate Identifier 2013-SW-004-AD]**

#### **Airworthiness Directives; Eurocopter France Helicopters**

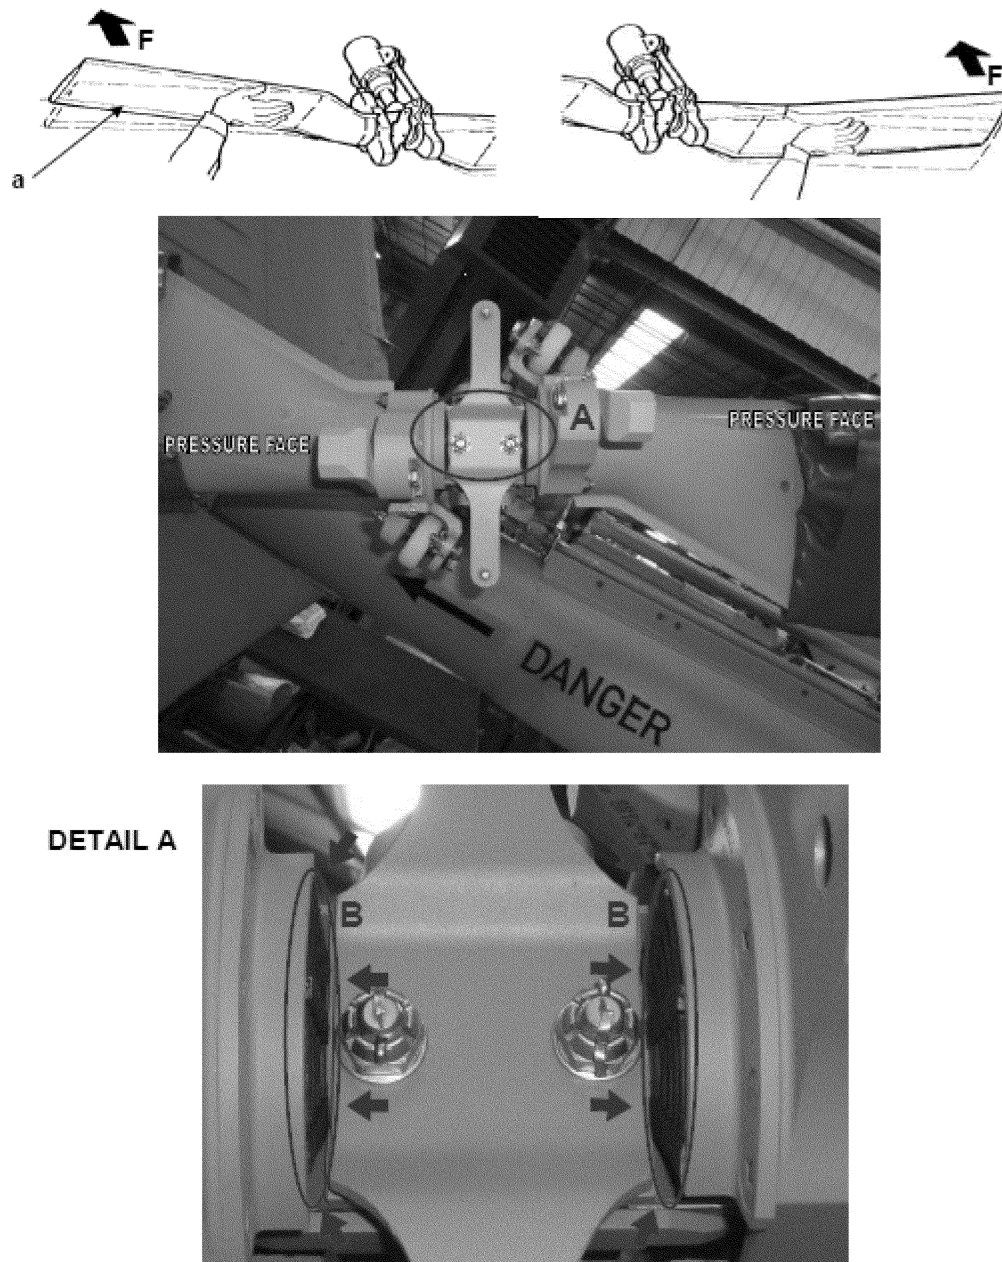
(B) Apply load (F) by hand, perpendicular to the pressure face of one tail rotor blade (a), as shown in Figure 1 to paragraph (f) of this AD, taking care not to reach the extreme position against the tail rotor hub. The load will deflect the tail rotor blade towards the tail boom.

(C) While maintaining the load, check all the visible faces of the bearings (front and side faces) in area B of DETAIL A of Figure 1 to paragraph (f) of this AD for separation between the elastomer and metal parts, a crack in the elastomer, or an extrusion (see example in Figure 2 to paragraph (f) of this AD). A flashlight may be used to enhance the check.

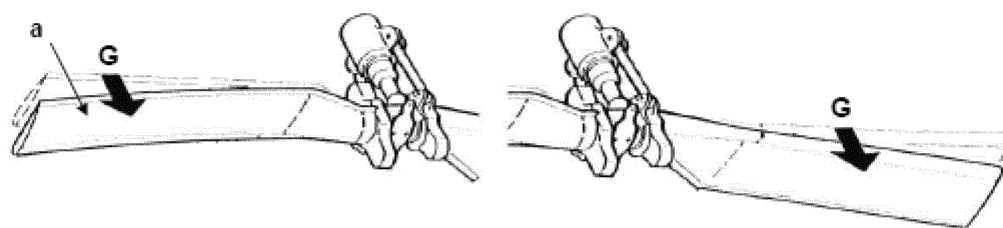
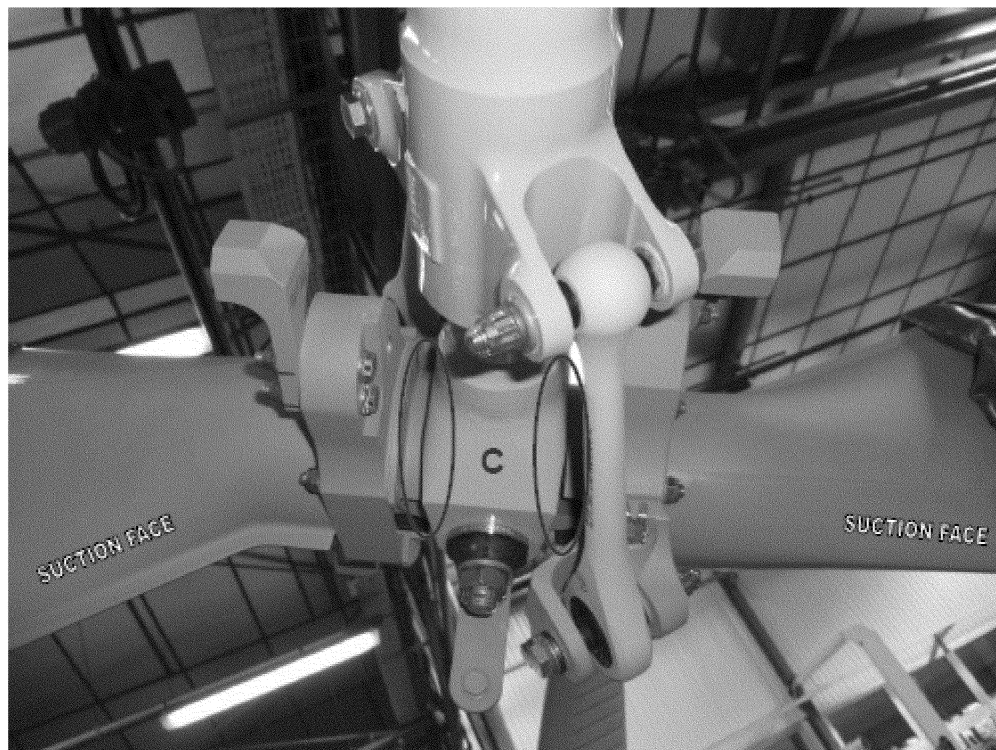
(E) Apply load (G) by hand perpendicular to the suction face of one tail rotor blade as shown in Figure 3 to paragraph (f) of this AD.

(F) While maintaining the load, check visible faces of Area C as shown in Figure 3 to paragraph (f) of this AD for any extrusion. A flashlight may be used to enhance the check.

(v) If there is an extrusion on any bearing, before further flight, replace the four bearings with airworthy bearings.

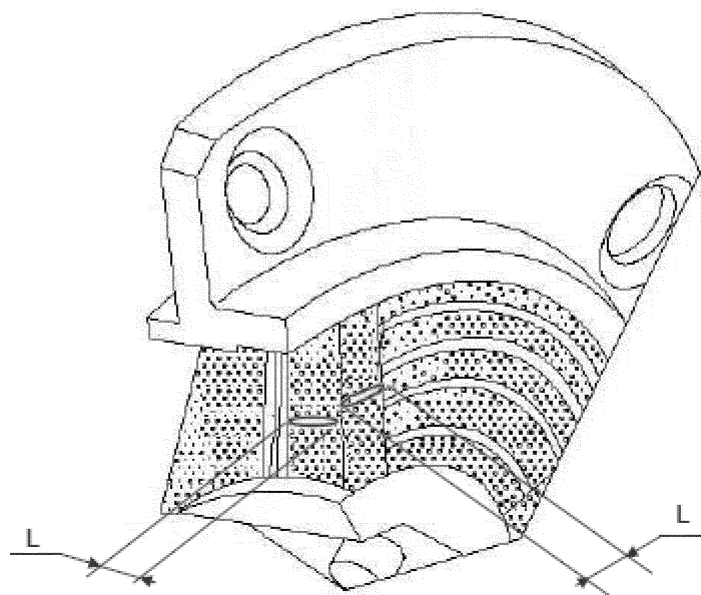
(vi) If there is a separation or a crack on the pressure side bearing, measure the separation or the crack. If the separation or crack is greater than 5 millimeters (.196 inches) as indicated by dimension “L” in Figure 4 to paragraph (f) of this AD, before further flight, replace the four bearings with airworthy bearings.
