Airworthiness Directives; Airbus Helicopters

Airbus Helicopters: Docket No. FAA–2021–0872; Project Identifier MCAI–2021–00312–R.

Joint Aircraft Service Component (JASC) Code: 6400, Tail rotor system.

(e) Unsafe Condition

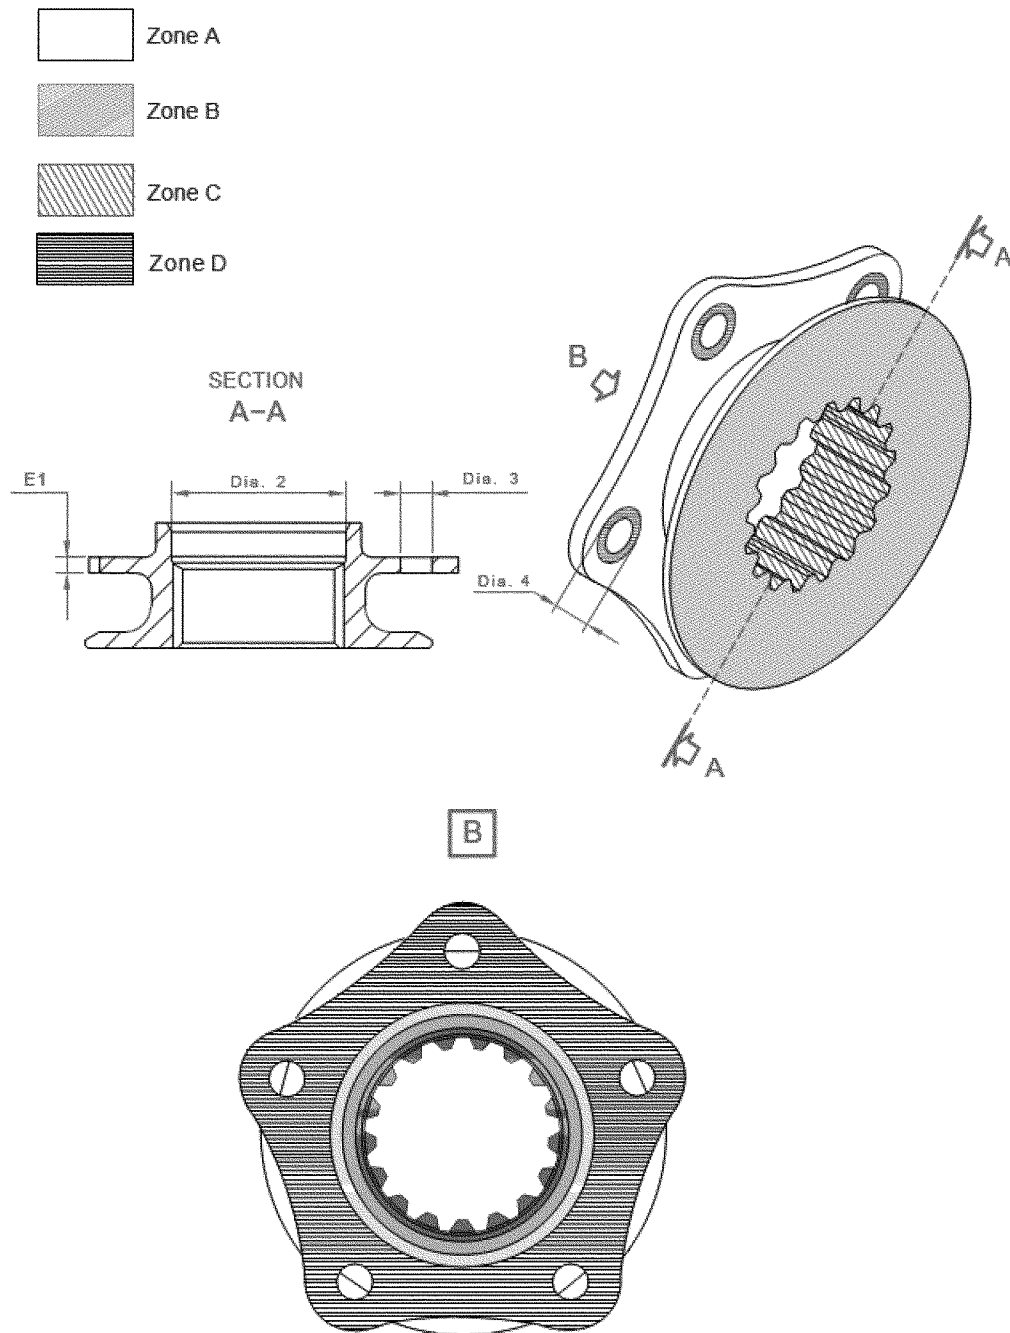
Figure 2 to paragraph (g)(1)(ii) – Inspection Areas of Tail Rotor Splined Flange

(ii) Inspect the TR splined flange for corrosion, impacts, fretting, wear, and a crack in the areas identified in Figure 2 of this AD. If the condition of the part (including corrosion, impacts, fretting, wear, or cracks) exceeds the criteria as specified in Figure 1 of this AD, before further flight, remove the splined flange from service and replace with an airworthy part.

Location as specified in figure 2 to paragraph (g)(1)(ii) of this AD	Maximum damage, which causes replacement (E1, Dia. 2, Dia. 3, and Dia. 4 are shown in figure 2 to paragraph (g)(1)(ii) of this AD)
Zone A	Scratch depth > 0.2 mm (0.008 in.). Crack. E1 < 2.75 mm (0.108 in.). Dia. 3 > 6.02 mm (0.2371 in.). Dia. 2 > 33.03 mm (1.3004 in.).
Zone B	Touch-up depth > 0.1 mm (0.004 in.). Crack.
Zone C	Crack. Scratch depth > 0.2 mm (0.008 in.).
Zone D [Dia. 4 = 14 mm +/- 0.1 mm (0.548; 0.555in.)]	Touch-up depth > 0.1 mm (0.004 in.). Crack. E1 < 2.75 mm (0.108 in.).
