[Docket No. FAA-2006-25773; Directorate Identifier 2006-SW-16-AD; Amendment 39-14758; AD 2006-19-01]

**Airworthiness Directives; Eurocopter Model AS350B, B1, B2, B3, BA, D, and AS355E Helicopters**

**ACTION:** Final rule; request for comments.

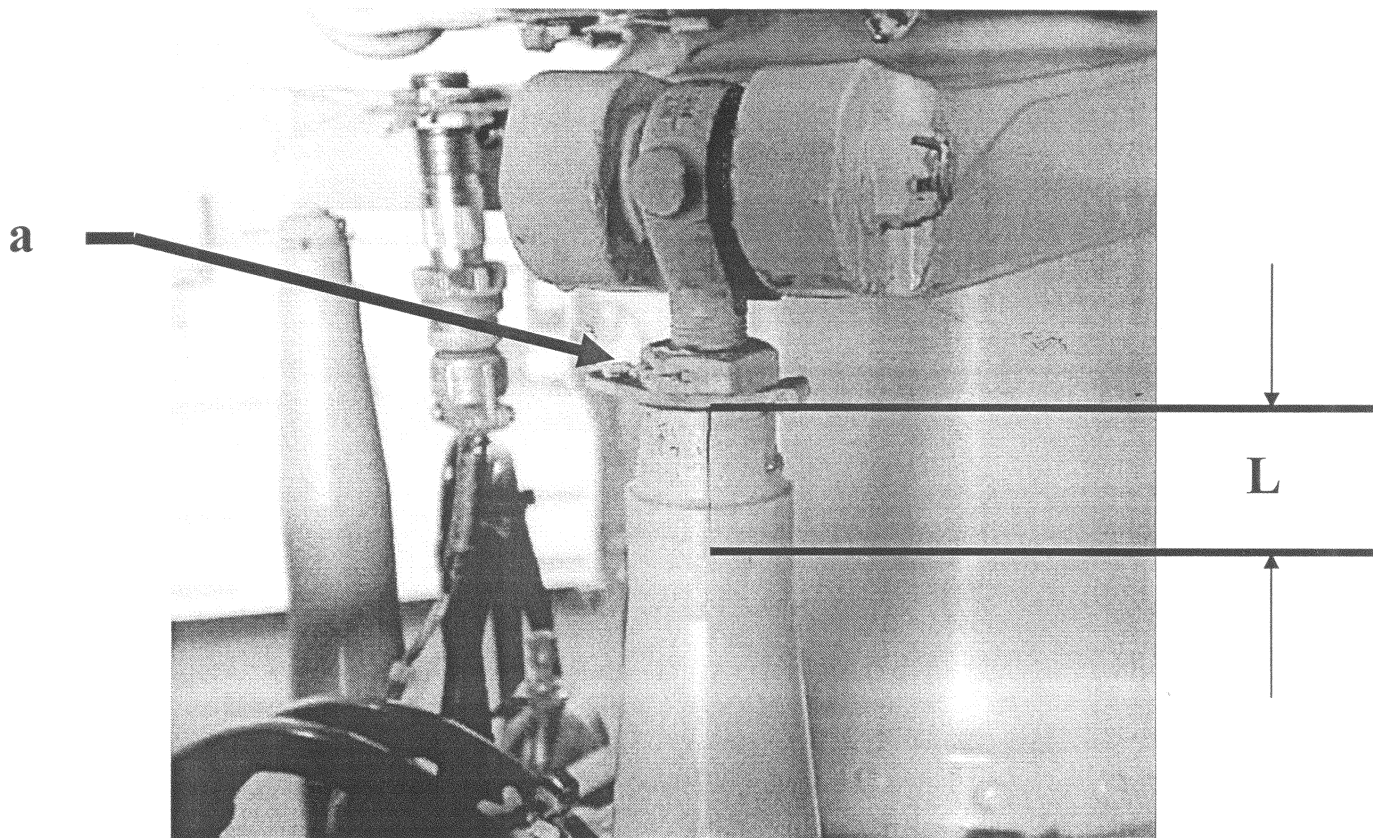
**Figure 1**

(3) Loosen attachment nut “a” shown in Figure 1 of this AD and lift the positioning lock washer under the attachment nut so the edge below the lock washer at the top of the tapered housing is visible around the entire periphery.

(4) Visually inspect each MSC tapered housing for a crack using a 10-power or higher magnifying glass paying particular attention to area “L” and to the edge of the tapered housing located under the lock washer under attachment nut “a” as depicted in Figure 1 of this AD.

(1) Adjust the tightening torque on the attachment nut that secures the upper ball end of the MSC to between 177–199 in-lbs (2–2.25 decanewton meters (daN·m)).

(c) If you find any crack (oblique, horizontal, or vertical), before further flight, replace the MSC with an airworthy MSC and adjust the tightening torque of the attachment nut to between 177–199 in-lb (2–2.25 daN·m)).
