[Docket No. 2000-NM-67-AD; Amendment 39-11618; AD 2000-05-09]

#### Airworthiness Directives; Boeing Model 757-200, -200PF, and -200CB Series Airplanes Powered by Rolls-Royce RB211-535C/E4/E4B Turbofan Engines

**2000-05-09 Boeing:** Amendment 39-11618. Docket 2000-NM-67-AD. Supersedes AD 99-27-06, Amendment 39-11487.

## Appendix 1.—Thrust Control Cable Inspection Procedure

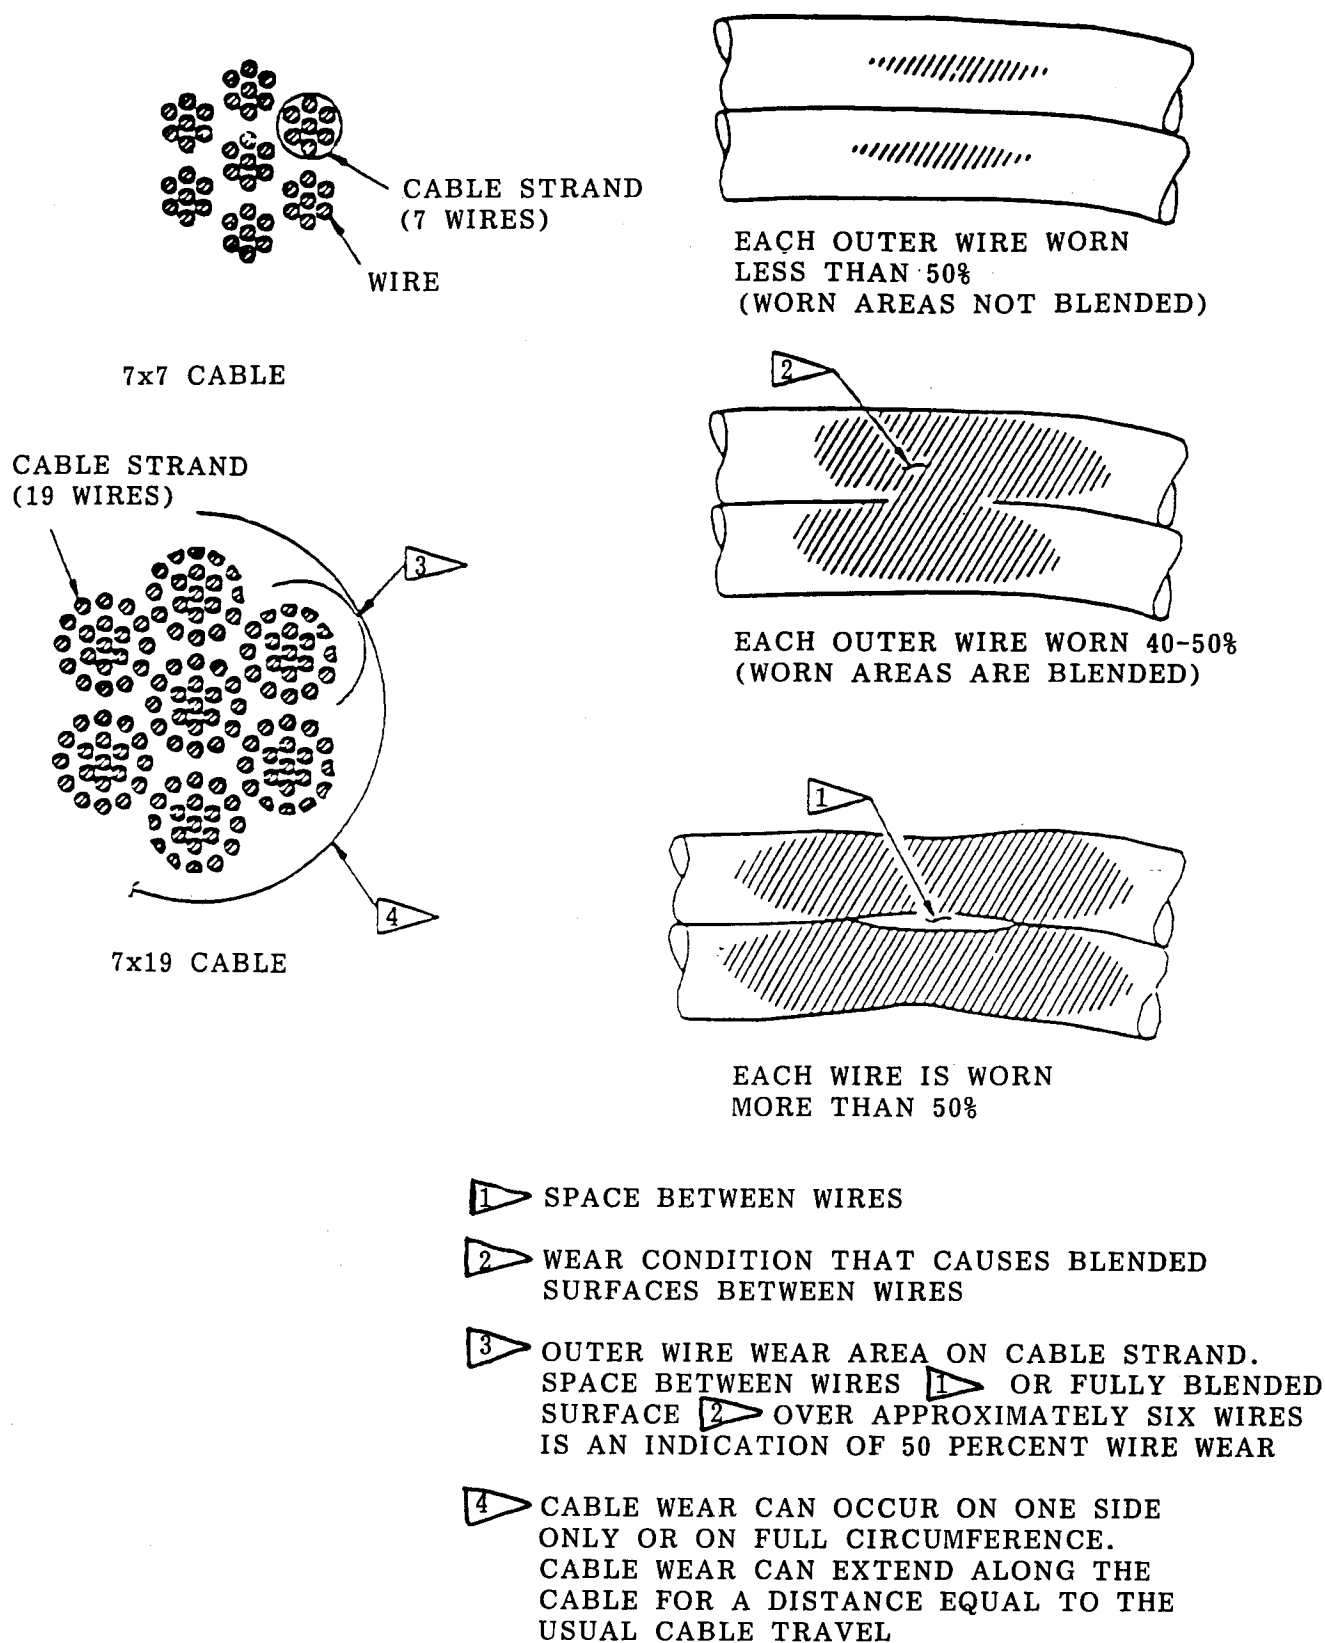
FIGURE 1

- (1) One cable strand had worn wires where one wire cross section is decreased by more than 40 percent (see Figure 1),
- (2) A kink is found, or
- (3) Corrosion is found.

B. Perform a detailed visual inspection of the cable runs to detect incorrect routing, kinks in the wire rope, or other damage. Replace the cable assembly if:
