[Docket No. 2002–NM–128–AD; Amendment 39–13269; AD 2003–16–16]

**Airworthiness Directives; Boeing Model 747–400 Series Airplanes Equipped With General Electric Model CF6–80C2 Series Engines**

**ACTION:** Final rule.

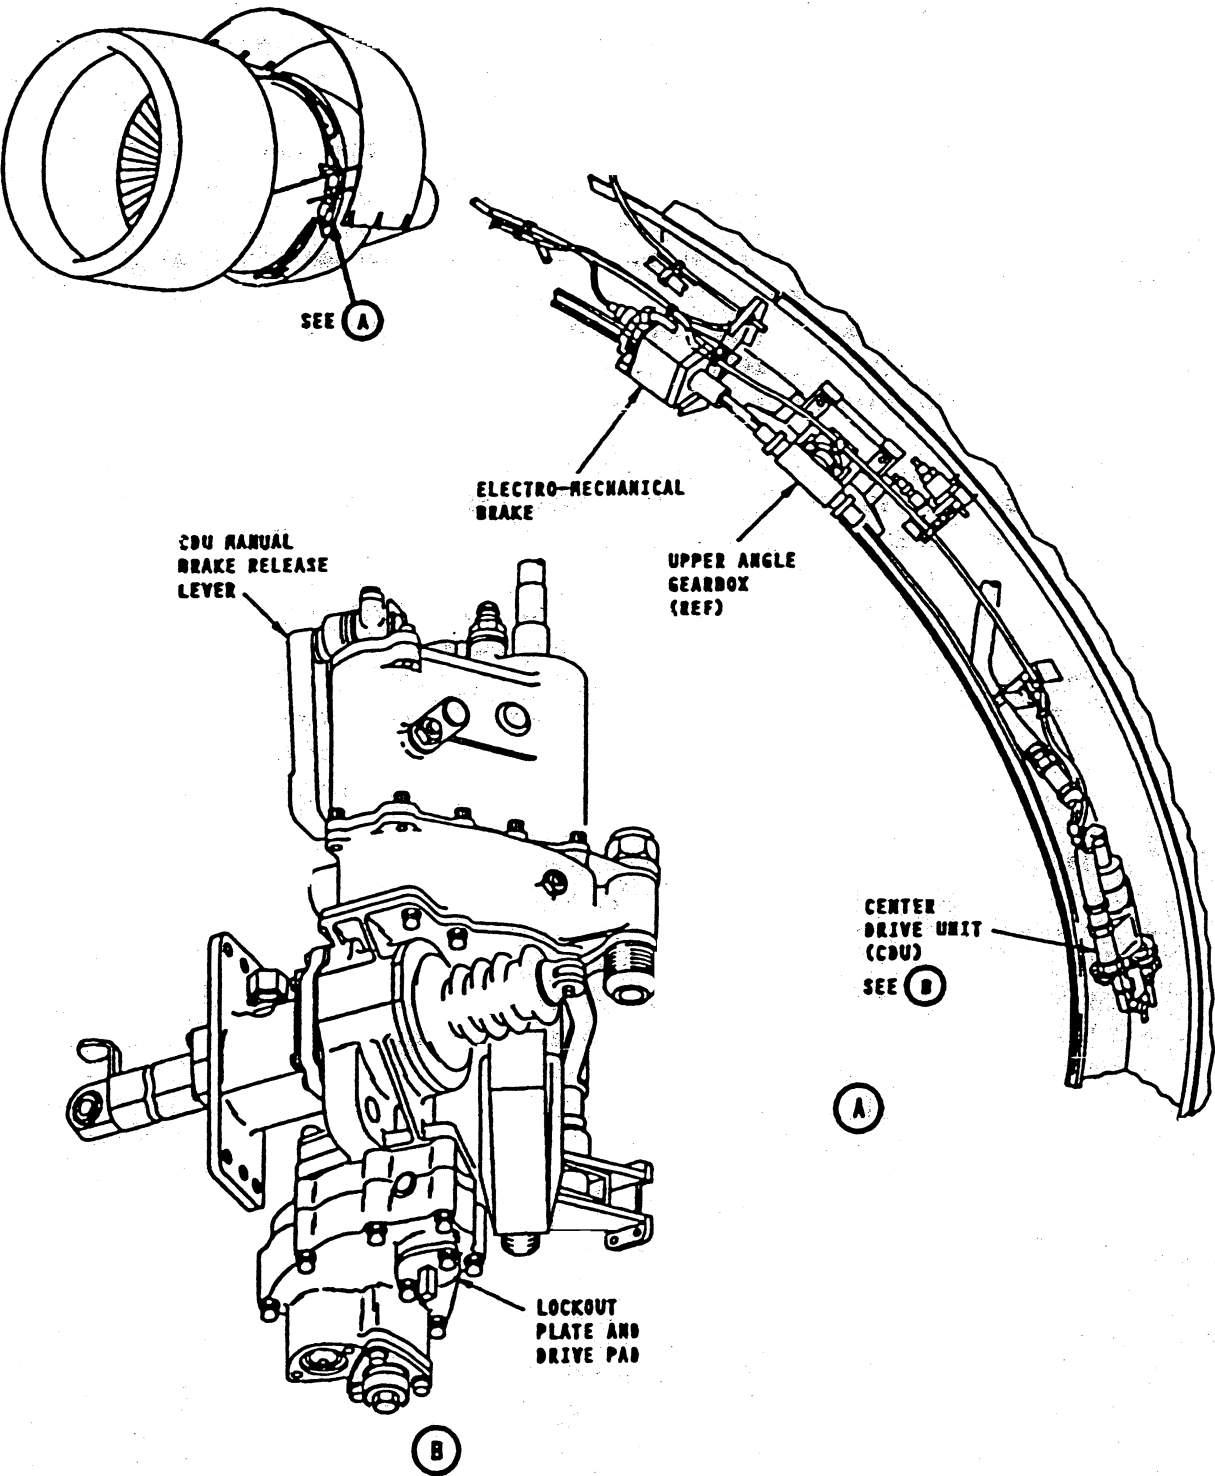
Electro-Mechanical Brake and CDU Cone Brake Torque Check  
Figure 1

1. This procedure contains steps to do a check of the holding torque of the CDU cone brake.

**Caution:** Do not use more than 100 pound-inches of torque when you do this check. Excessive torque will damage the CDU.

**Note:** The cone brake prevents movement in the extend direction only. If you try to measure the holding torque in the retract direction, you will get a false reading.

(8) If the torque is less than 15 pound-inches, you must replace the CDU.
