[Docket No. FAA-2023-0430; Project Identifier MCAI-2022-01092-R; Amendment 39-22378; AD 2023-05-09]

Airworthiness Directives; Airbus Helicopters Deutschland GmbH (AHD) Helicopters

ACTION: Final rule; request for comments.

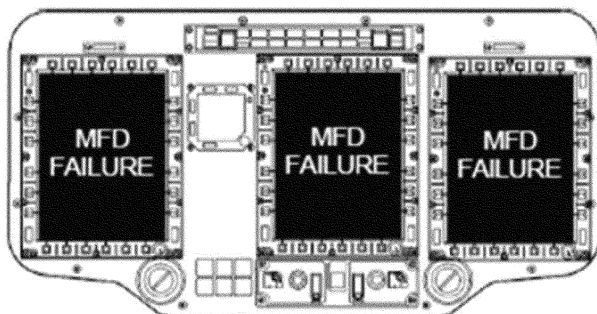
Figure 1 to Paragraph (g)(2): RFM
Emergency Procedure—Model MBB-BK117
Helicopters

- MFD FAILURE displayed on all MFDs
- If autopilot upper modes were coupled, they may decouple after 10 seconds (indicated by an „autopilot decouple“ voice message).

1. Aircraft trajectory
 - Maintain using IESI and stand-by compass.
 - Use AFCS "recovery" or "go-around" modes, if desired
 - Operate aircraft within the approved performance
2. MFD2 pb - OFF

4. MFD2 - Maintain in FND format
5. LAND AS SOON AS POSSIBLE

4. VMC conditions – Establish
5. LAND AS SOON AS POSSIBLE

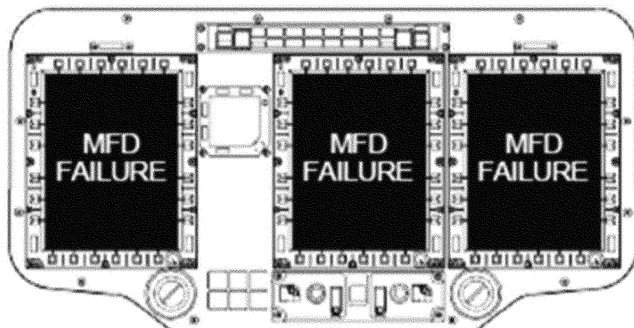
**Figure 2 to Paragraph (g)(2): RFM
Emergency Procedure—Model EC135
Helicopters**

- MFD FAILURE displayed on all MFDs
- If autopilot upper modes were coupled, they may decouple after 10 seconds (indicated by an „autopilot decouple“ voice message).

1. Aircraft trajectory
 - Maintain using IESI and stand-by compass.
 - Use AFCS "recovery" or "go-around" modes, if desired
 - Operate aircraft within the approved performance
2. MFD2 pb
 - OFF

4. MFD2
 - Maintain in FND format
5. LAND AS SOON AS POSSIBLE

4. VMC conditions – Establish
5. LAND AS SOON AS POSSIBLE
