#### Airworthiness Directives; Sikorsky Aircraft Corporation Helicopters

##### 2012-08-01 Sikorsky Aircraft Corporation:

This AD defines the unsafe condition as inaccurate above specification engine power margin data. This condition could result in the use of inaccurate engine performance data in calculating maximum gross weight.

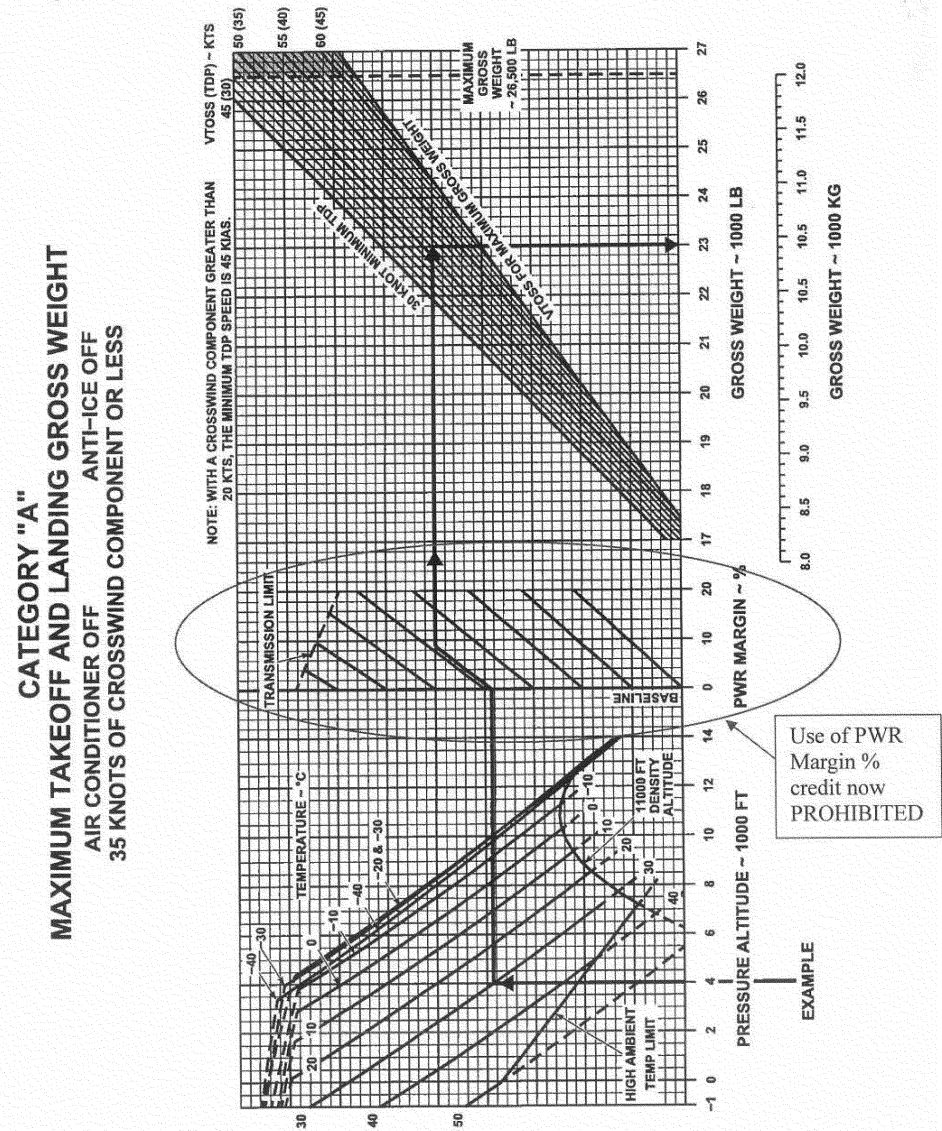
Figure 1. Cat 'A' Takeoff and Landing Gross Weight

**Note to paragraph (e)(2) of this AD:**  
Previous RFM revisions allowed for the use of above-specification engine power margin as depicted in the circled area of Figure 1 of this AD.

(1) By making pen and ink changes, insert into the Operating Limitations section, Part 1, Section 1, Weight Limits, of Rotorcraft Flight Manuals (RFMs) SA S92A-RFM-002, -003, -004, -005, and -006 the following limitation “Performance credit for above specification engine power margin is prohibited.”

(2) If the RFM already contains the revisions appropriate for your helicopter as listed in the following Table 1, all dated April 9, 2008, with the correct performance charts, without the performance credit as depicted in the circled area of Figure 1 of this AD, the operating limitation required by paragraph (1) of this AD does not need to be inserted into the RFM.
