[Docket No. FAA-2005-21680; Directorate Identifier 2004-SW-48-AD]

Airworthiness Directives; Bell Helicopter Textron Canada Model 206A, A-1, B, B-1, L, L-1, L-3, L-4 Helicopters

ACTION: Notice of proposed rulemaking (NPRM).

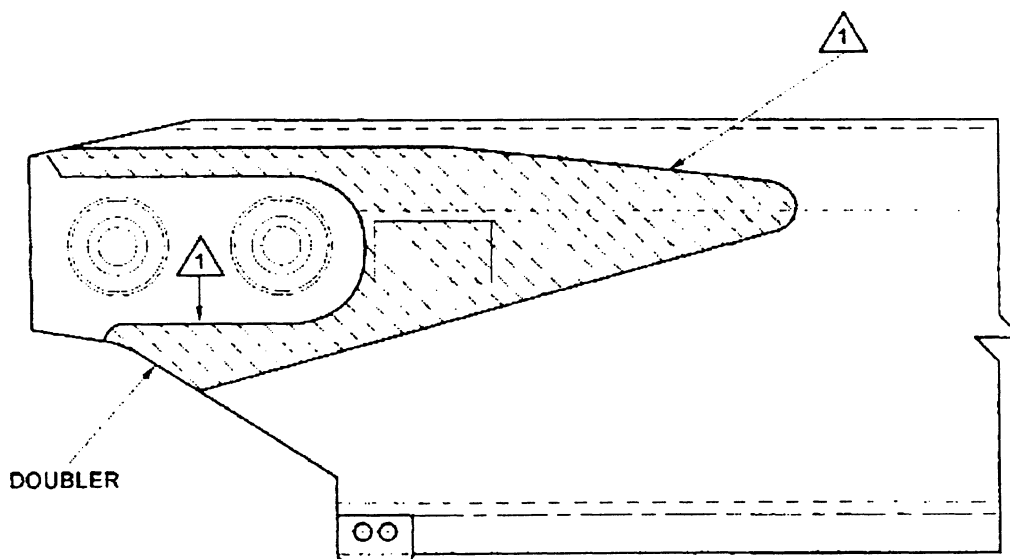
(a) Before the first flight of each day, clean each blade and visually check the blade root doublers for an edge void or de-bond on both sides of each blade as depicted in Figure 1 of this AD. An owner/operator (pilot), holding at least a private pilot certificate, may perform this visual check and must enter compliance with this paragraph into the helicopter maintenance records by following 14 CFR sections 43.11 and 91.417(a)(2)(v).

1 Inspect the doubler for an edge void or de-bond on both sides of each blade.

(b) If an edge void or a de-bond is found, before further flight, replace the blade with an airworthy blade with a serial number other than those to which this AD applies.

(c) Within 100 hours time-in-service, replace all affected, serial-numbered blades with airworthy blades with a serial number other than those to which this AD applies.
