[Docket No. FAA–2011–0939; Directorate Identifier 2010–SW–067–AD; Amendment 39 16798; AD 2011–18–16]

**Airworthiness Directives; Eurocopter**  
**France (Eurocopter) Model AS332C,**  
**AS332L, AS332L1, and AS332L2**  
**Helicopters**

##### 2011-18-16 Eurocopter France:

Amendment 39-16798; Docket No. FAA 2011-0939; Directorate Identifier 2010-SW-067-AD.

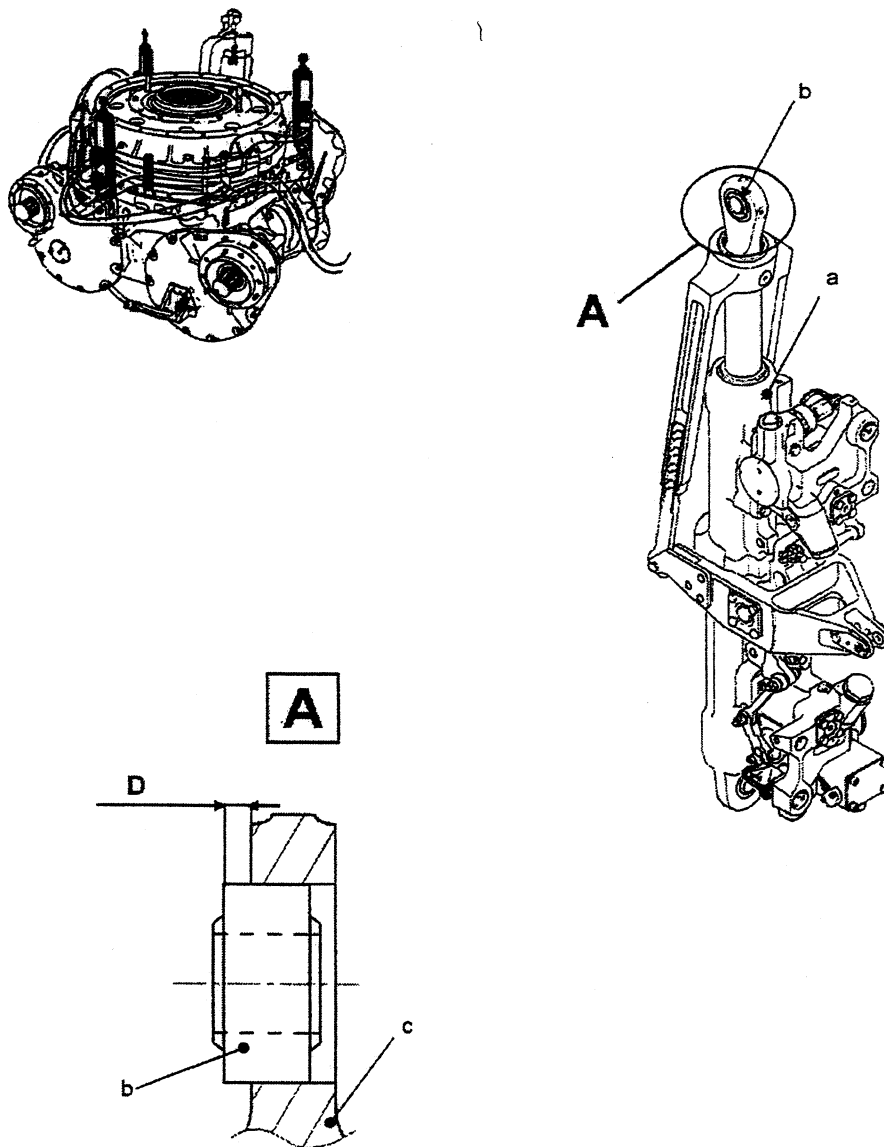
**SUMMARY:** This amendment adopts a new airworthiness directive (AD) for the specified Eurocopter model helicopters. This action requires inspecting the upper end fitting ball joints of the main rotor servocontrols for lateral play, and depending on the findings either repetitively inspecting the ball joint or replacing the servocontrol. This amendment is prompted by reports of noncompliant swaging of the end fitting ball joints on main rotor servocontrols.

Investigation has shown that the swaging load applied to the ball joints was 1.3 metric tons instead of the specified 13 metric tons. The actions specified in this AD are intended to prevent failure of the upper end fitting ball joints of the main rotor servocontrols, failure of the upper end fittings, and loss of control of the helicopter.

(a) Within 15 hours time-in-service (TIS), unless accomplished previously, using a feeler gage, measure the lateral play between the outer ring of the ball joint and each of the two faces of the upper end fitting as depicted in Figure 1 of this AD.

(b) If the lateral play is greater than or equal to 1 millimeter (MM) (0.04 inch) and the servocontrol has accumulated 825 or more hours TIS, before further flight, replace it with an airworthy servocontrol.

servocontrol has accumulated less than 825 hours TIS, on or before the servocontrol accumulates 825 hours TIS, replace it with an airworthy servocontrol.

paragraph (a) of this AD. At each 300 hour TIS interval inspection, if the lateral play is greater than or equal to 1 mm (0.04 inch), within 525 hours TIS, replace the servocontrol with an airworthy servocontrol.

(e) Replacing a servocontrol with an airworthy servocontrol that is marked with a letter "R" by the manufacturer after the S/N constitutes terminating action for the requirements of this AD.
