#### Airworthiness Directives; McDonnell Douglas Model DC-10 and MD-10 Series Airplanes

#### 2001-17-22 McDonnell Douglas:

#### Airworthiness Directives; Bombardier Model DHC-8-100, -200, and -300 Series Airplanes

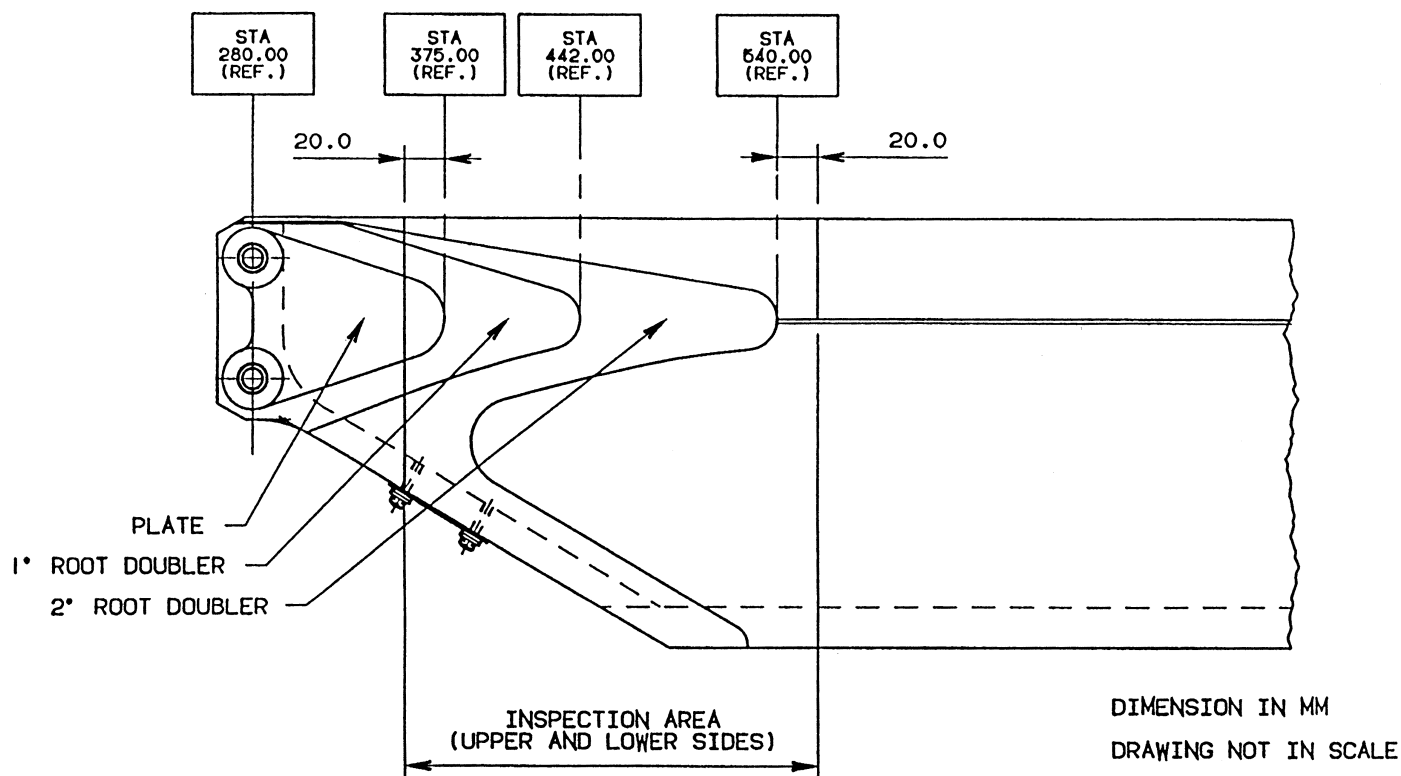
## FIGURE 2

P/N 109-8132-01-109 T/R BLADE

(b) Within 10 hours time-in-service (TIS), and thereafter at intervals not to exceed 10 hours TIS or before the next flight after any abnormal tail rotor vibration, inspect each blade for a crack using a 5-power or higher magnifying glass in accordance with the Compliance Instructions, Part II, of Agusta Bollettino Tecnico No. 109EP-14, Revision A, dated March 19, 2001 (ABT).

(c) Within 25 hours TIS and thereafter at intervals not to exceed 25 hours TIS, dye-penetrant inspect each blade for a crack in accordance with the Compliance Instructions, Part III, of the ABT.

(d) If a crack is found, replace the blade with an airworthy blade before further flight.
