[Docket No. FAA-2016-9254; Directorate Identifier 2015-CE-030-AD; Amendment 39-18948; AD 2017-14-04]

#### Airworthiness Directives; Piper Aircraft, Inc. Airplanes

**2017–14–04 Piper Aircraft, Inc.:**  
Amendment 39–18948; Docket No. FAA–2016–9254; Directorate Identifier 2015–CE–030–AD.

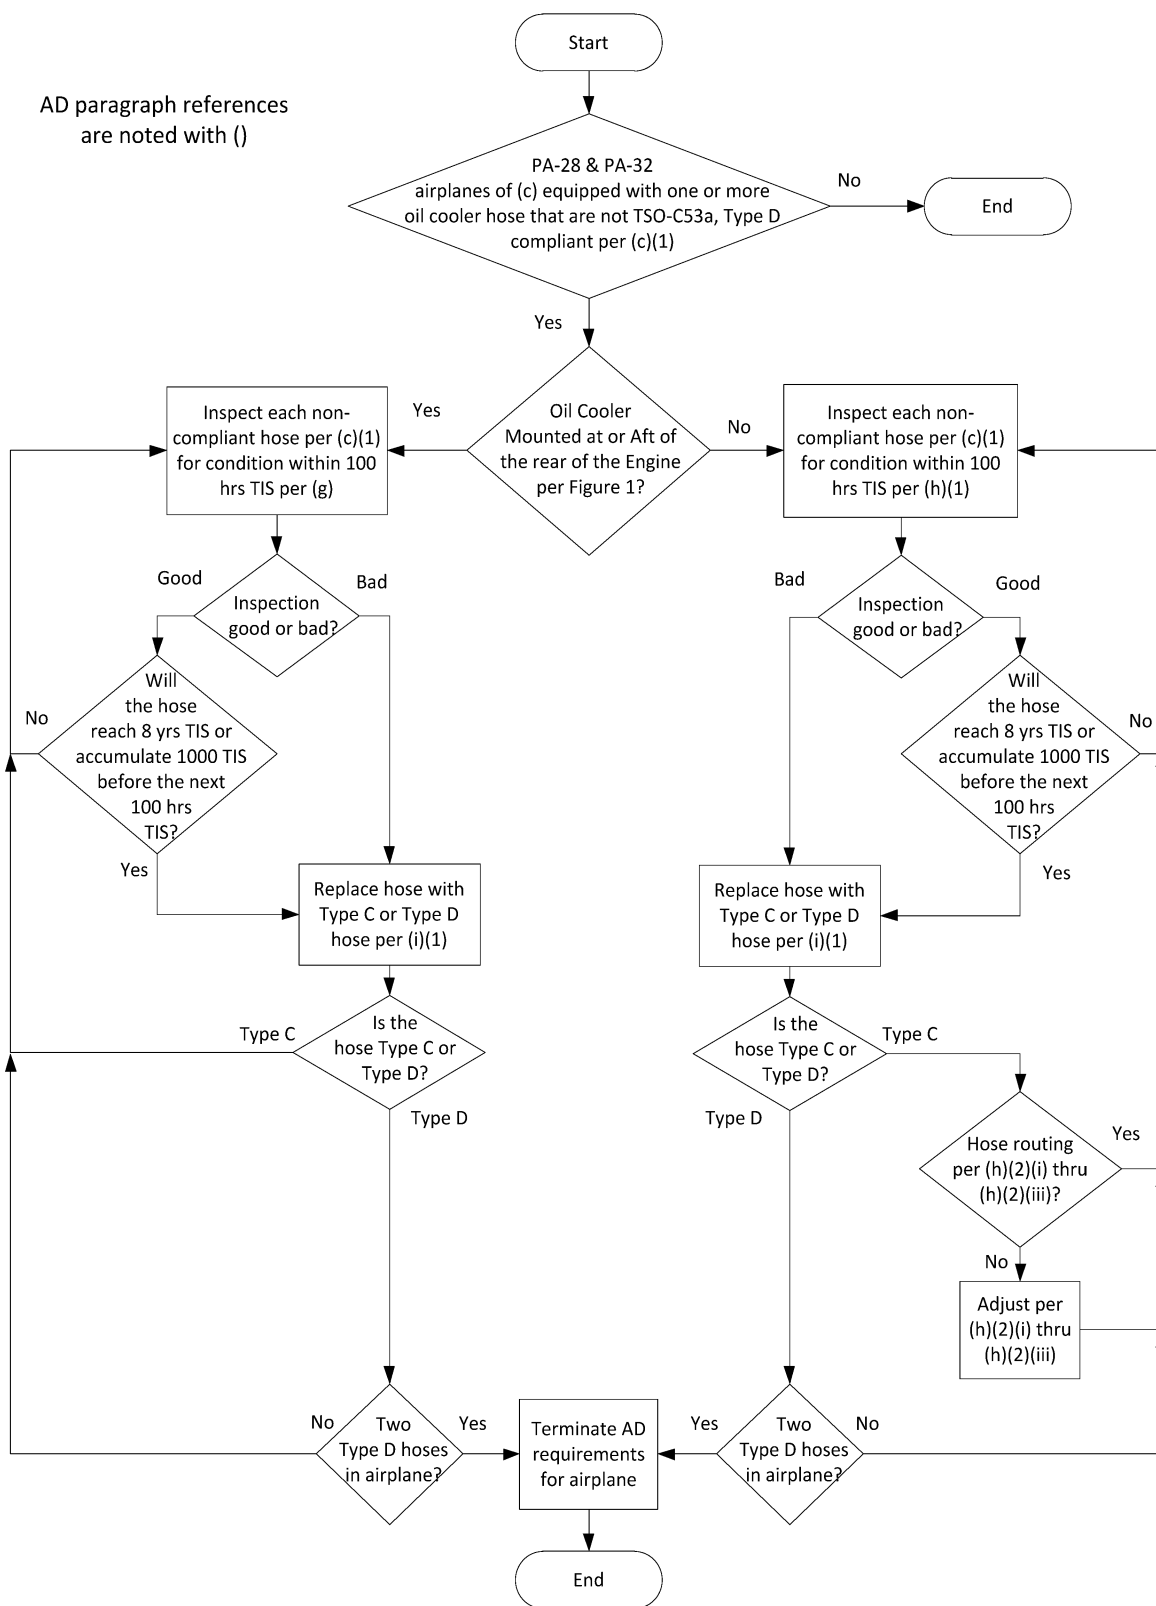
## Appendix 1 to AD 2017-14-04

Comply with this AD within the compliance times specified, unless already done. You may review the flow chart found in appendix 1 to assist you in complying with the actions of this AD.
