**Airworthiness Directives; Eurocopter Deutschland GmbH Helicopters**

**2012–10–53 Eurocopter Deutschland GMBH (ECD):** Amendment 39–17254; Docket No. FAA–2012–1188; Directorate Identifier 2012–SW–049–AD.

This AD defines the unsafe condition as a crack in the MRH shaft flange, which could result in failure of the MRH shaft and subsequent loss of control of the helicopter.

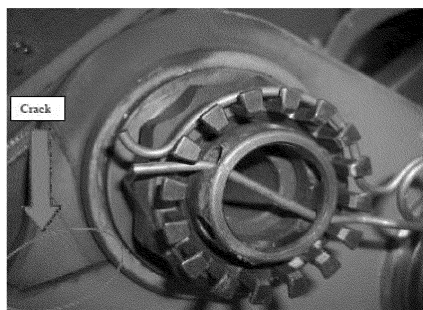
Figure 1 to Paragraph (f)(1)

(1) Before further flight, and thereafter at intervals not to exceed 6 hours time-in-service (TIS), check the MRH shaft lower flange and the visible area of the MRH shaft upper flange for a crack. Figures 1 and 2 to Paragraph (f)(1) of this AD are examples of cracks that have been discovered in the MRH shaft lower flange. The actions required by this paragraph may be performed by the owner/operator (pilot) holding at least a private pilot certificate, and must be entered into the aircraft records showing compliance with this AD in accordance with 14 CFR 43.9 (a)(1)–(4) and 14 CFR 91.417(a)(2)(v). The record must be maintained as required by 14 CFR 91.417, 121.380, or 135.439.

(3) If there is a crack in the upper or lower MRH shaft flange, before further flight, replace the MRH shaft. Replacing the MRH shaft with an MRH shaft having a part number listed in the applicability of this AD does not constitute terminating action for the requirements of this AD.

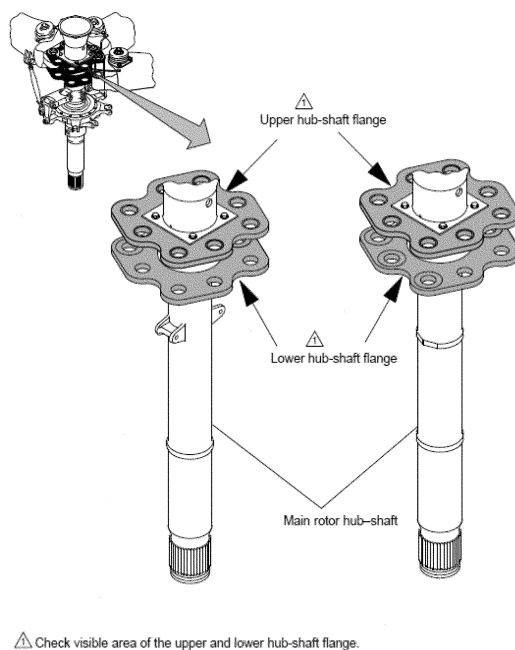
- (i) Remove rotor-hub cap.
- (ii) Clean the upper and lower MRH shaft flange as depicted in Figure 3 to Paragraph

(f)(2)(ii) of this AD and visually inspect for a crack.

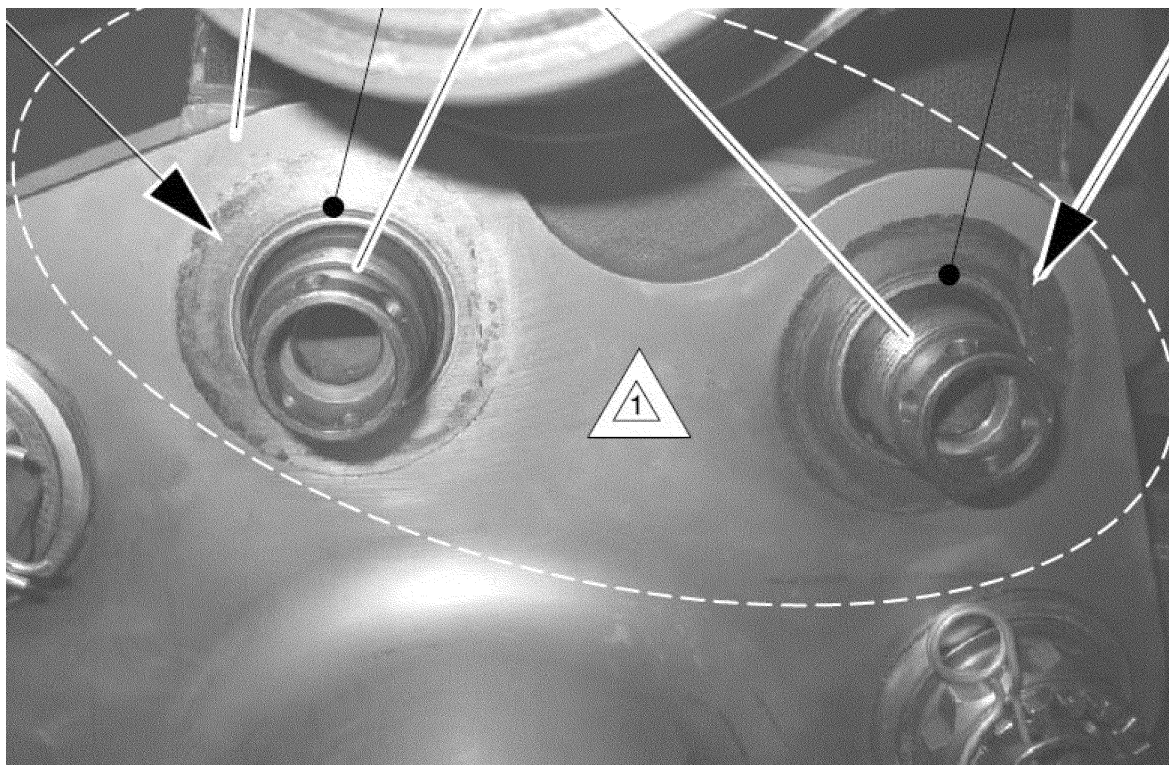
(iv) Clean the blade bolt attachment area.  
(v) Using a 10X or higher power magnification, inspect all lower MRH shaft

flange blade bolt attachment areas for a crack as shown in Figure 4 to Paragraph (f)(2)(v) of this AD.
