[Docket No. FAA-2020-0883; Project Identifier 2019-CE-034-AD; Amendment 39-21460; AD 2021-05-17]

**Airworthiness Directives; Rockwell Collins, Inc. Flight Display System Application**

**ACTION:** Final rule.

**2021-05-17 Rockwell Collins, Inc.:**  
Amendment 39-21460; Docket No. FAA-2020-0883; Project Identifier 2019-CE-034-AD.

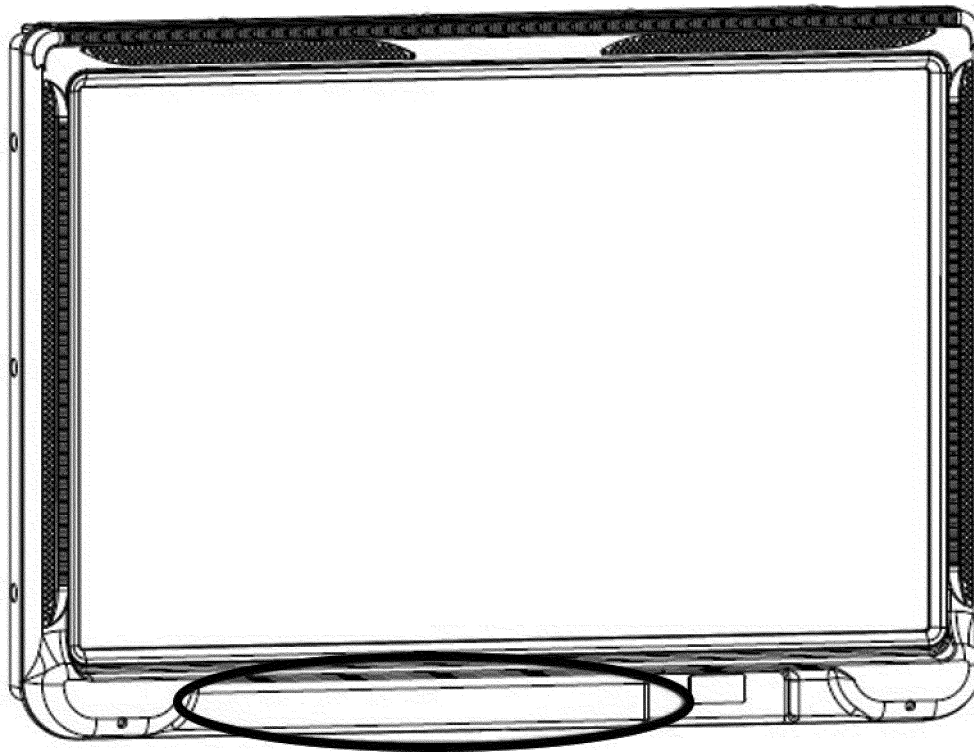
Figure 1 to paragraph (g)(1)(iii); placard location on bezel

This AD was prompted by a conflict between the traffic collision avoidance system (TCAS) primary display indications and aural alerts during a resolution advisory (RA) scenario. The FAA is issuing this AD to prevent conflicting TCAS information, which could result in the pilot under-correcting or over-correcting and may lead to inadequate aircraft separation and a mid-air collision.

(ii) Fabricate a placard for each aircraft primary flight display, using at least 1/8 inch letters, with the following text: TCAS Flight Ops—TA Only mode (TA/RA mode prohibited).

(iii) Install the placard on the bottom of each aircraft primary flight display bezel in the area depicted in figure 1 to paragraph (g)(1)(iii) of this AD.
