[Docket No. FAA–2011–0994; Directorate Identifier 2010–NM–143–AD; Amendment 39–16949; AD 2012–03–08]

Airworthiness Directives; Bombardier, Inc. Airplanes

2012–03–08 Bombardier Inc.: Amendment 39–16949; Docket No. FAA–2011–0994; Directorate Identifier 2010–NM–143–AD.

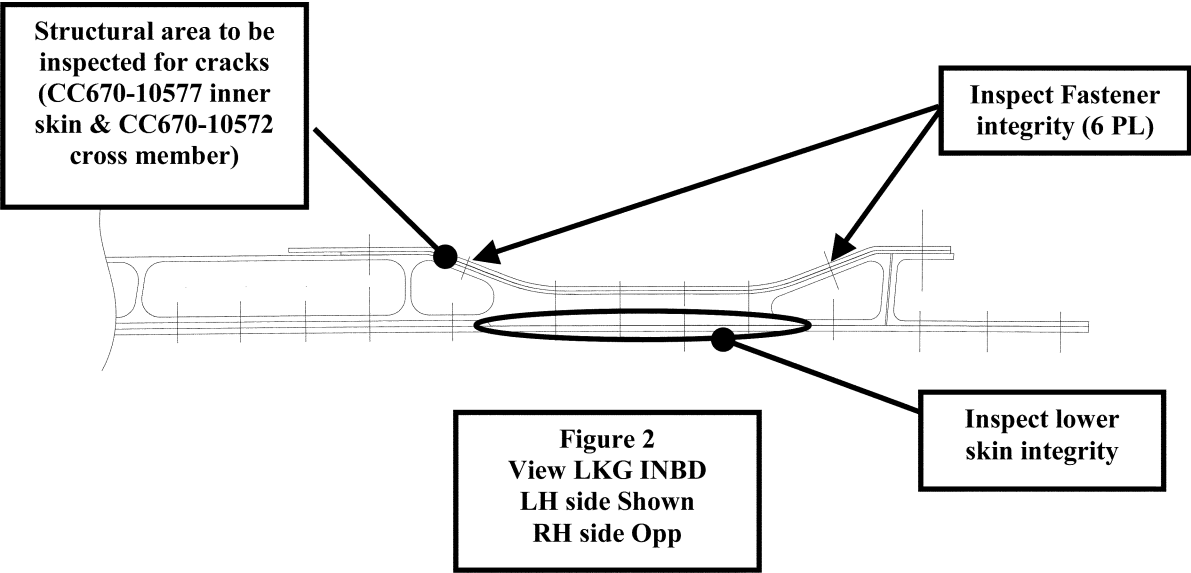
(1) Inspect the cross member, P/N CC670–10572, of the MLG door lower panel for cracking or deformation, in accordance with Figure 2 of this AD.

(2) Inspect the inner skin, P/N CC670–10577, of the MLG door lower panel at the cross member (P/N CC670–10572) for cracking or deformation, or pulled or missing fasteners, in accordance with Figure 2 of this AD.

(3) Inspect the outer skin, P/N CC670–10574, of the MLG door lower panel at the cross member (P/N CC670–10572) for cracking or deformation, or pulled or missing fasteners, in accordance with Figure 2 of this AD.

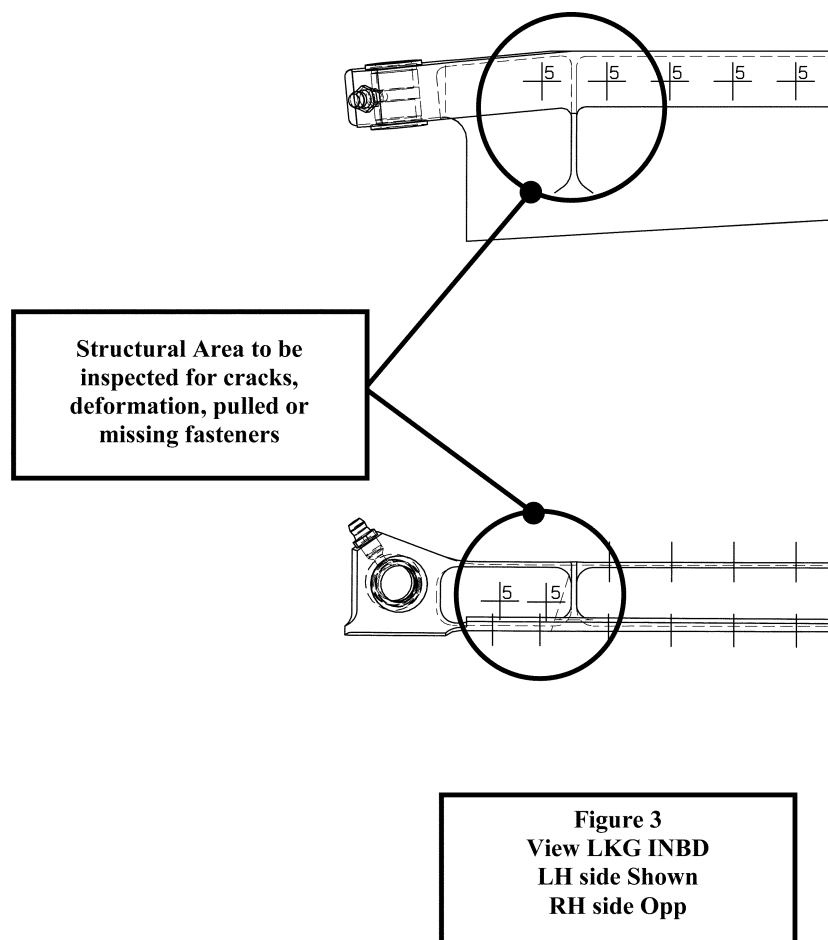
Figure 3
View LKG INBD
LH side Shown
RH side Opp

(4) Inspect the forward member, P/N CC670–10570, and aft member, P/N CC670–10571, of the MLG door lower panel for cracking or deformation, or pulled or missing fasteners, in accordance with Figure 3 of this AD. Figures 1 through 3 of this AD follow.
