[Docket No. FAA-2012-0887; Directorate Identifier 2009-SW-02-AD]

#### Airworthiness Directives; Eurocopter Deutschland GmbH Helicopters

**ACTION:** Notice of proposed rulemaking (NPRM).

**EUROCOPTER DEUTSCHLAND GmbH (ECD):** Docket No. FAA-2012-0887; Directorate Identifier 2009-SW-02-AD.

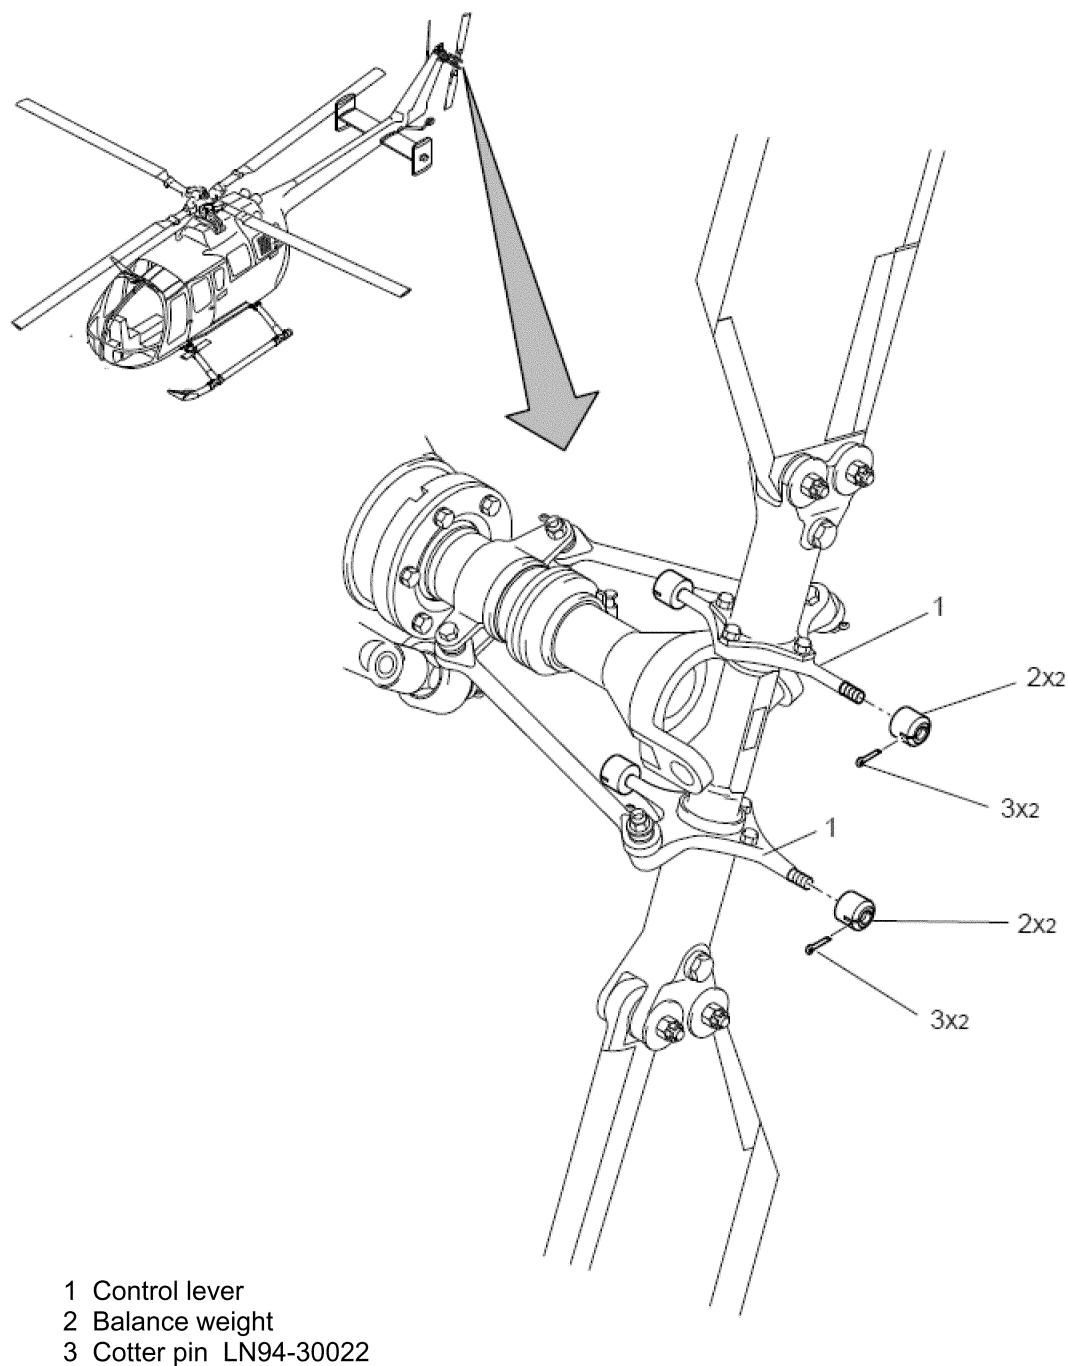
Figure 1 to paragraph (d) Tail Rotor Balance Weights

- (1) Remove the weights from the lever as depicted in Figure 1 to paragraph (d) of this AD. Apply marks to the weights before they are removed in order to be able to re-establish the correct assignment and the old installation position towards the lever when the weights are installed.

(3) Apply corrosion preventive paste onto the thread of the lever and install weights to

the lever as depicted in Figure 1 to paragraph (d) of this AD. Ensure during installation of the weights that the weights are correctly assigned and installed to the control lever in accordance with the applied marks.

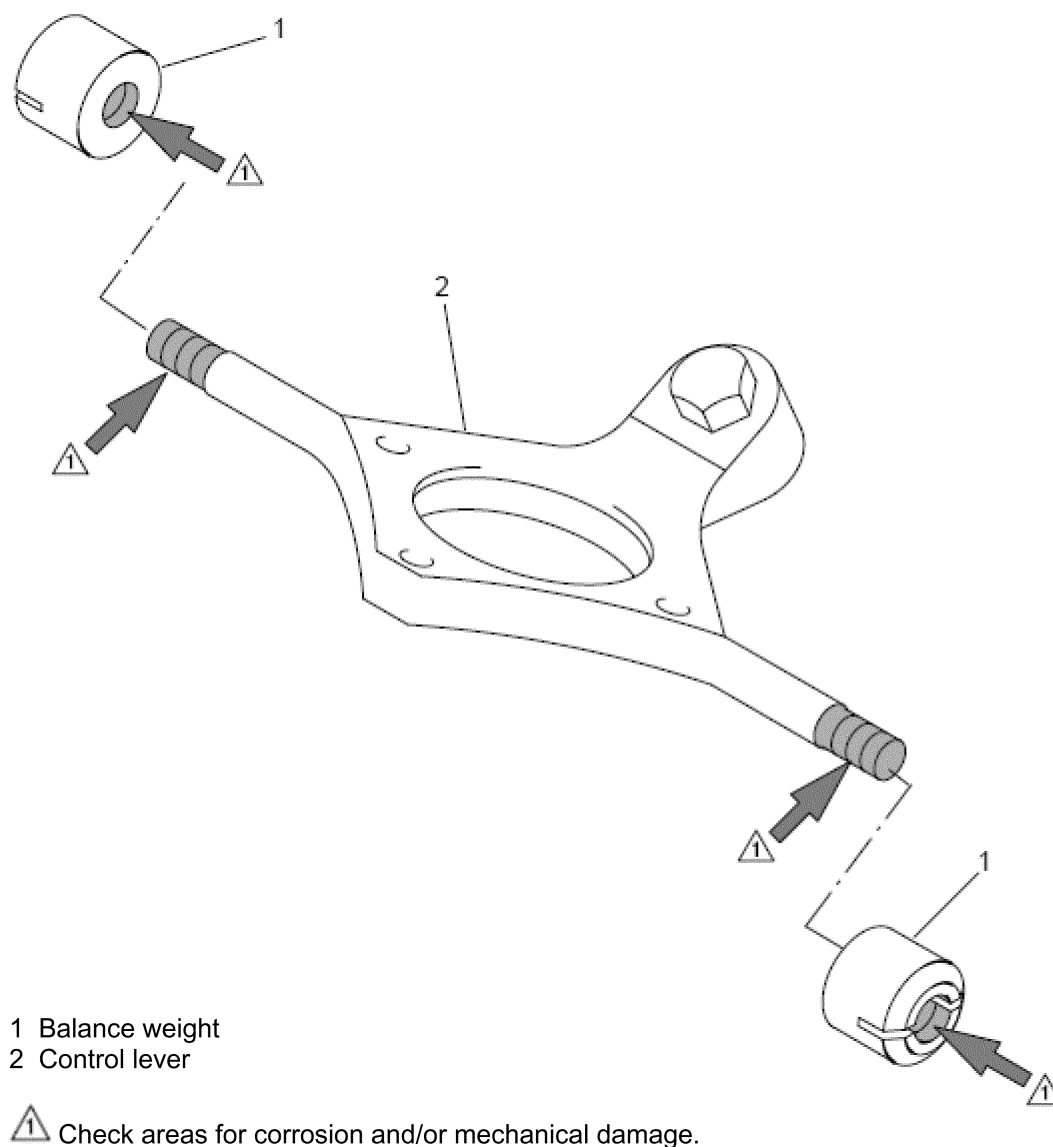
Figure 2 to paragraph (d) Inspection of Balance Weights and Control Lever

(2) Visually inspect each weight and lever for corrosion and damage in the threaded

areas as depicted in Figure 2 to paragraph (d) of this AD.

(A) If the total area of corrosion or thread damage, or both, covers less than 25 percent of the length of the threaded area, the weight can be threaded (screwed) onto the lever, and the cylindrical mating surface has no damage, before further flight, remove the

(B) If the total area of corrosion or thread damage, or both, covers 25 percent or more of the length of the threaded area, the weight cannot be threaded (screwed) onto the lever, or the cylindrical mating surface has damage, before further flight, replace the weight with an airworthy weight by following paragraph (d)(3) of this AD.

(A) If the thread depth does not exceed 0.3 millimeter (mm) and the diameter of the lever in the area before the threaded area is not less than 9.95 mm after polish out, before further flight, install airworthy weights to the lever by following paragraph (d)(3) of this AD.

(B) If the thread depth is 0.3 mm or greater or the diameter of the lever in the area before the threaded area is less than 9.95 mm after polish out, before further flight, replace the lever with an airworthy lever.

(iii) If there is corrosion or thread damage on the threaded portion of the *lever*, polish out the corrosion and thread damage using a polishing cloth 600 and:
