[Docket No. FAA–2015–3989; Directorate Identifier 2014–NM–250–AD]

#### Airworthiness Directives; Airbus Airplanes

**ACTION:** Notice of proposed rulemaking (NPRM).

**Airbus:** Docket No. FAA-2015-3989; Directorate Identifier 2014-NM-250-AD.

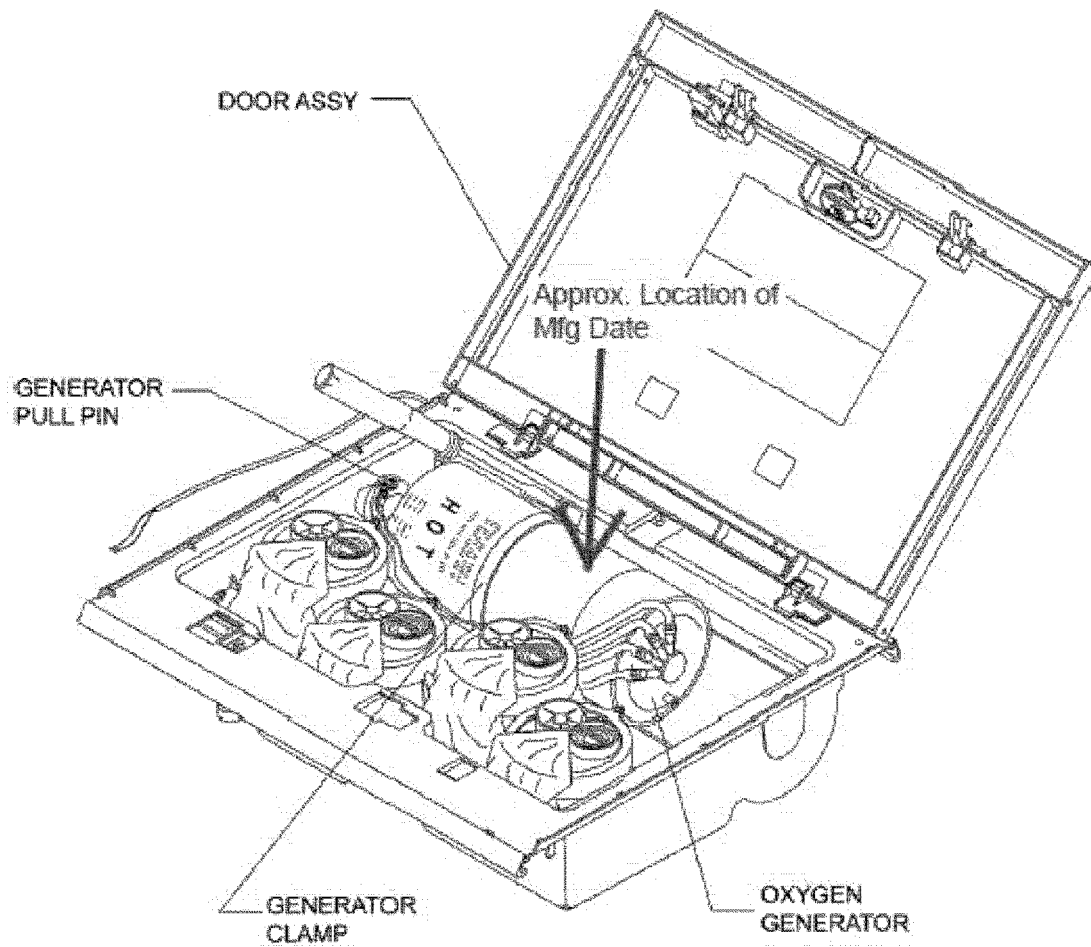
Within 30 days after the effective date of this AD, do a one-time inspection of passenger chemical oxygen generators, part numbers (P/N) 117042-02 (15 minutes (min)-2 masks), 117042-03 (15 min-3 masks), 117042-04 (15 min-4 masks), 117042-22 (22 min-2 masks), 117042-23 (22 min-3 masks), and 117042-24 (22 min-4 masks) to determine the date of manufacture as specified in Airbus Alert Operators Transmission (AOT) A35N006-14, dated December 10, 2014, including Appendix 01. Refer to figure 1 and figure 2 to paragraph (g) of this AD for the location of the date. A review of airplane maintenance records is acceptable for the inspection required by paragraph (g) of this AD, provided the date of manufacture can be conclusively determined by that review.

Figure 1 to paragraph (g) of this AD - location of date (MM-YY)

If, during any inspection required by paragraph (g) of this AD, any passenger chemical oxygen generator having a date of manufacture in 1999, 2000, or 2001 is found: At the applicable time specified in paragraph (h)(1), (h)(2), or (h)(3) of this AD, remove and replace the affected passenger chemical oxygen generator with a serviceable unit, in accordance with the Accomplishment Instructions of B/E Aerospace Service Bulletin 117042-35-001, dated December 10, 2014 (for 15 minute passenger chemical oxygen generators); and Airbus AOT A35N006-14, dated December 10, 2014, including Appendix 01 (for 22 minute passenger chemical oxygen generators).

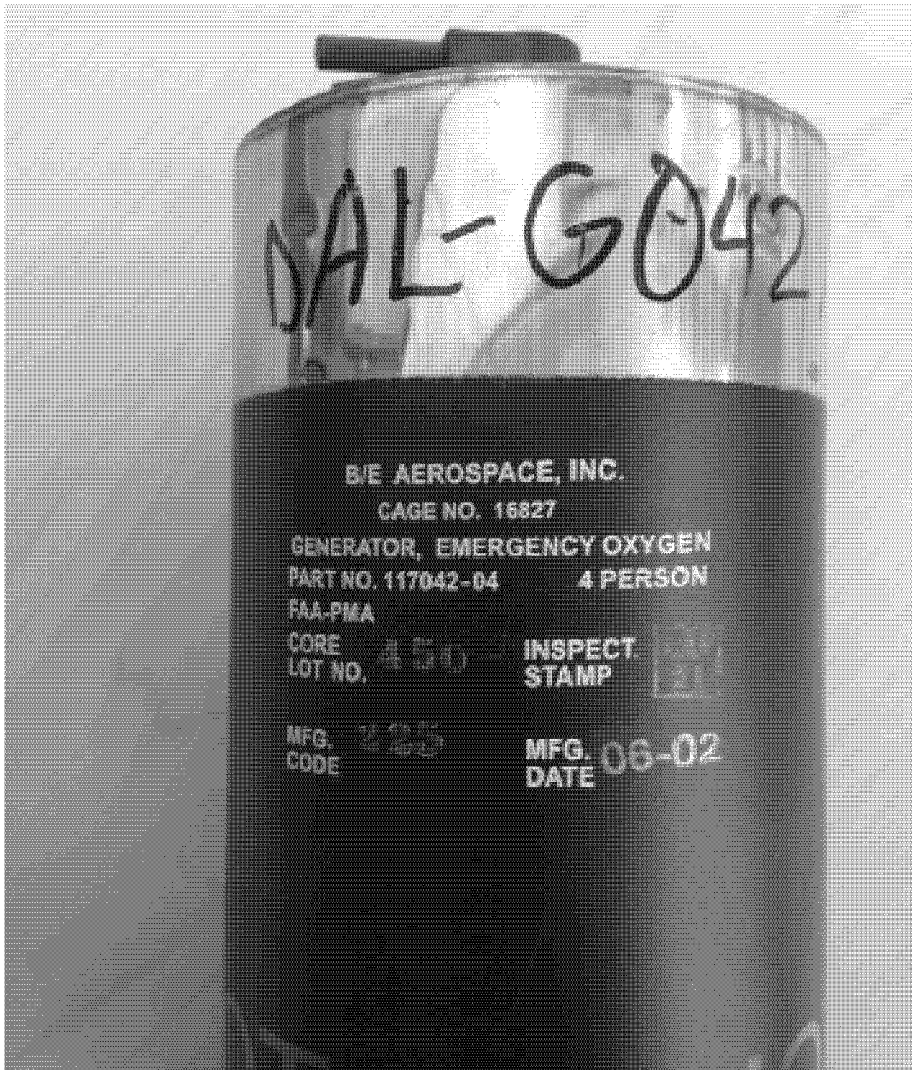
Figure 2 to paragraph (g) of this AD - MFG.DATE (06-02 = June 2002) example
