[Docket No. 99-SW-86-AD; Amendment 39-11737; AD 2000-10-13]

#### **Airworthiness Directives; Eurocopter France Model SA-365N, SA-365N1, AS-365N2 and AS-365N3 Helicopters**

#### **AD 2000-10-13 Eurocopter France:**

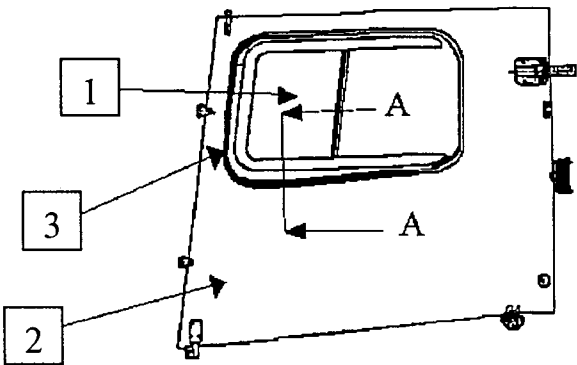
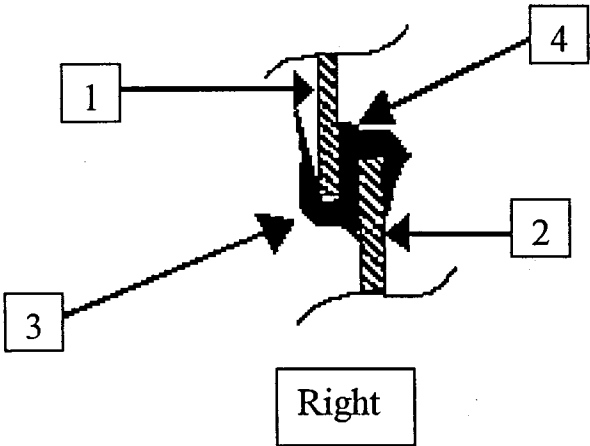
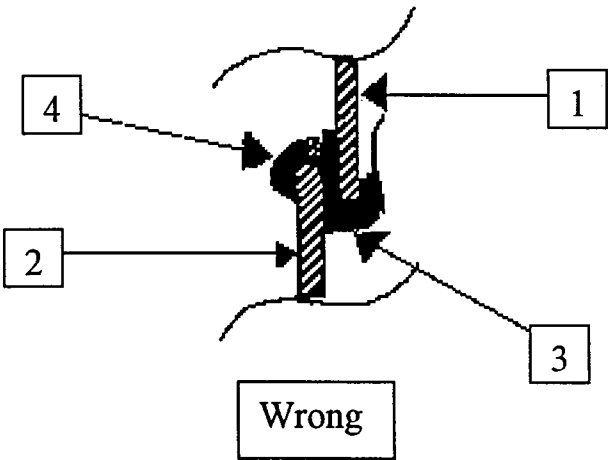
Figure 1

(a) Visually inspect each window panel in any enlarged sliding door (door) for correct positioning on the inside of the door. See Figure 1.

- 1 - Window
- 2 - Door Structure
- 3 - Seal
- 4 - Sealant

(2) If a window is installed on the outside, before further flight, remove the window and reinstall using a new seal.

a. From inside the door, cut the seal (see Figure 1, item 3). Push the window out and remove remnants of the seal from the window panel and door structure.

b. Remove all traces of the sealing compound (see Figure 1, item 4) with methyl ethyl ketone (MEK), acetone, or equivalent.

h. Apply PR1222 sealant between the seal and the door structure. Wipe off any excess sealant.
