#### DEPARTMENT OF TRANSPORTATION

##### National Highway Traffic Safety Administration

[Docket No. NHTSA 2001–11041; Notice 1]

##### Toyota Motor Corporation; Receipt of Application for Decision of Inconsequential Noncompliance

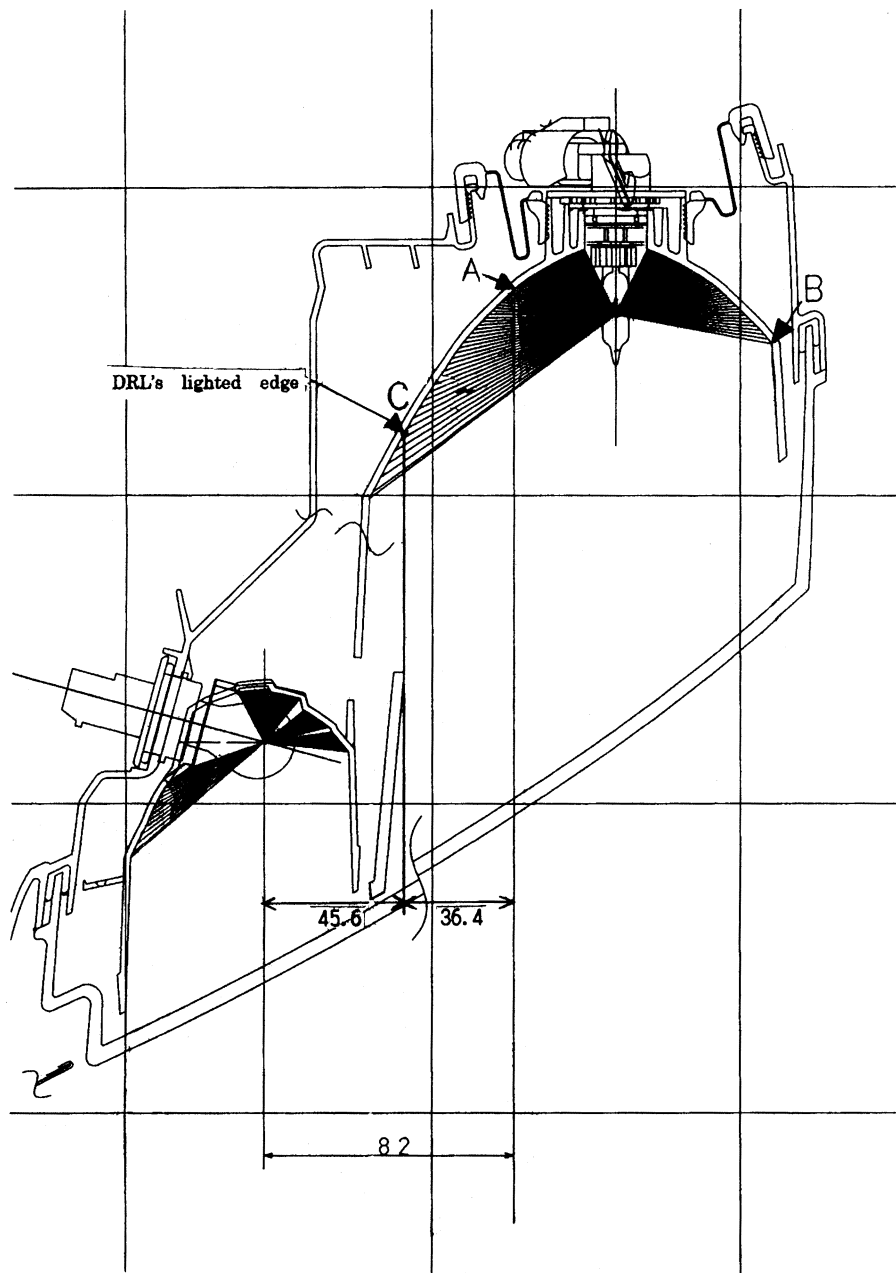
The DRLs on the Celica are provided by the upper beam headlamps operating at a lower intensity, with each lamp having a maximum luminous intensity of roughly 5,880 candelas at test point H–V (as described in FMVSS No. 108 test procedures). S5.5.11(a)(4) of FMVSS No. 108 requires that “\* \* \* if not optically combined with a turn signal lamp, (the DRL) (shall be) located so that the distance from its lighted edge to the optical center of the nearest turn signal lamp is not less than 100 mm, unless \* \* \* the luminous intensity of the DRL is not more than 2,600 candela any location in the beam. \* \* \*” However, for the noncompliant Celicas the distance from the DRL’s lighted edge to the optical center of the nearest turn signal lamp is only 45.6 mm and therefore, the DRLs exceed the maximum luminous intensity specified in section 5.5.11(a)(4)(i) of FMVSS 108.

The substantial distance from the turn signal optical center (bulb filament axes) to the DRL’s lighted edge is 82 mm, exceeding 80% of the requirements. In this case, the “substantial” distance refers to the distance from the turn signal’s optical center to the actual lighted edge “A” (as given by the Figure below), although the theoretical lighted edge is point “C” (45.6mm). In the Figure, the lighted range from A to C of the reflector emits only light which is parallel to the axis of the DRL, which can only be seen by drivers in oncoming vehicles that are looking along the optical axis of the DRL. However, as one moves off center, this light is no longer visible. Therefore, the perceptible DRL’s lighted area, except for the unique case where the eye-point is on the optical axis of the DRL, is actually from A to B (as given in the Figure).
