[Docket No. 99-NM-76-AD; Amendment 39-11540; AD 2000-02-22]

#### **Airworthiness Directives; Boeing Model 747-400 Series Airplanes Equipped with Rolls-Royce RB211-524G/H and RB211-524G-T/H-T Engines**

**ACTION:** Final rule; request for comments.

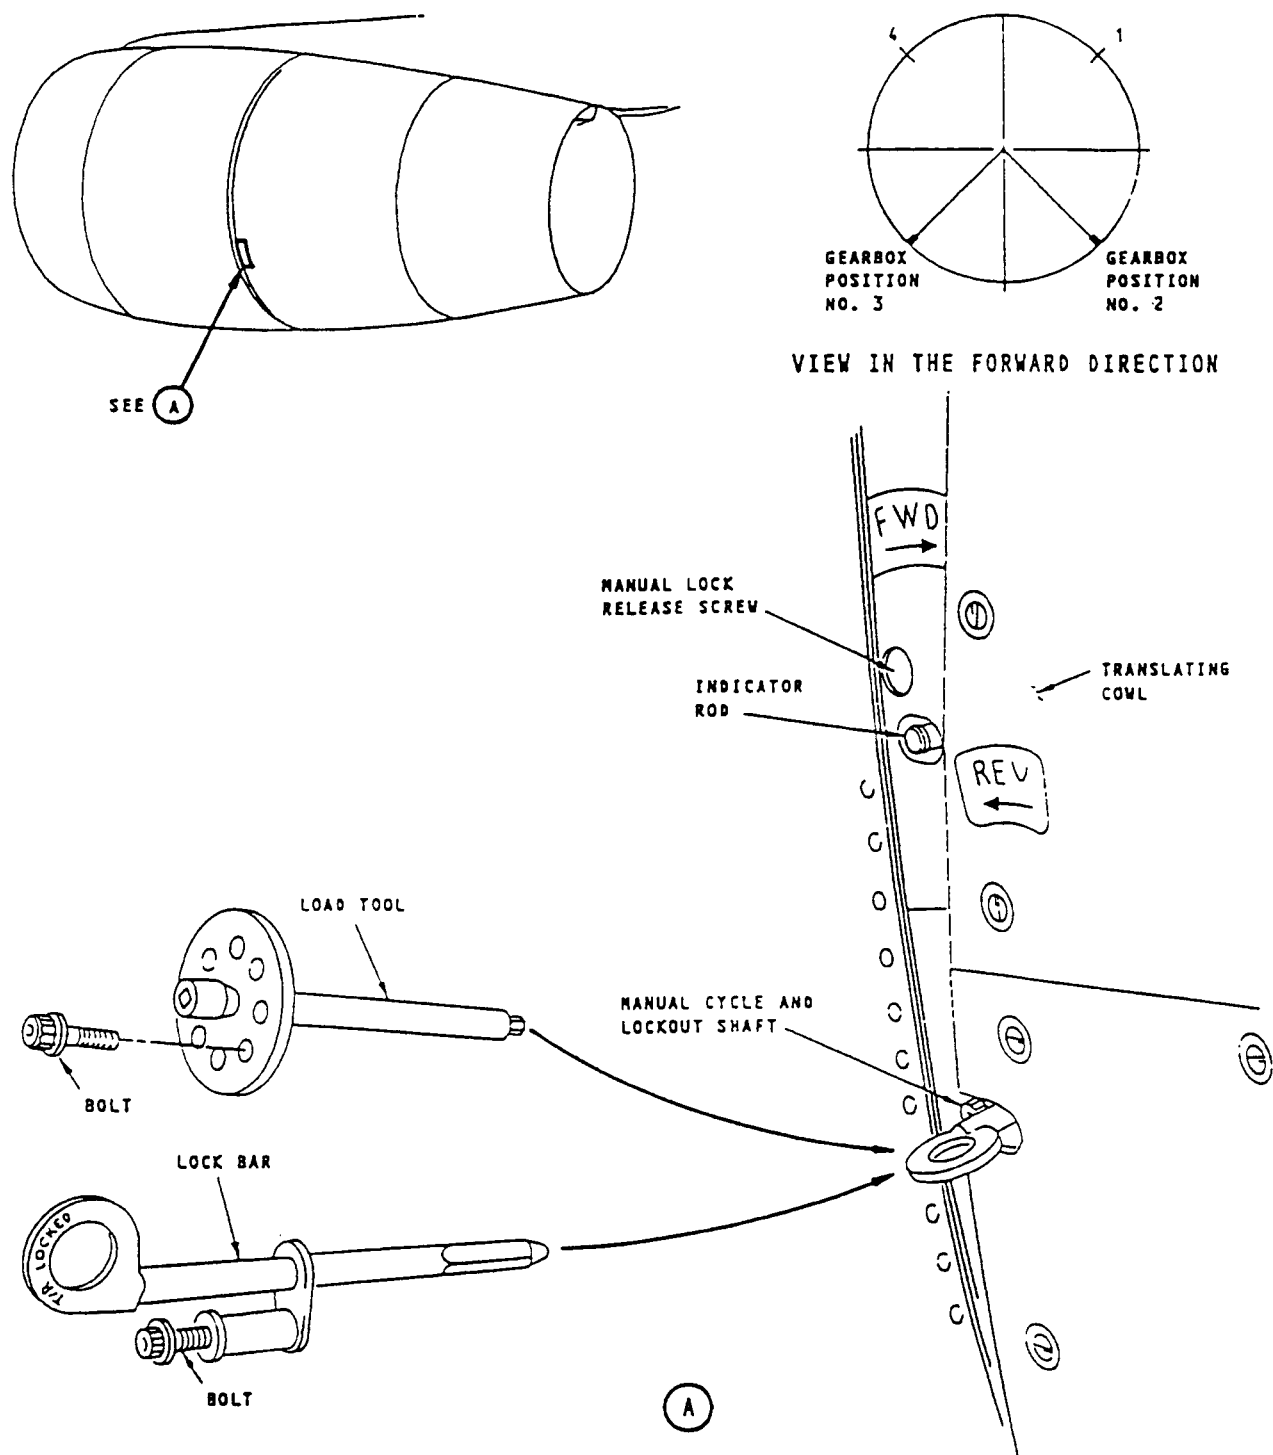
Lock Bar/Load Tool Installation and Gearbox Manual Lock Release  
Figure 1

##### C. Procedure (Fig. 1).

(2) Use a 0.25 inch (6.4 mm) square drive to turn the manual lock release screw to release the No. 2 and No. 3 gearbox locks.

(c) If the translating cowl moves, replace the air motor and shutoff valve.

(b) If the translating cowl moved, lock the thrust reverser until the No. 3 gearbox is replaced.

(b) If the manual cycle and lockout shaft can be turned more than approximately  $\frac{1}{4}$  turn, the second lock dog is unserviceable. Lock the thrust reverser until the No. 3 gearbox is replaced.
