[Docket No. 2003-NE-52-AD; Amendment 39-13381; AD 2003-24-12]

#### Airworthiness Directives; Pratt & Whitney JT9D-3A, -7, -7A, -7F, -7H, -7AH, and -7J Turbofan Engines

**SUMMARY:** The FAA is adopting a new airworthiness directive (AD) for Pratt & Whitney (PW) JT9D-3A, -7, -7A, -7F, -7H, -7AH, and -7J turbofan engines, with gearbox pressure tube, part number (P/N) 697896, and No. 4 bearing front pressure manifold, P/N 670663, installed. This AD requires a one-time visual inspection of the gearbox pressure tube and No. 4 bearing front pressure manifold and the attaching clamp assemblies for correct positioning and for wear and damage, and replacement if necessary. This AD is prompted by a report of a failed gearbox pressure tube that resulted in an engine fire. We are issuing this AD to prevent engine fires caused by failed gearbox pressure tubes or failed No. 4 bearing front pressure manifolds.

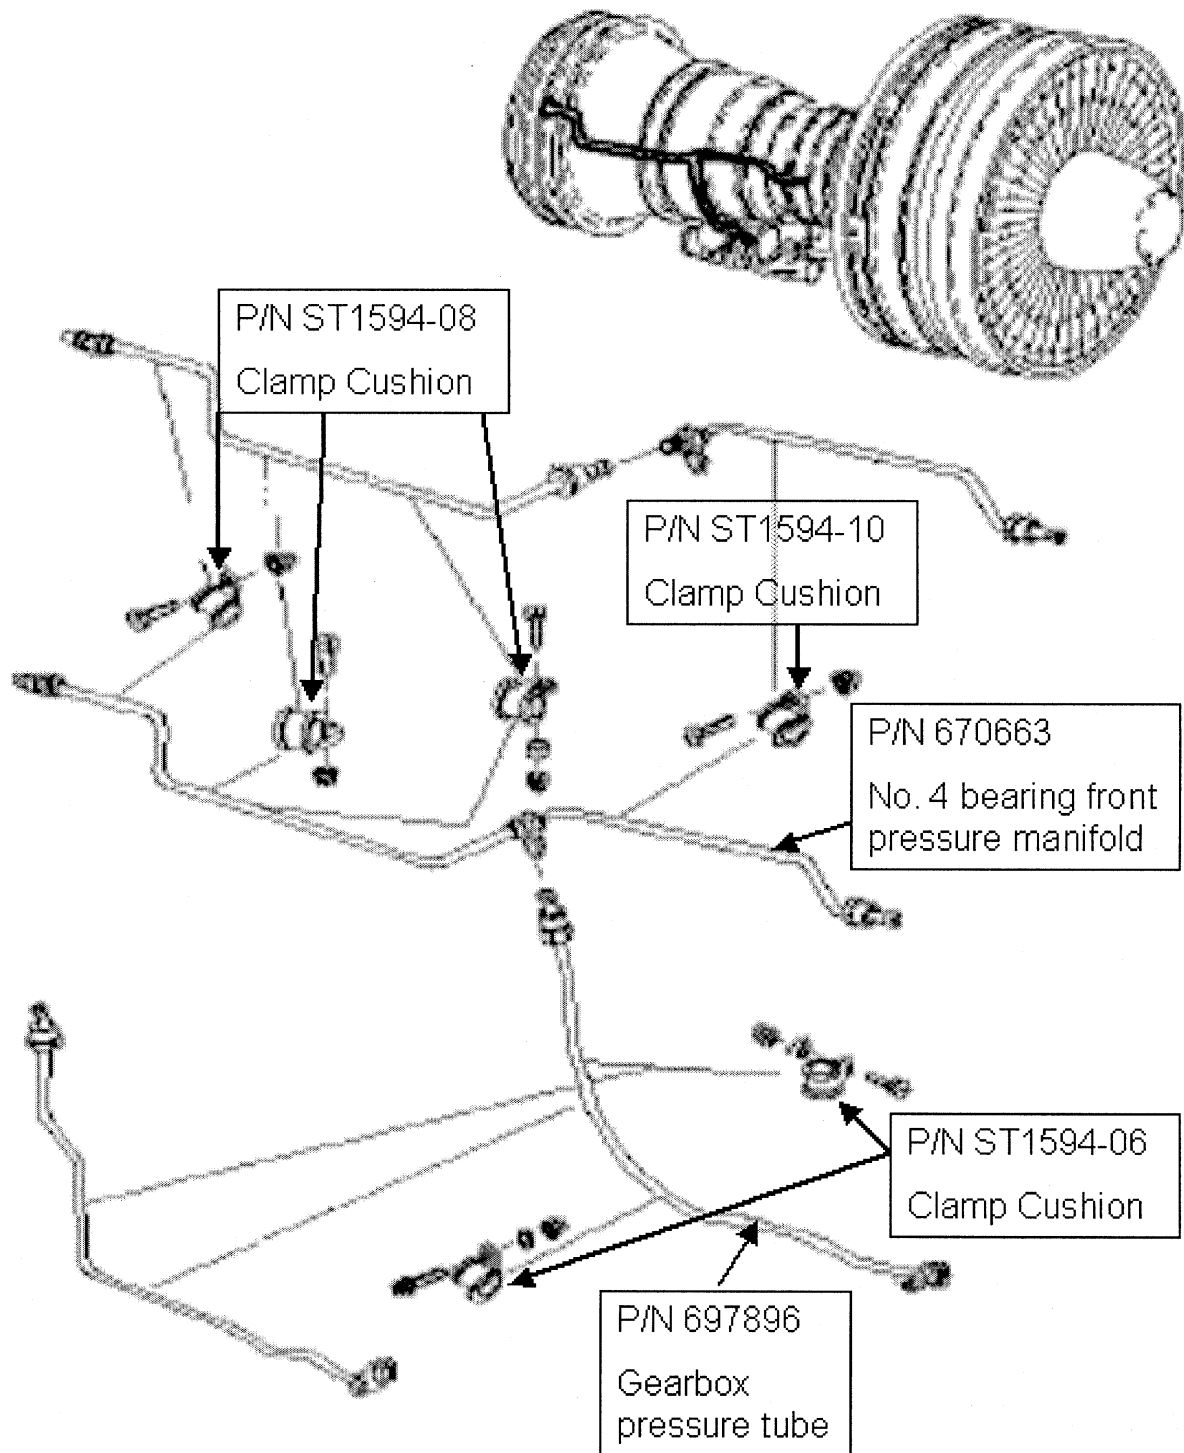
(h) If the gearbox pressure tube, No. 4 bearing front pressure manifold, or clamp assemblies are not properly positioned, then correctly position them before further flight, as shown in the following Figure 1 of this AD.
