[Docket No. 2000-SW-12-AD]

#### Airworthiness Directives; Eurocopter France Model AS350B, B1, B2, BA, C, D, D1, and AS355E, F, F1, F2, and N Helicopters

**ACTION:** Notice of proposed rulemaking (NPRM).

**Eurocopter France:** Docket No. 2000-SW-12-AD. Supersedes AD 98-24-35 Amendment 39-10921, Docket No. 98-SW-41-AD.

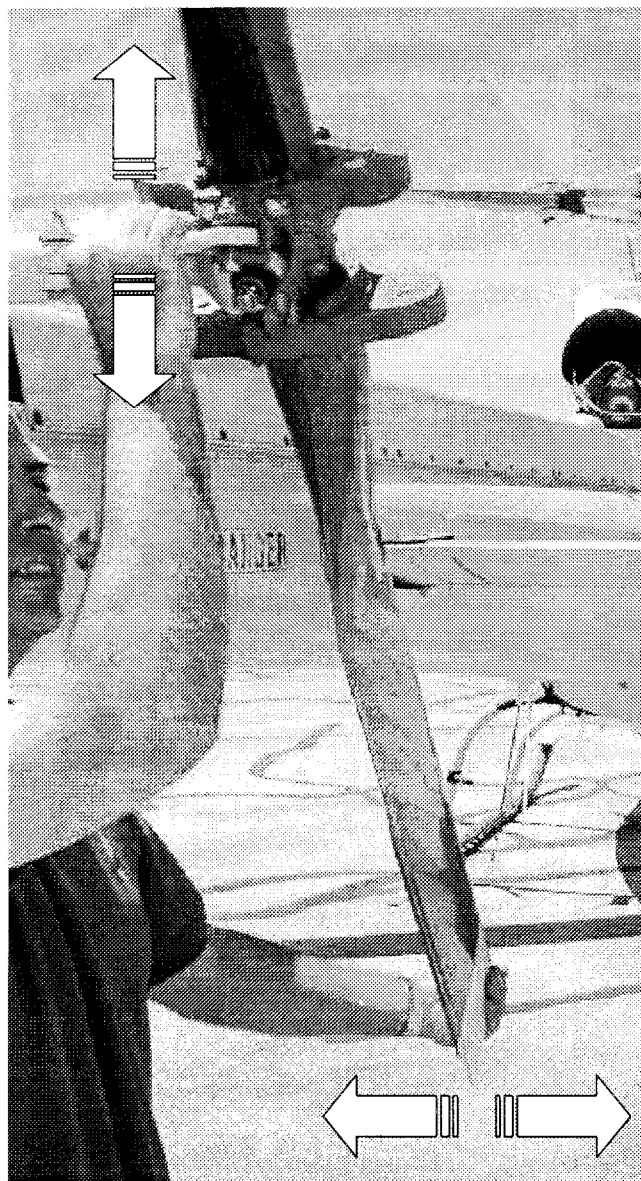
Figure 1: Manual Inspection for play of the Tail Rotor Pitch Control Rod

(a) Before the first flight of each day, configure the helicopter by ensuring the tail rotor pedals are in neutral position. If the helicopter is fitted with a tail rotor load compensator, discharge the accumulator as described in the flight manual. Inspect the bearing for play (Figure 1) on the helicopter, by observation and feel, by slightly moving the tail rotor blade in the flapping axis while monitoring the bearing for movement.

(1) If the Teflon cloth is found to be coming out of its normal position within the bearing, totally or partially, replace the control rod with an airworthy control rod before further flight.

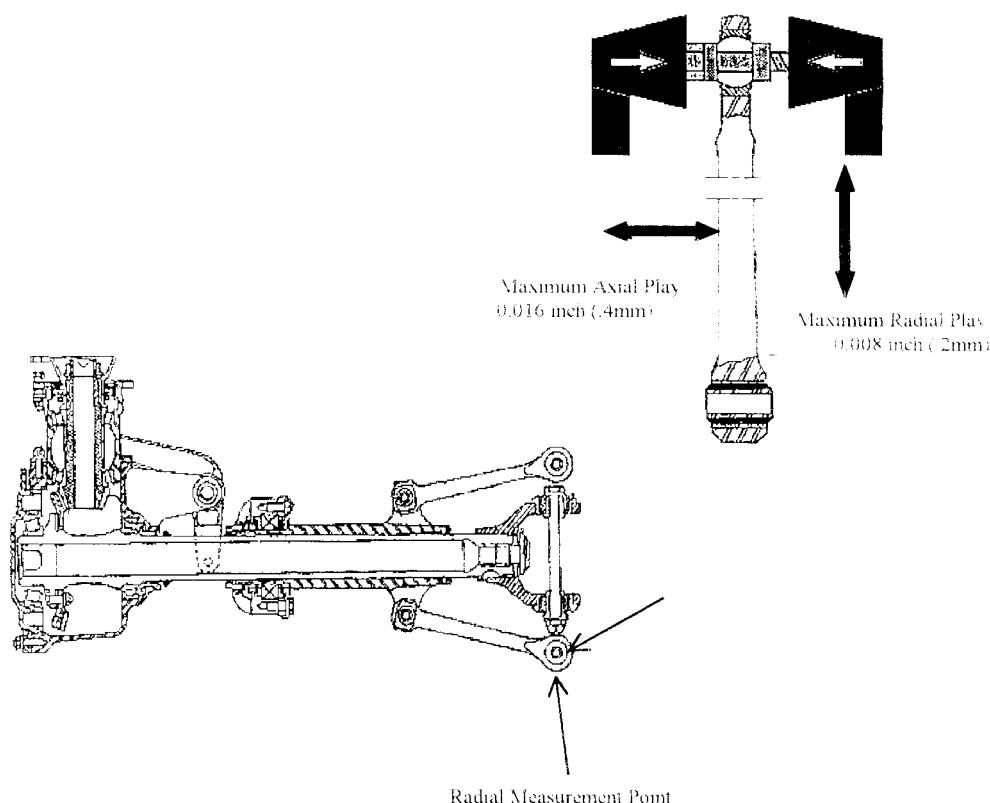
Figure 2. Play Measurement on Tail Rotor Pitch Control Rod

(2) If play is detected, measure the bearing wear using a dial indicator as shown in Figure 2. Perform the following steps (Figure 2) unless they were accomplished within the last 30 hours TIS.

(vii) If the radial play exceeds 0.008 inch or axial play exceeds 0.016 inch, replace the

control rod with an airworthy control rod before further flight.

(i) Remove the control rod.

(ii) Install a bolt, washers, and a nut to secure the bearing.

(iii) Mount the bearing in a vise as shown in Figure 2.

(iv) Using a dial indicator, take two radial measurements in the areas shown by the two arrows.

(v) Take axial measurements in the area shown by an arrow.

(vi) Record the hours of operation on each control rod.

(3) If the radial and axial play are within limits, reinstall the control rod.

(4) At intervals not to exceed 30 hours TIS, remove the control rod and measure the bearing wear with a dial indicator (Figure 2) using steps (a)(2)(i) through (a)(2)(vii).
