**[Docket No. FAA–2012–0415; Directorate Identifier 2008–SW–065–AD]**

#### **Airworthiness Directives; Bell Helicopter Textron, Incorporated Helicopters**

**Bell Helicopter Textron, Inc. (BHTI):** Docket No. FAA–2012–0415; Directorate Identifier 2008–SW–065–AD.

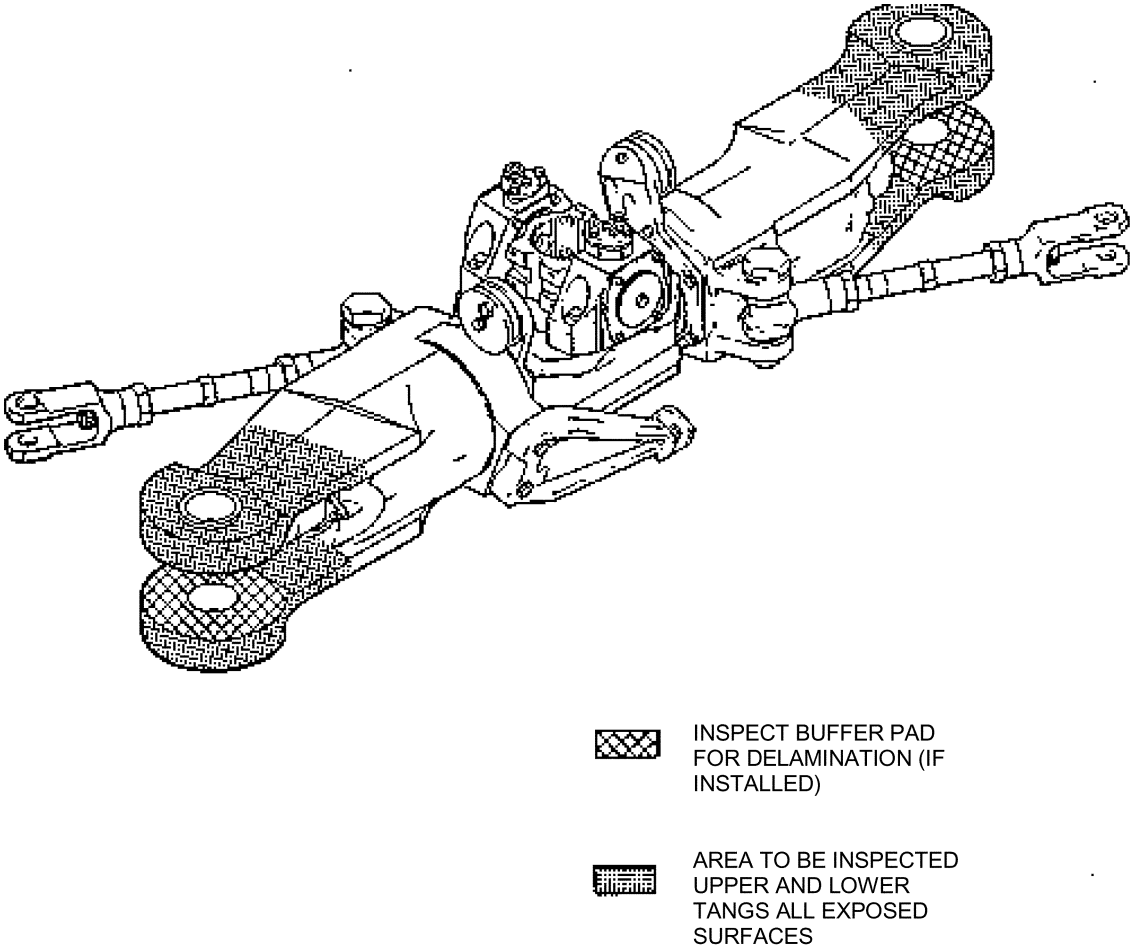
Figure 1. Inspection of Main Rotor Hub Grip Tangs

- (i) Clean the exposed surfaces of the upper and lower tangs of each grip with denatured alcohol, and wipe dry.
- (ii) Using a 10-power or higher magnifying glass, visually inspect the exposed surfaces of the upper and lower tangs of each grip for a crack. Pay particular attention to the lower surface of each lower grip tang from the main rotor blade bolt-bushing flange to the leading and trailing edge of each grip tang. See Figure 1 of this AD.

- (i) Remove each main rotor blade, and
- (ii) Inspect each grip buffer pad on the inner surfaces of each grip tang for delamination (see Figure 1 of this AD). If there is any delamination, remove the buffer pad and inspect the grip surface for corrosion or other damage.

- (i) Replace any cracked grip with an airworthy grip.
- (ii) Replace any grip with any corrosion or other damage with an airworthy grip, or repair the grip if the corrosion or other damage is within the maximum repair damage limitations found in the applicable Component and Repair Overhaul Manual.
- (iii) Replace any grip, P/N 204-011-121-009 or ASI-4011-121-9, which has been in service for 15,000 or more hours TIS.
- (iv) Replace any grip, P/N 204-011-121-121, which has been in service for 25,000 or more hours TIS.
