[Docket No. 2001–SW–54–AD]

#### Airworthiness Directives; Bell Helicopter Textron Canada Model 407 Helicopters

**ACTION:** Notice of proposed rulemaking (NPRM).

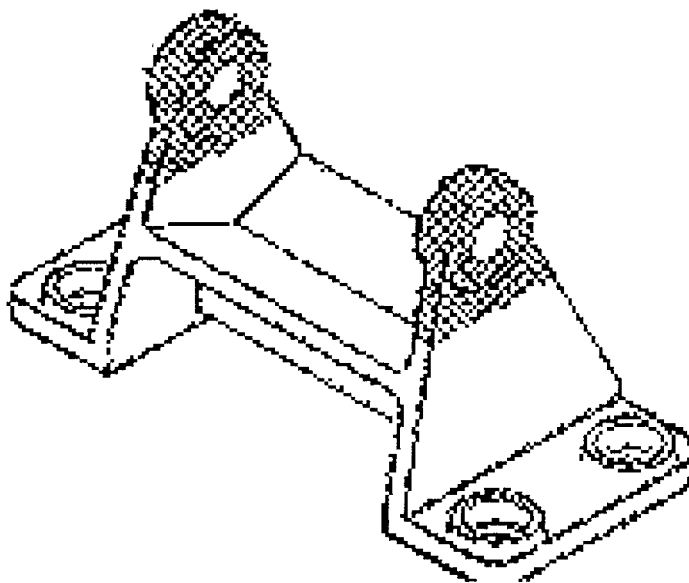
**Figure 1**

**SUMMARY:** This document proposes adopting a new airworthiness directive (AD) for Bell Helicopter Textron Canada (BHTC) Model 407 helicopters. This proposal would require visually inspecting the forward hanger bearing bracket (bracket). This proposal is prompted by reports of cracks in the bracket. The actions specified by this proposed AD are intended to detect a crack in the bracket, to prevent loss of tail rotor drive or tail rotor control and subsequent loss of control of the helicopter.

(a) Within 25 hours time-in-service (TIS) and thereafter at intervals not to exceed 25 hours TIS, visually inspect each bracket, P/N 407-040-321-101 or -103, for a crack in the shaded area shown in Figure 1 of this AD. Remove any cracked bracket from service.

## Bracket P/N 407-040-321-101/-103

This unsafe condition is likely to exist or develop on other helicopter models of the same type design registered in the United States. Therefore, the proposed AD would require initial and repetitive visual inspections for a crack in certain brackets and if a crack is found, removing the bracket before further flight.
