[Docket No. 2001-SW-28-AD; Amendment 39-12479; AD 2001-22-01]

**Airworthiness Directives; Enstrom Helicopter Corporation Model F-28, F-28A, F-28C, F-28F, 280, 280C, 280F and 280FX Helicopters**

**ACTION:** Final rule; request for comments.

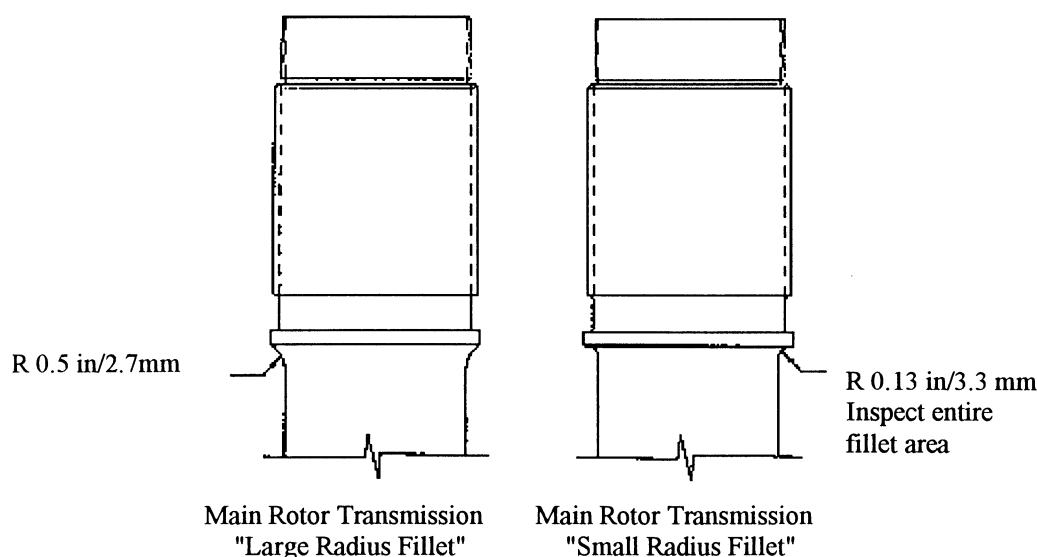
**Figure 1. Main Rotor Shaft Inspection**

The FAA and the National Transportation Safety Board (NTSB) investigated the accident involving the failure of a shaft on the EHC Model F28A helicopter. The shaft was designed with a small upper fillet radius of 0.13 inch and failed due to a fatigue crack. Such a shaft design causes a high stress concentration. That, coupled with the occurrence of more frequent than anticipated high flight load conditions, can accelerate the development of fatigue cracks. Preliminary investigation revealed that the shaft installed in the transmission, P/N 28-13101-1-R, failed because of a fatigue crack in the fillet area of the shaft directly beneath the main rotor hub. The FAA concluded, based on its investigation and after reviewing NTSB Report 01-052, dated April 13, 2001, that an inspection should be made of such shafts for cracks before further flight. The FAA determined that since inspections for cracks are imprecise and detection of all existing cracks is uncertain, a shaft with a small radius fillet should be replaced with an airworthy shaft with a large radius fillet on certain model helicopters within 300 hours time-in-service (TIS).

(a) Before further flight, determine the part number (P/N) of the main rotor transmission (transmission) and the radius of the upper fillet of the shaft (see Figure 1).

(2) If the installed transmission is P/N 28-13101-1 or -1-R and has a small radius shaft, before further flight and thereafter at intervals not to exceed 25 hours TIS, visually inspect each transmission for a crack in the shaft upper fillet using a 10X or higher magnifying glass.

(i) Dye-penetrant inspect the shaft upper fillet for a crack, a nick, or a scratch.

(ii) If the shaft is cracked, before further flight, replace the transmission with an airworthy transmission having a large radius shaft fillet.

(iii) If the shaft is cracked or has a nick or scratch 0.005 inch or more deep, replace the transmission with an airworthy transmission having a large radius shaft fillet before further flight.

(4) Within 300 hours TIS or at the next overhaul after the effective date of this AD, whichever occurs first, replace transmission, P/N 28-13101-1 or -1-R, with an airworthy transmission having a large radius shaft fillet.
