**DEPARTMENT OF TRANSPORTATION****Federal Aviation Administration****14 CFR Part 39**

[Docket No. FAA-2012-0415; Directorate Identifier 2008-SW-065-AD; Amendment 39-17865; AD 2014-12-04]

**Airworthiness Directives; Bell Helicopter Textron, Inc. (BHTI) Helicopters**

**2014–12–04 Bell Helicopter Textron, Inc. (BHTI):** Amendment 39–17865; Docket No. FAA–2012–0415; Directorate Identifier 2008–SW–065–AD.

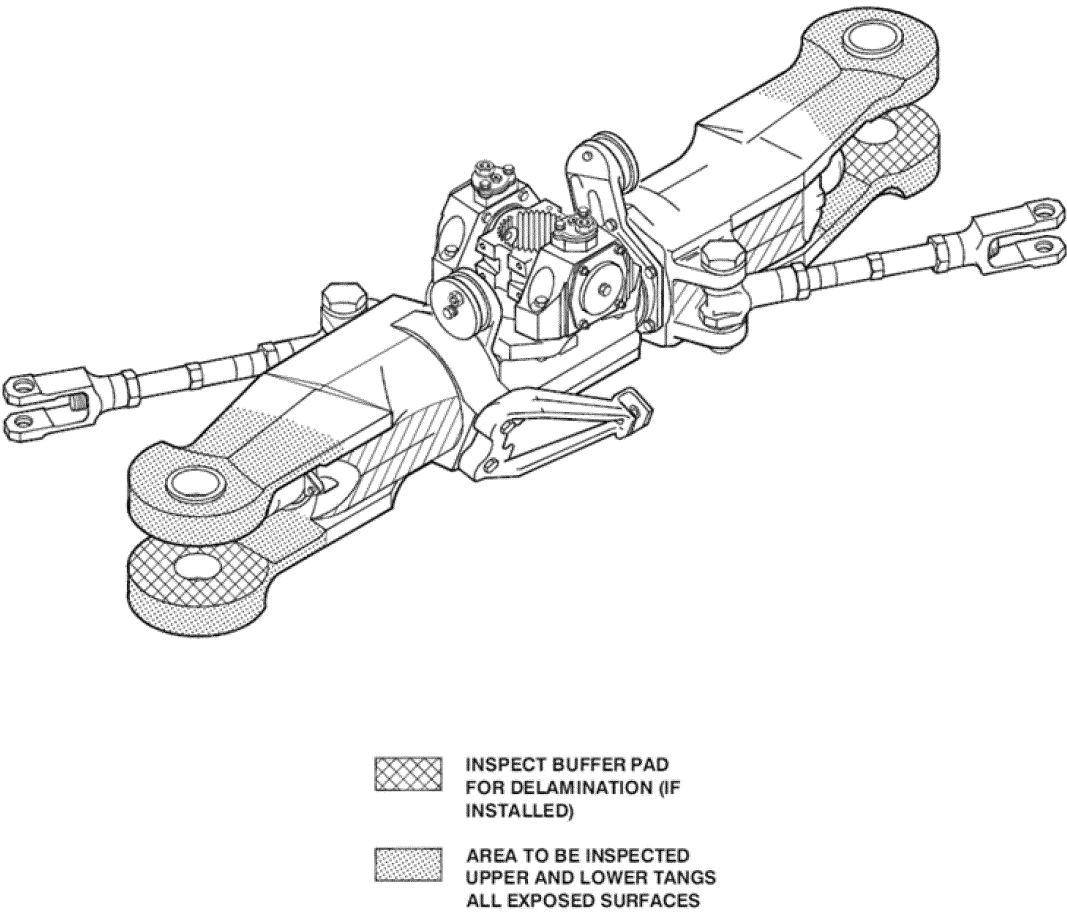
Figure 1 to Paragraphs (f)(2)(ii) and (f)(4)(ii)  
Inspection of Main Rotor Hub Grip Tangs

- (ii) Using a 10-power or higher magnifying glass, visually inspect the exposed surfaces of the upper and lower tangs of each grip for a crack. Pay particular attention to the lower surface of each lower grip tang from the main rotor blade bolt-bushing flange to the leading and trailing edge of each grip tang as depicted in Figure 1 to Paragraphs (f)(2)(ii) and (f)(4)(ii) of this AD.

(ii) Inspect each grip buffer pad on the inner surfaces of each grip tang for delamination as depicted in Figure 1 to Paragraphs (f)(2)(ii) and (f)(4)(ii) of this AD. If there is any delamination, remove the buffer pad and inspect the grip surface for corrosion or other damage.

(i) Replace any cracked grip with an airworthy grip.

(ii) Replace any grip with any corrosion or other damage with an airworthy grip, or repair the grip if the corrosion or other damage is within maximum repair damage limitations.
