## DEPARTMENT OF TRANSPORTATION

[Docket No. 2003-SW-02-AD]

#### Airworthiness Directives; Eurocopter France Model AS350B, B1, B2, B3, BA, and D Helicopters

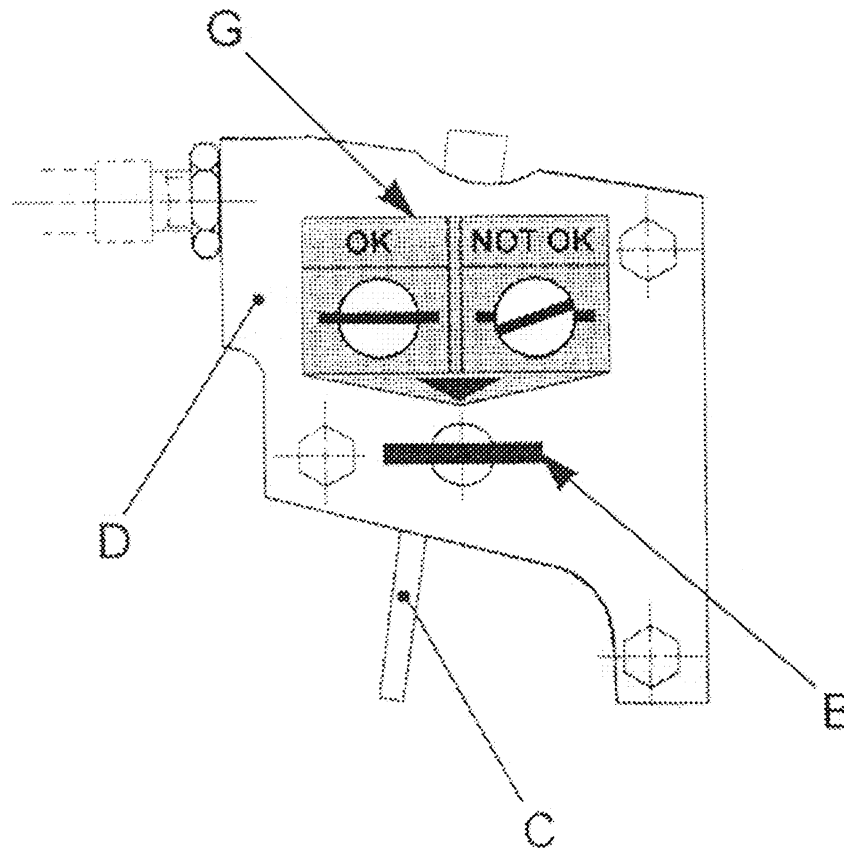
Figure 1

(3) Determine whether the section of reference line (B) marked on the bolt (A) and the section of reference line (B) marked on the cover plate (D) form a straight line.

(i) If the reference line is straight, the cargo hook is considered airworthy.

(ii) If the reference line is not straight, the cargo hook is unairworthy and may not be used.

(c) For cargo hook, P/N AS-21-5-7, without Amendment B, before the next sling load flight, incorporate Amendment B to the cargo hook in accordance with the Accomplishment Instructions, paragraphs 2.A.2.(a) and 2.A.2.(b), of Alert No. 05.00.39, for Model AS 350B3 helicopters; No. 05.00.41, for Model SA-365N, N1, AS-
