To prevent loss of the tail rotor gearbox due to attaching bolts of inadequate grip

[Docket No. 2001-CE-36-AD]

#### **Airworthiness Directives; Air Tractor, Inc. AT-400, AT-500, and AT-800 Series Airplanes**

**ACTION:** Notice of proposed rulemaking (NPRM).

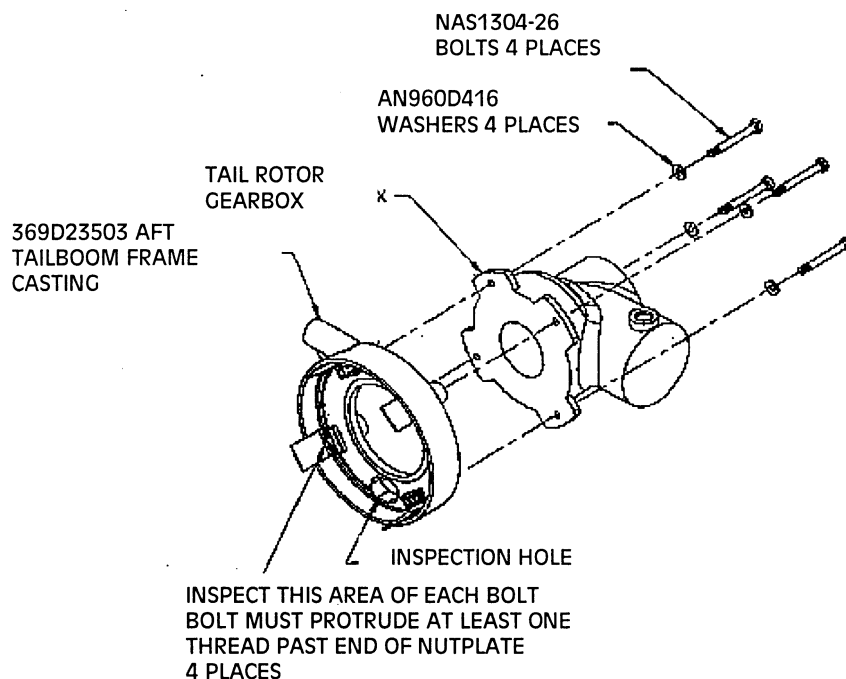
**Figure 1 – Inspection Location**

(2) Remove the tailboom control rod and determine the number of bolt threads protruding from each nutplate on the internal surface of the aft tailboom frame casting, P/

N 369D23503, as shown in Figure 1. At least one thread must protrude. If more than four threads protrude, add an additional washer, P/N AN960D416, under the bolt head. Torque the bolt to 100–110 in-lbs., and reapply a slippage mark.
