[Docket No. FAA–2018–1046; Product Identifier 2018–CE–049–AD]

#### **Airworthiness Directives; Piper Aircraft, Inc. Airplanes**

**ACTION:** Notice of proposed rulemaking (NPRM).

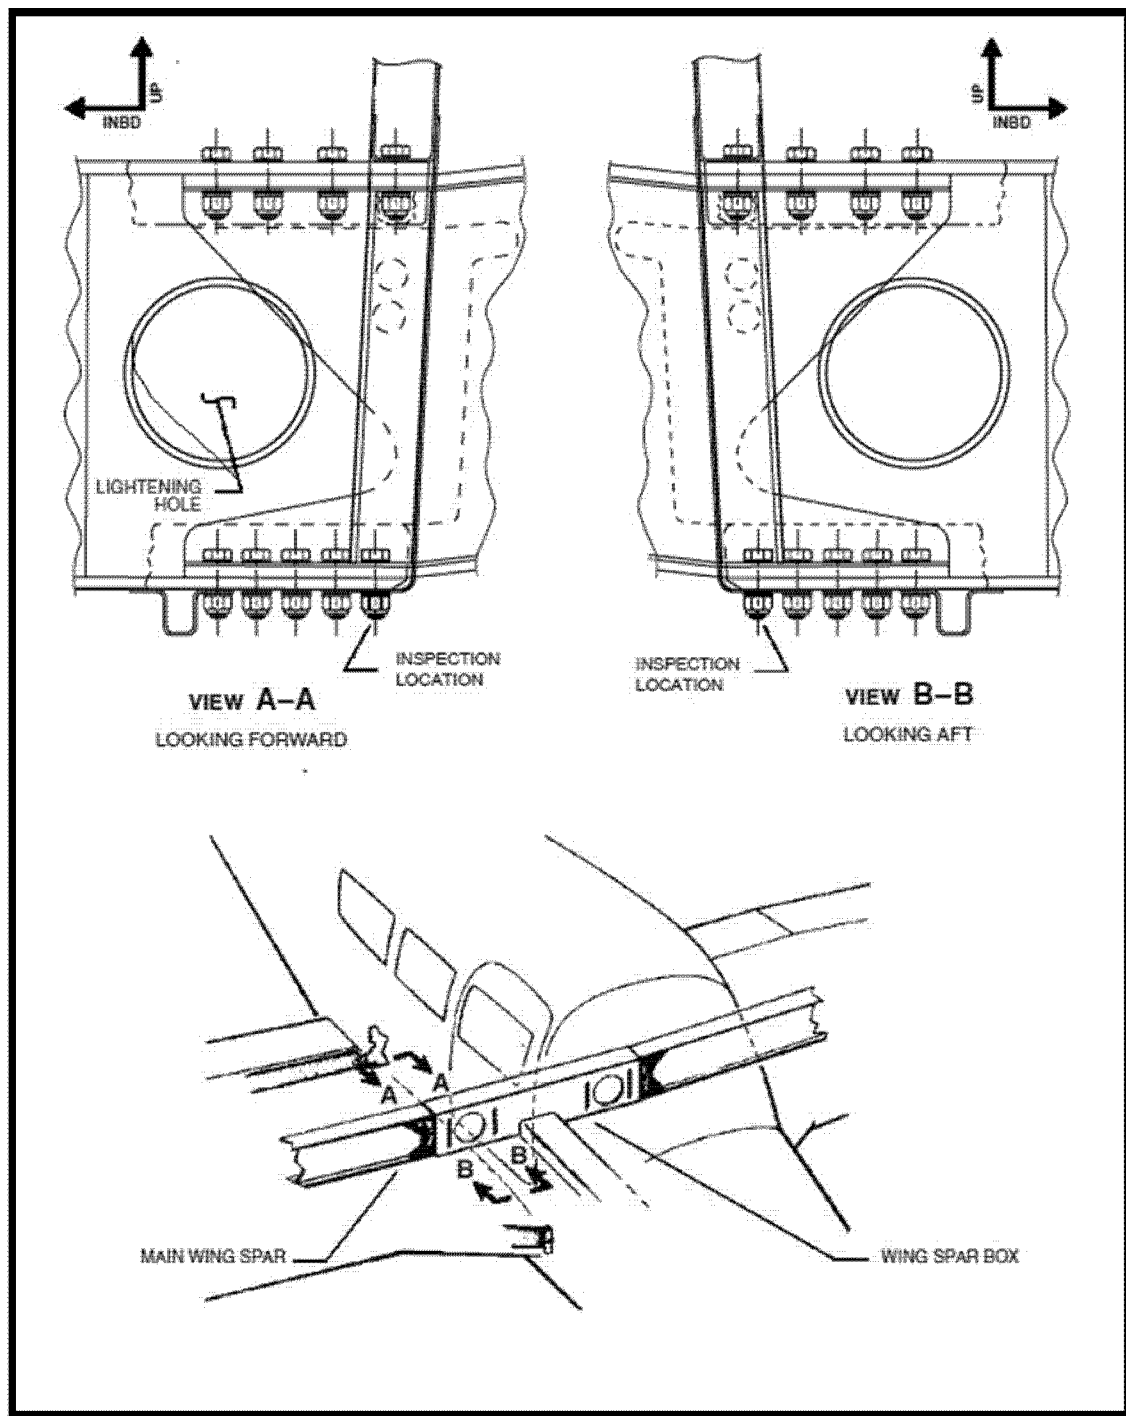
Figure 1. Main Spar Attach Bolt Locations (RH Side Shown)

We received a report of a fatigue crack found in the lower main wing spar cap on a Piper Model PA–28R–201 airplane. An investigation revealed that repeated high-load operating conditions accelerated the fatigue crack growth in the lower main wing spar cap. In addition, because of the structural configuration of the wing assembly, the cracked area was inaccessible for a visual inspection. Model PA–28–140,

This AD was prompted by a report of a fatigue crack found in a visually inaccessible area of the lower main wing spar cap. We are issuing this AD to detect and correct fatigue cracks in the lower main wing spar cap bolt holes. The unsafe condition, if not addressed, could result in the wing separating from the fuselage in flight.

(1) Locate the two (2) lower outboard main spar attach bolts, as shown in Figure 1 of Appendix 1, installed on the lower cap of the main spar, on the forward and aft sides of the spar web.

further flight, replace the main wing spar with a new (zero hours TIS) main wing spar or with a main wing spar that has been inspected as specified in appendix 1 of this AD and no cracks were found.

(3) Use eddy current surface and bolt hole examinations to detect surface and shallow subsurface cracking and discontinuities on the left and right lower outboard spar bolt holes. Use SAE ARP4402, "Eddy Current Inspection of Open Fastener Holes in Aluminum Aircraft Structure," or another FAA-approved eddy current inspection method to do these inspections.
