[Docket No. FAA-2021-0872; Project Identifier MCAI-2021-00312-R; Amendment 39-21866; AD 2021-26-07]

#### Airworthiness Directives; Airbus Helicopters

##### **2021–26–07 Airbus Helicopters:**

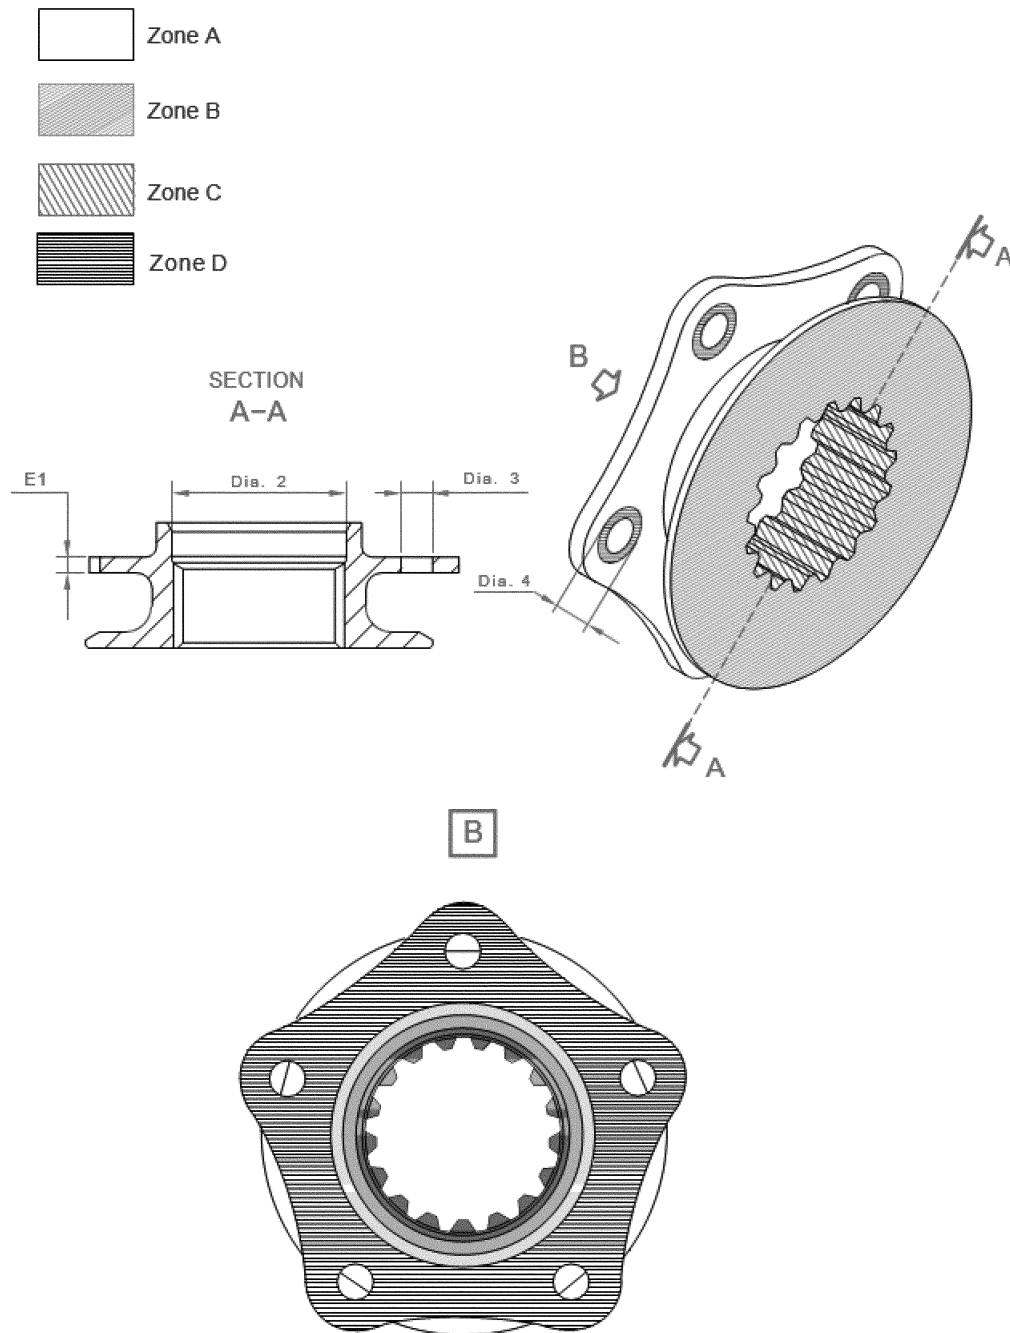
**Figure 2 to paragraph (g)(1)(ii) – Inspection Areas of Tail Rotor Splined Flange**

(ii) Inspect the TR splined flange for corrosion, impacts, fretting, wear, and a crack in the areas identified in Figure 2 to paragraph (g)(1)(ii) of this AD. If the condition of the part (including corrosion, impacts, fretting, wear, or cracks) exceeds the criteria as specified in Figure 1 to paragraph (g)(1)(ii) of this AD, before further flight, remove the splined flange from service and replace with an airworthy part.

<b>Location as specified in Figure 2 to paragraph (g)(1)(ii) of this AD</b>	<b>Maximum damage, which causes replacement (E1, Dia. 2, Dia. 3, and Dia. 4 are shown in Figure 2 to paragraph (g)(1)(ii) of this AD)</b>
Zone A	Scratch depth > 0.2 mm (0.008 in.). Crack. E1 < 2.75 mm (0.108 in.). Dia. 3 > 6.02 mm (0.2371 in.). Dia. 2 > 33.03 mm (1.3004 in.).
Zone B	Touch-up depth > 0.1 mm (0.004 in.). Crack.
Zone C	Crack. Scratch depth > 0.2 mm (0.008 in.).
Zone D [Dia. 4 = 14 mm +/- 0.1 mm (0.548; 0.555in.)]	Touch-up depth > 0.1 mm (0.004 in.). Crack. E1 < 2.75 mm (0.108 in.).
