[Docket No. FAA-2011-1158; Directorate Identifier 2010-SW-018-AD]

#### Airworthiness Directives; Eurocopter France Helicopters

**ACTION:** Notice of proposed rulemaking (NPRM).

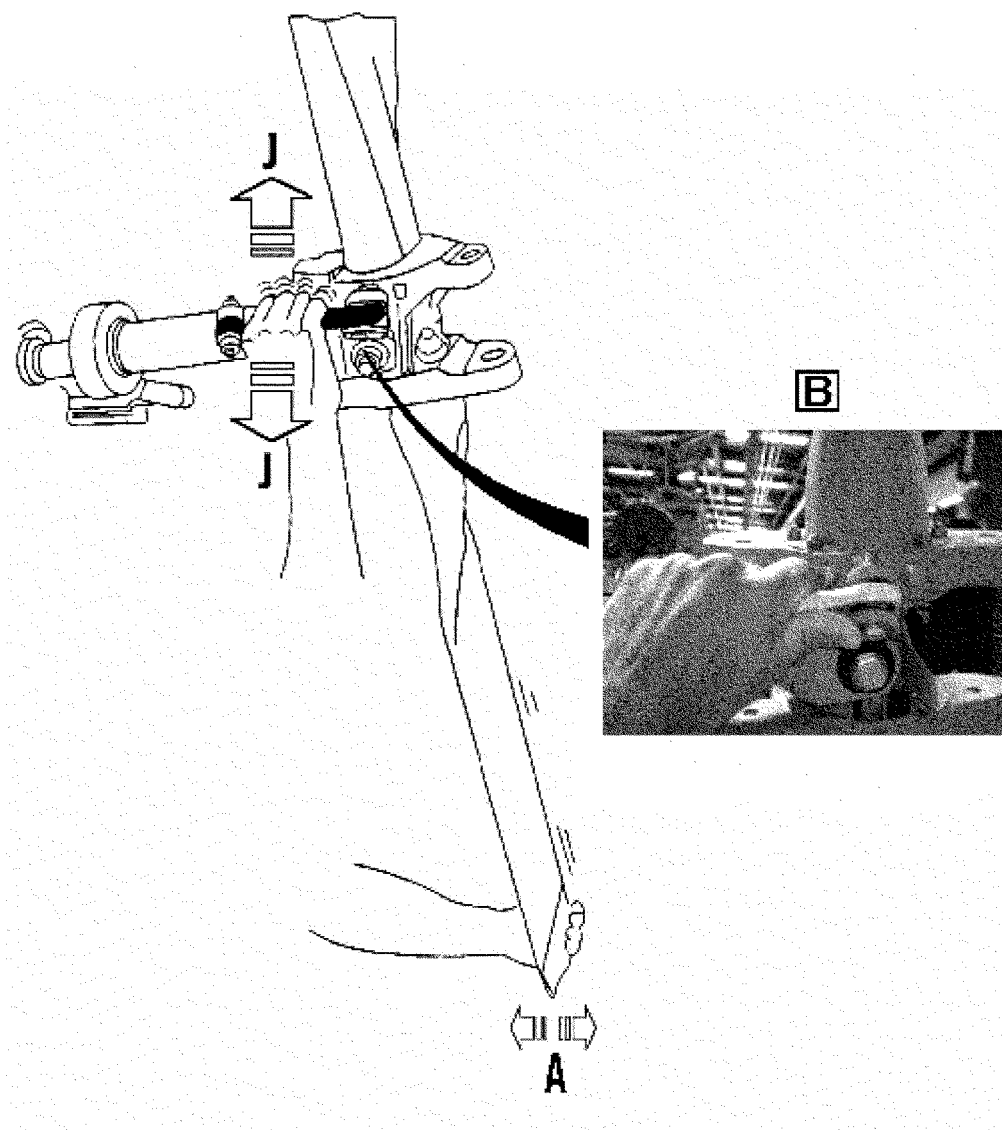
Manual Check for Play of the Tail Rotor Pitch Control Rod  
Figure 1 to Paragraph (f)

This AD defines the unsafe condition as excessive play in the control rod. This condition could result in failure of a T/R control rod, loss of T/R control, and subsequent loss of control of the helicopter.

(1) Within 30 hours time-in-service (TIS) and, if no bearing play is detected, thereafter at intervals not to exceed 30 hours TIS, place the T/R pedals in the neutral position. If the helicopter is fitted with a T/R load compensator, discharge the accumulator as described in the rotorcraft flight manual. Check the control rod bearing (bearing) for play on the helicopter, by observation and feel, by slightly moving the T/R blade in the flapping axis while monitoring the bearing for movement. See the following Figure 1 to Paragraph (f) of this AD. The actions required by this paragraph of may be performed by the owner/operator (pilot) holding at least a private pilot certificate, and must be entered into the helicopter maintenance records showing compliance with this AD in accordance with 14 CFR 43.9(a)(1)–(4) and 14 CFR 91.417(a)(2)(v). The record must be maintained as required by 14 CFR 91.417, 121.380, or 135.439.

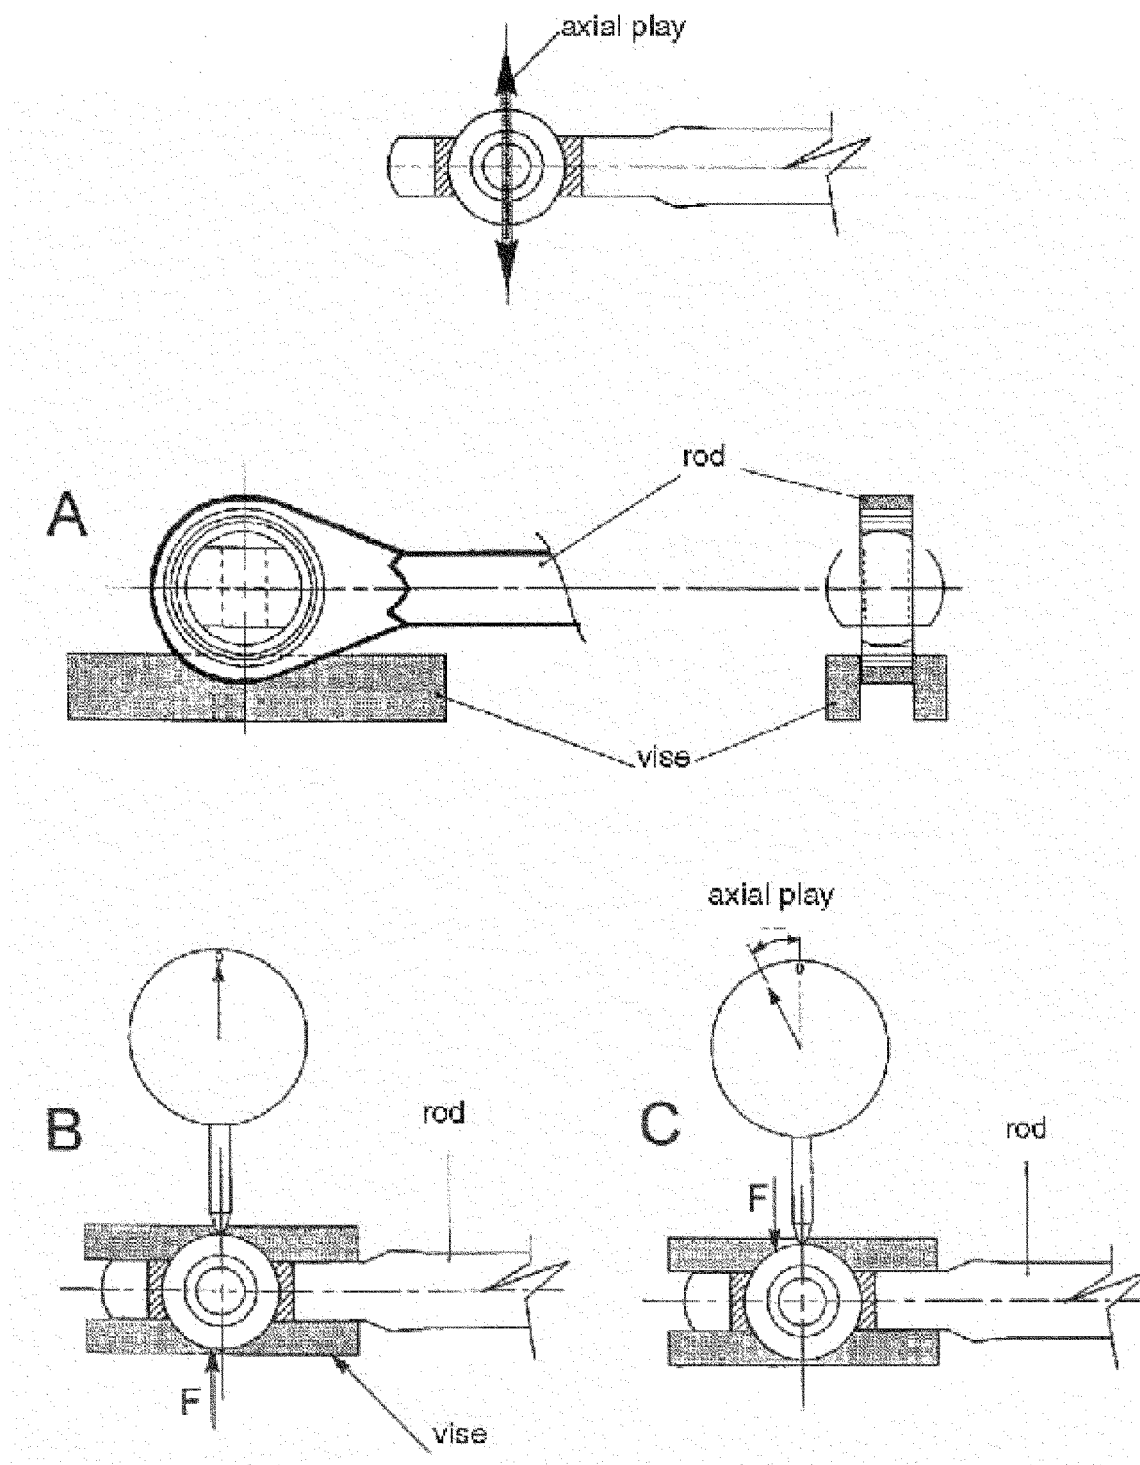
Measurement of the Axial Play (A) of the Bearing

(ii) Mount the control rod in a vise as shown in Figure 2 to Paragraph (f) of this AD.

(iii) Using a dial indicator, take axial play readings by moving the spherical bearing in the direction F (up and down) as shown in Figure 2 to Paragraph (f) of this AD.

(viii) If the radial play exceeds 0.008 inch or axial play exceeds 0.016 inch, replace the control rod with an airworthy control rod before further flight.

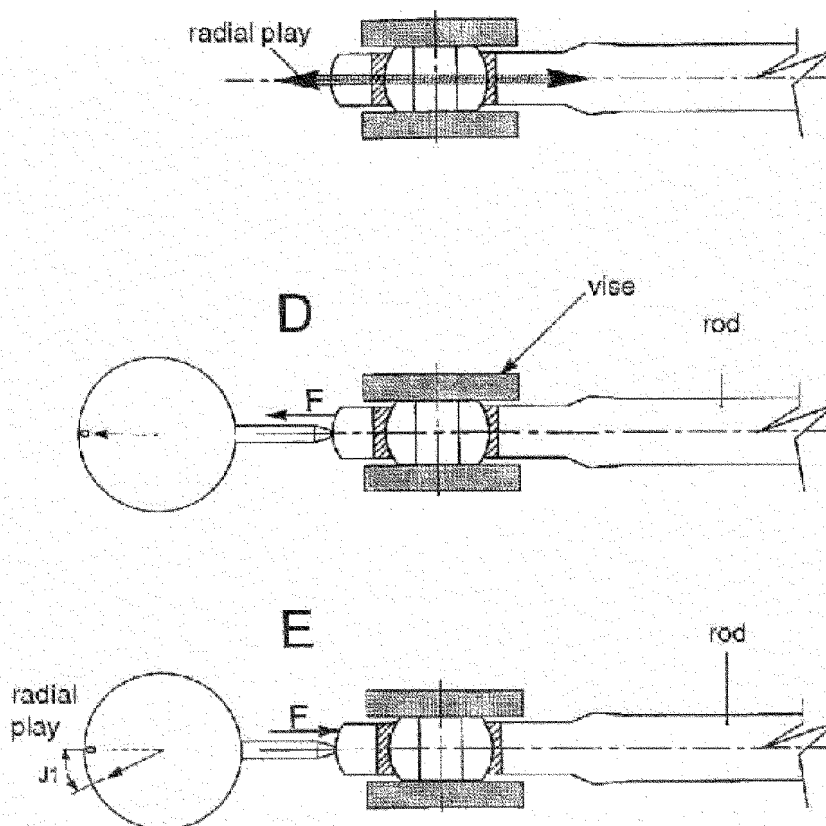
Figure (3) to Paragraph (f)

Measurement of the Radial Play (R) of the Bearing

(v) Mount the control rod and bearing in a vise as shown in Figure 3 to Paragraph (f) of this AD.

(vi) Using a dial indicator, take radial play measurements by moving the control rod in the direction F as shown in Figure 3 to Paragraph (f) of this AD.
