#### 14 CFR Part 39

[Docket No. FAA-2007-0096; Directorate Identifier 2007-NE-39-AD]

#### **Airworthiness Directives; Honeywell International Inc. ALF502 Series and LF507 Series Turbofan Engines**

**ACTION:** Notice of proposed rulemaking (NPRM).

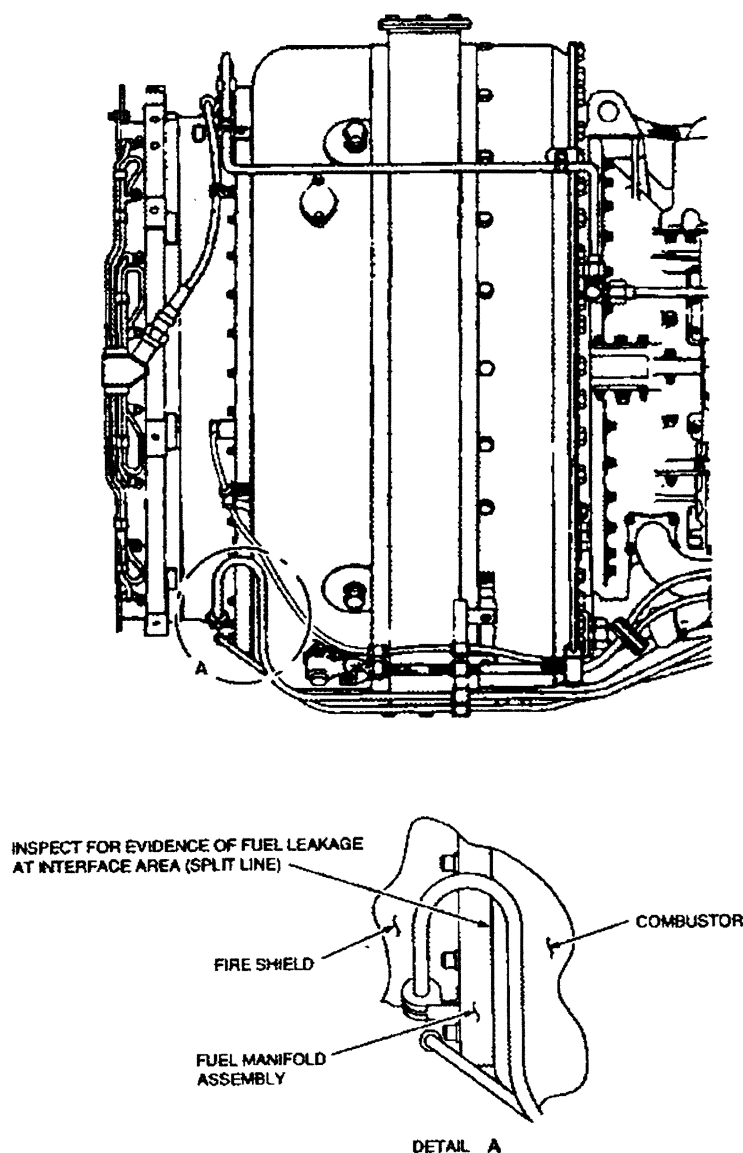
Figure 1 - Fuel Manifold Assembly-to-Fire Shield Interface Area

Since we issued that AD, we have received reports of about 36 events of fuel leaking at the fuel nozzles on fuel manifold assemblies, P/Ns 2-163-620-37 and 2-163-620-38, due to loosening of the fuel nozzles. Failure to detect and remove a leaking manifold assembly is likely to result in a fire in the engine nacelle and create a hazard to the aircraft.

(2) With the engine operating, look for fuel leaking from the fuel manifold assembly to the fire shield interface area (see Figure 1). No leaks allowed.

(5) Look for fuel leaking from the fuel manifold assembly to the fire shield interface area (see Figure 1.) No leaks allowed.

(3) If you find any leaks, shut down the engine and replace the fuel manifold assembly with an FAA approved serviceable assembly.

(6) If you find any leaks, replace the fuel manifold assembly with an FAA approved serviceable assembly.
