[Docket No. FAA-2011-0450; Directorate Identifier 2011-CE-010-AD; Amendment 39-16758; AD 2011-15-11]

**Airworthiness Directives; Cessna Aircraft Company (Cessna) Models 337, 337A (USAF 02B), 337B, 337C, 337D, 337E, T337E, 337F, T337F, 337G, T337G, M337B, F 337E, FT337E, F 337F, FT337F, F 337G, and FT337GP Airplanes**

**2011–15–11 Cessna Aircraft Company:**  
Amendment 39–16758; Docket No. FAA–2011–0450; Directorate Identifier 2011–CE–010–AD.

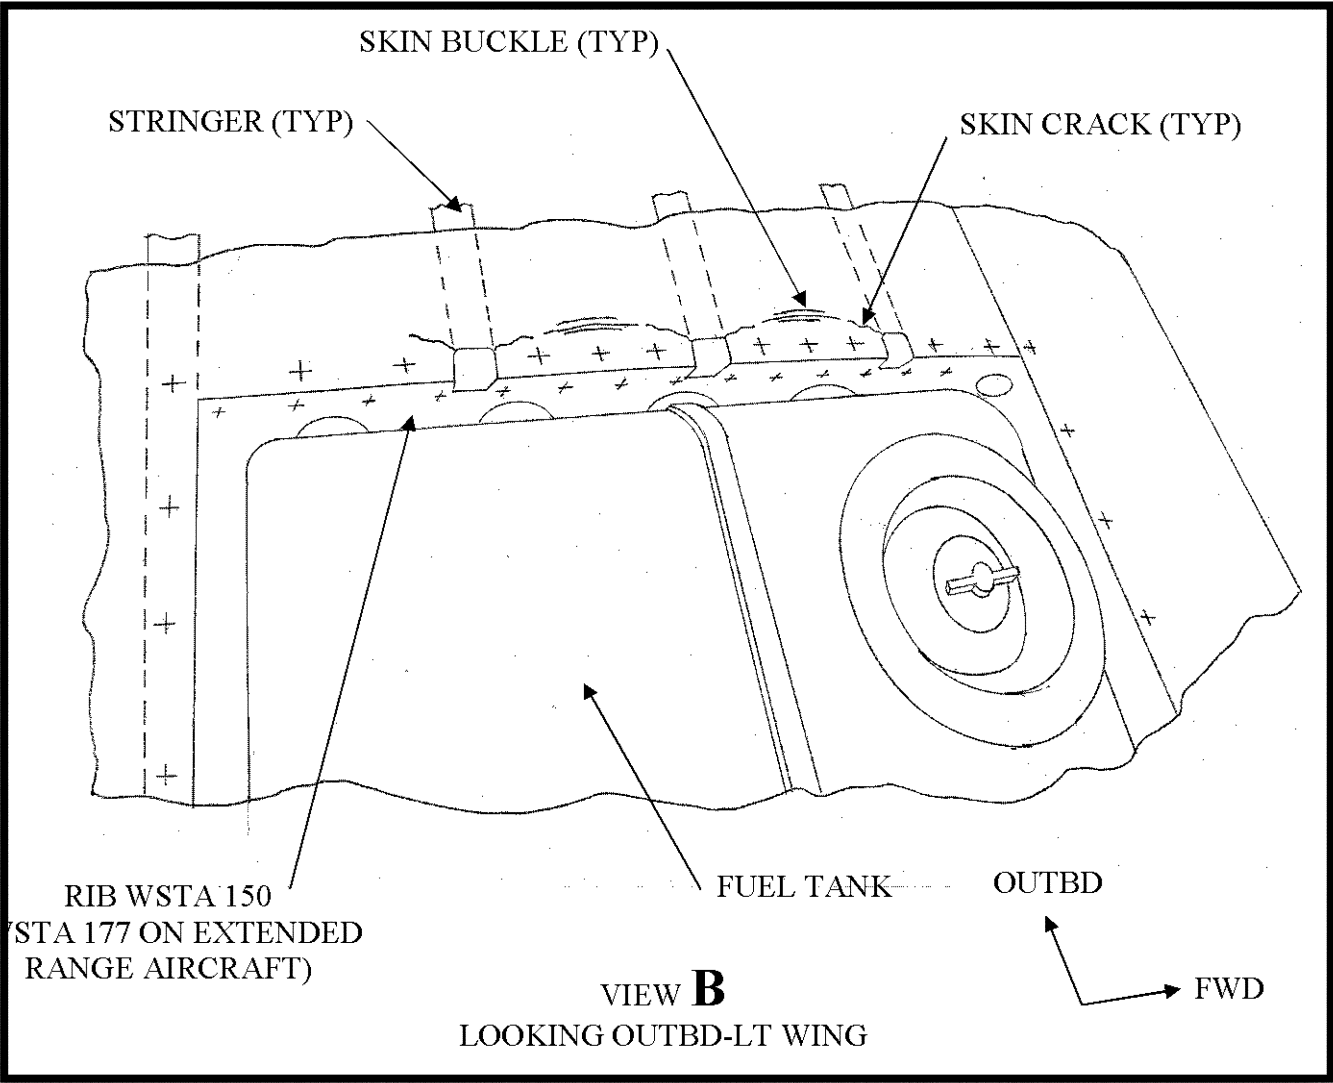
Figure 3

(1) Wrinkles in upper wing skins, from the outboard edge on the fuel tank access covers (WSTA 150 or 177) to the WSTA 222 (See View B, Figure 3).

(3) Cracking of the upper wing skins. Pay particular attention to any wrinkles, the radius between stiffeners at WSTA 150 (under fuel tank covers), and unreinforced access holes (See View B, Figure 3).

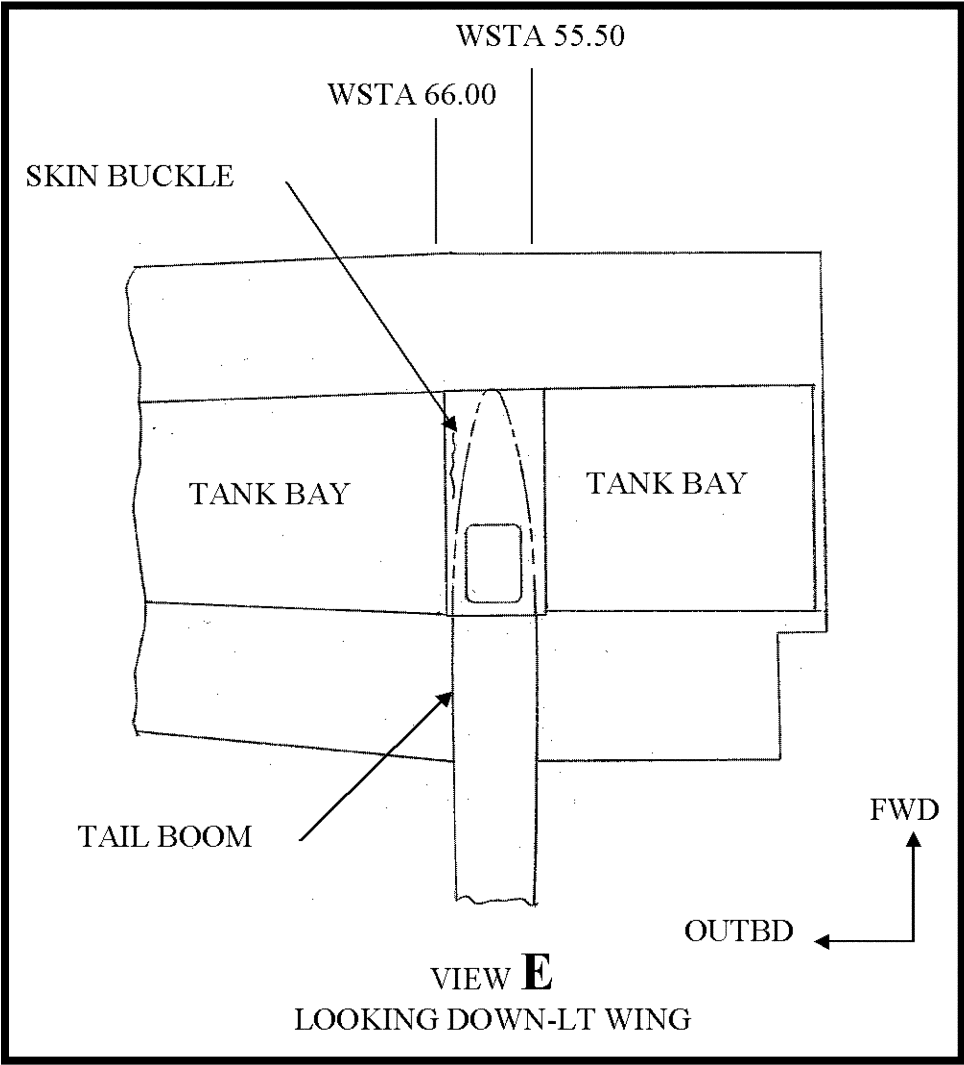
Figure 6

(2) Wrinkles in the upper wing skins from WSTA 55 to 66, adjacent to the booms (See View E, Figure 6).

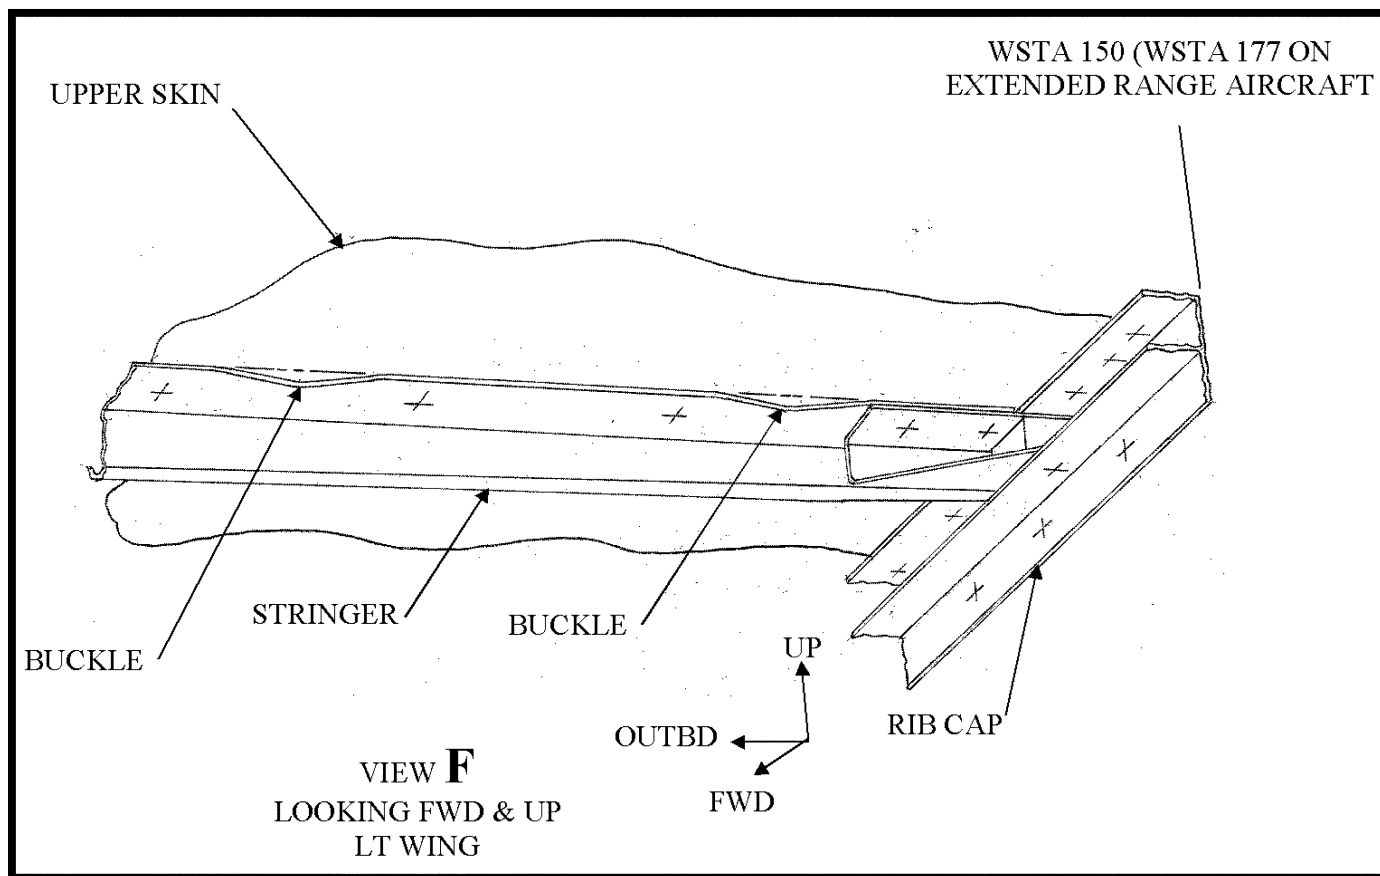
Figure 7

(10) Inter-rivet buckling of the stringers attached to the upper surface skin, outboard of the fuel tank access covers (See View F, Figure 7).
