[Docket No. FAA–2015–0497; Directorate Identifier 2012–NM–192–AD; Amendment 39–18128; AD 2015–06–10]

#### Airworthiness Directives; ATR–GIE Avions de Transport Régional Airplanes

**SUMMARY:** We are adopting a new airworthiness directive (AD) for certain ATR–GIE Avions de Transport Régional Model ATR72–212A airplanes. This AD requires inspection of the shock mount pick-up fittings and cone bolts, and replacement of certain shock mount pick-up fittings if necessary. This AD was prompted by reports of several cases of engine shock mount pick-up fittings with cracks or failure on the engine left-hand (LH) aft side attachment. We are issuing this AD to detect and correct an aft side attachment

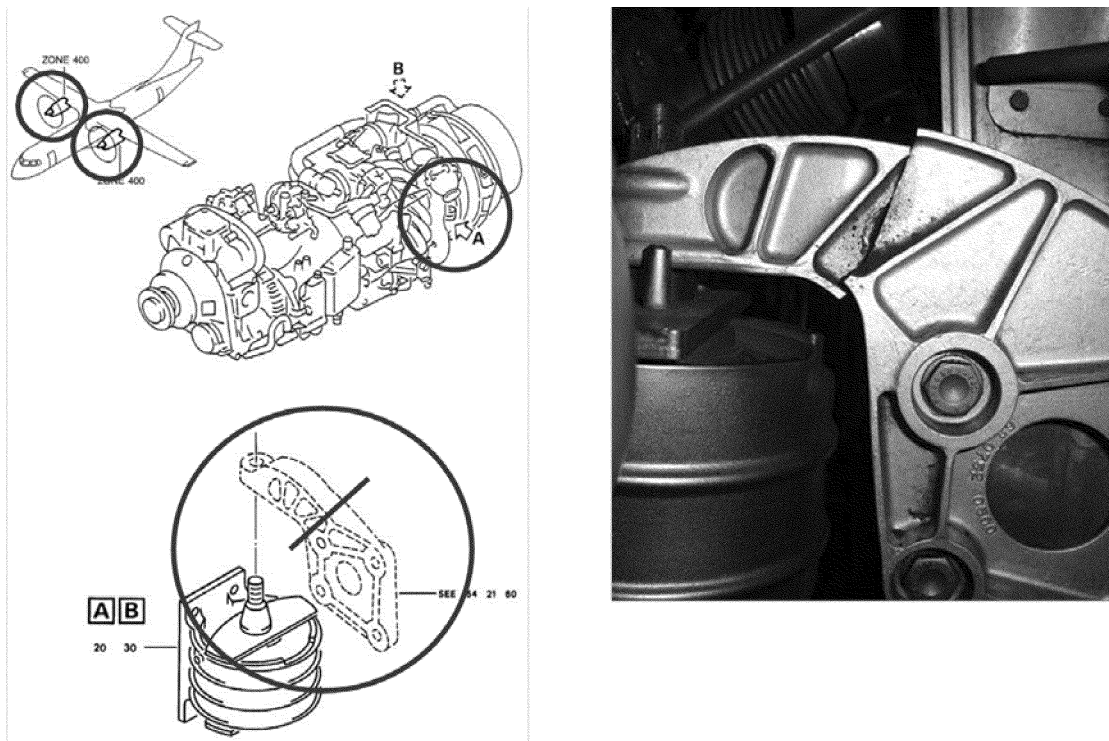
**Figure 2 to Paragraph (g)(2) of this AD - Shock Mount Pick-up Fitting**

(2) Do a detailed inspection of both LH and RH aft side isolator pick-up fittings on both engines to detect cracks, in accordance with

paragraph 004.1 of ATR ATR72 Aircraft Maintenance Manual (AMM) Job Instruction Card (JIC) 54-11-61 DVI 10000, dated March

1, 2012. Refer to figure 2 to paragraph (g)(2) of this AD for potential crack location.

(1) If any crack is found during any inspection required by paragraphs (g)(2) and (g)(3) of this AD: Before further flight, repair in accordance with a method approved by

the Manager, International Branch, ANM-116, Transport Airplane Directorate, FAA; or EASA; or ATR's EASA Design Organization Approval (DOA).

(2) If the serial number of the LH shock mount pick-up fitting, identified during any inspection required by paragraph (g)(1) of this AD, is lower than 2451 or is unreadable, and no crack has been found during any

inspection required by paragraphs (g)(2) and (g)(3) of this AD: Within 6 months after the inspection required by paragraph (g)(2) of this AD, replace the LH shock mount pick-up fitting P/N S54210394200 with a serviceable LH shock mount pick-up fitting having a serial number equal to or higher than 2451, in accordance with a method approved by the Manager, International Branch, ANM-116, Transport Airplane Directorate, FAA; or EASA; or ATR—GIE Avions de Transport Régional's EASA DOA.

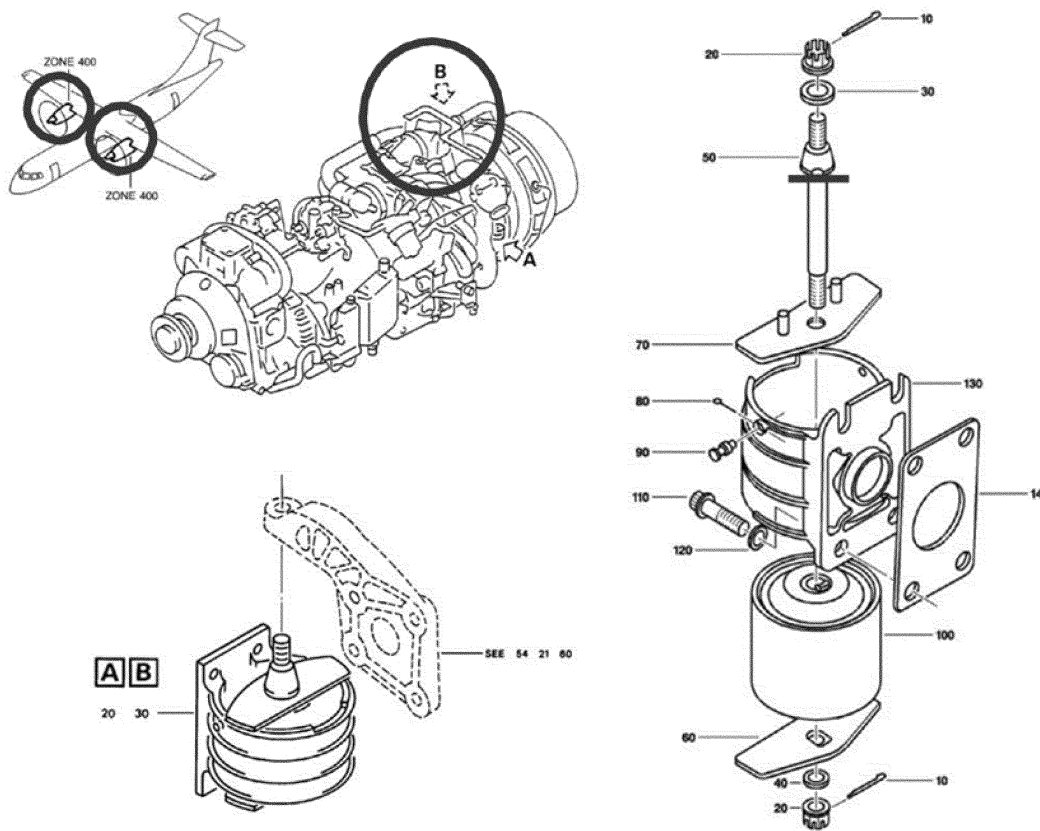
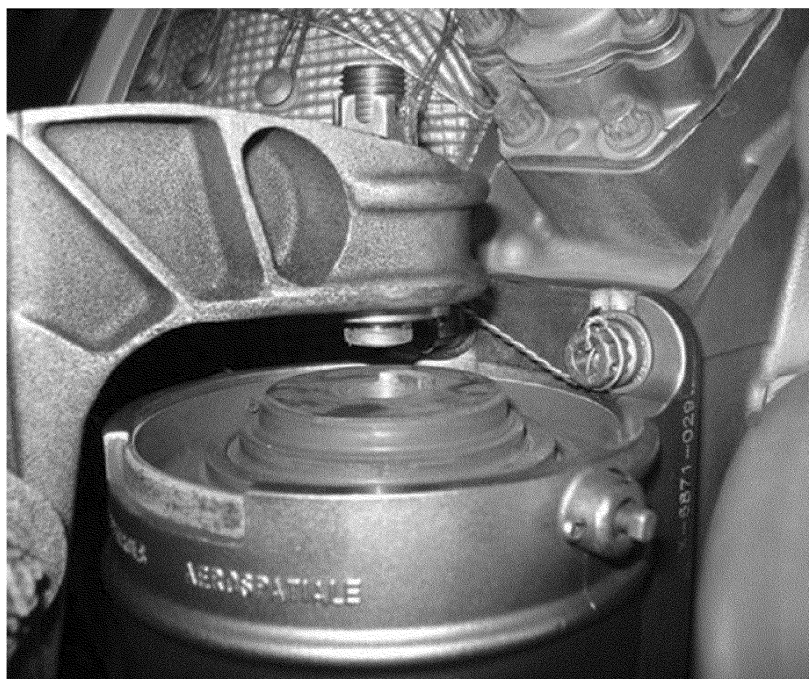
**Figure 3 to paragraph (g)(3) of this AD - Shock Mount Cone Bolt**

(3) Do a detailed inspection of both LH and RH aft shock mount cone bolts on both engines to detect cracks, in accordance with

paragraph 006.3.A. of ATR ATR72 AMM JIC 71-20-00 DVI 10000. Refer to figure 3 to

paragraph (g)(3) of this AD for potential crack location.
