[Docket No. FAA-2013-0019; Directorate Identifier 2010-SW-051-AD; Amendment 39-17485; AD 2013-12-07]

#### Airworthiness Directives; Bell Helicopter Textron Canada Helicopters

##### 2013-12-07 Bell Helicopter Textron

**Canada (BHTC):** Amendment 39-17485; Docket No. FAA-2013-0019; Directorate Identifier 2010-SW-051-AD.

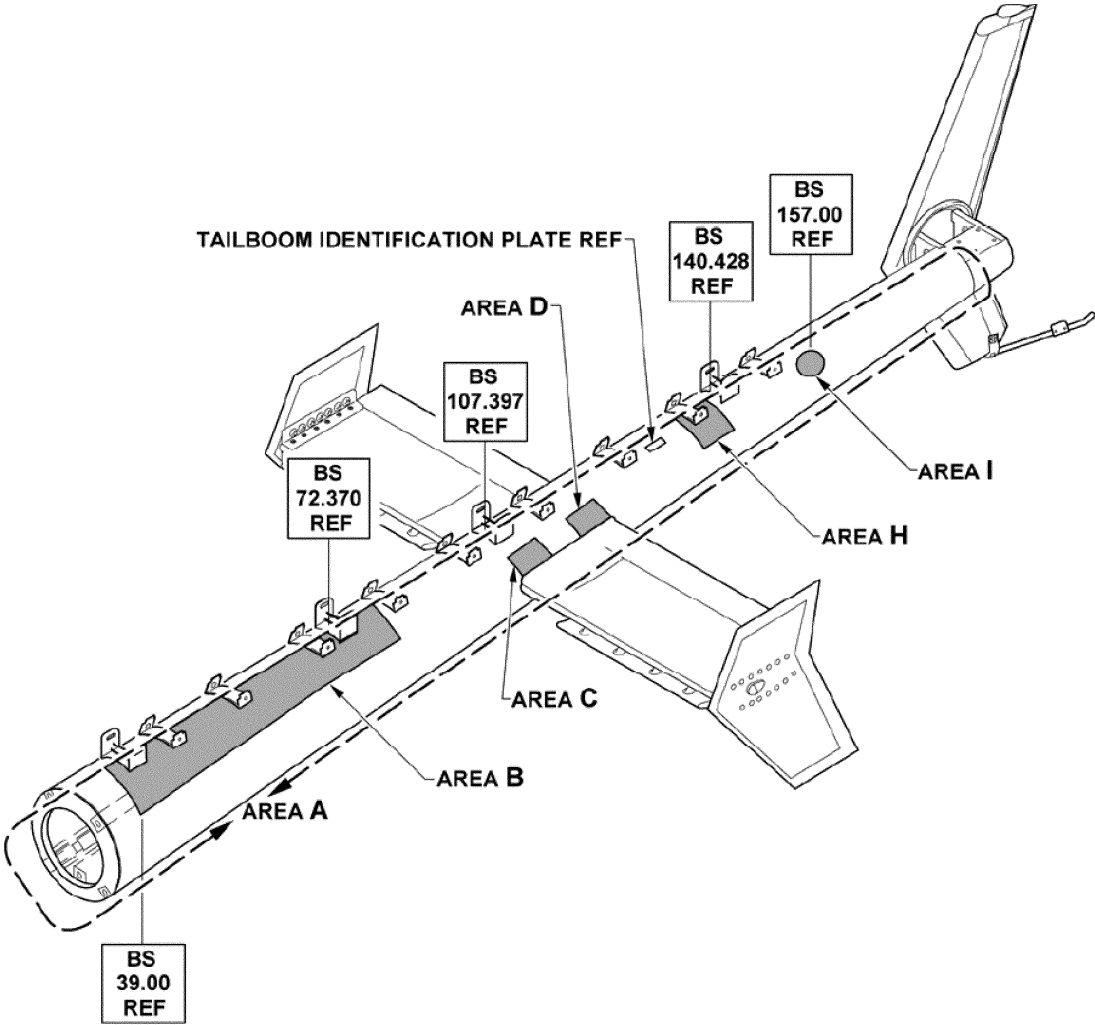
Figure 1 to Paragraph (e)

This AD defines the unsafe condition as high-stress-concentration areas in the tailboom skin that are at risk of cracking. This condition could result in a crack in the tailboom assembly, failure of the tailboom, and subsequent loss of helicopter control.

(A) Before the first flight of each day, visually check for a crack in the "C" and "D" areas depicted in Figures 1 and 2 to Paragraph (e) of this AD. The actions required by this paragraph may be performed by the owner/operator (pilot) holding at least a private pilot certificate, and must be entered into the aircraft records showing compliance with this AD in accordance with 14 CFR 43.9 (a)(1)–(4) and 14 CFR § 91.417(a)(2)(v). The record must be maintained as required by 14 CFR 91.417, 121.380, or 135.439; or

(5) If there is a crack in the tailboom assembly, before further flight, replace it with an airworthy tailboom assembly.

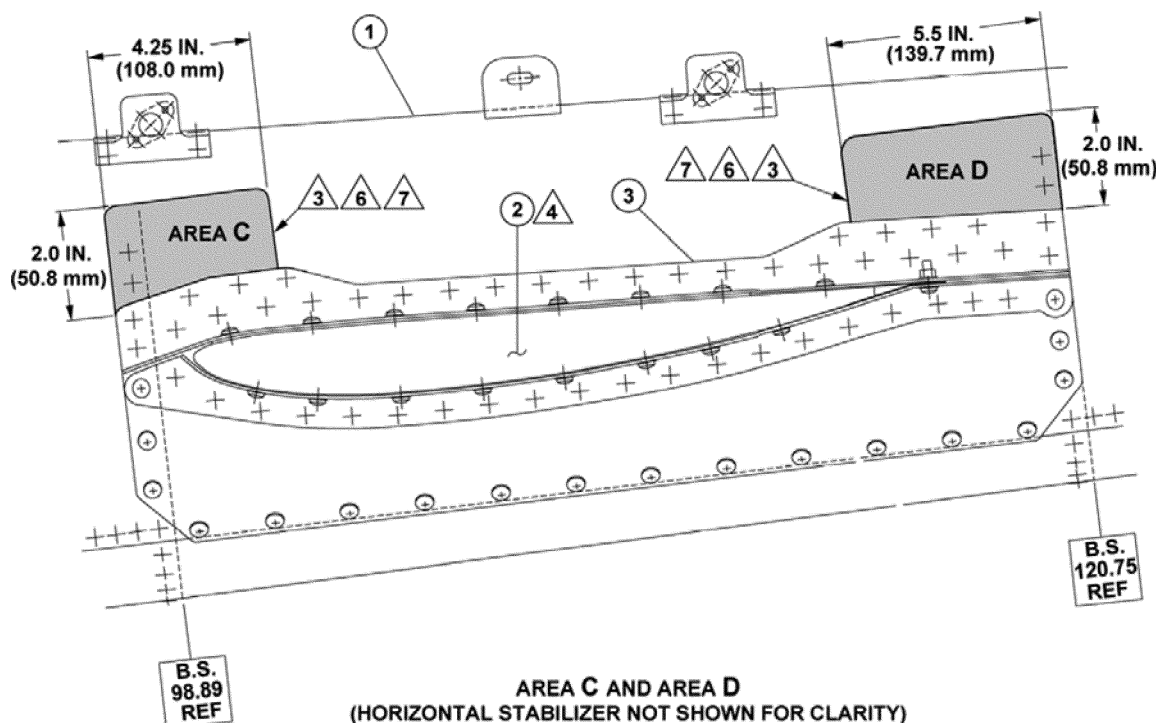
(B) Within 25 hours TIS, or 30 days, whichever comes first, and thereafter at intervals not to exceed 50 hours TIS, clean and inspect for a crack around each fastener and just above the edge of the upper stabilizer support in the "C" and "D" areas on the left side of the tailboom assembly, as depicted in Figure 2 to Paragraph (e) of this AD, using a 10X or higher power magnifying glass.
