DEPARTMENT OF TRANSPORTATION

Denial of Motor Vehicle Defect Petition, DP00-001

Appendix—Petition Analysis—DP00-001

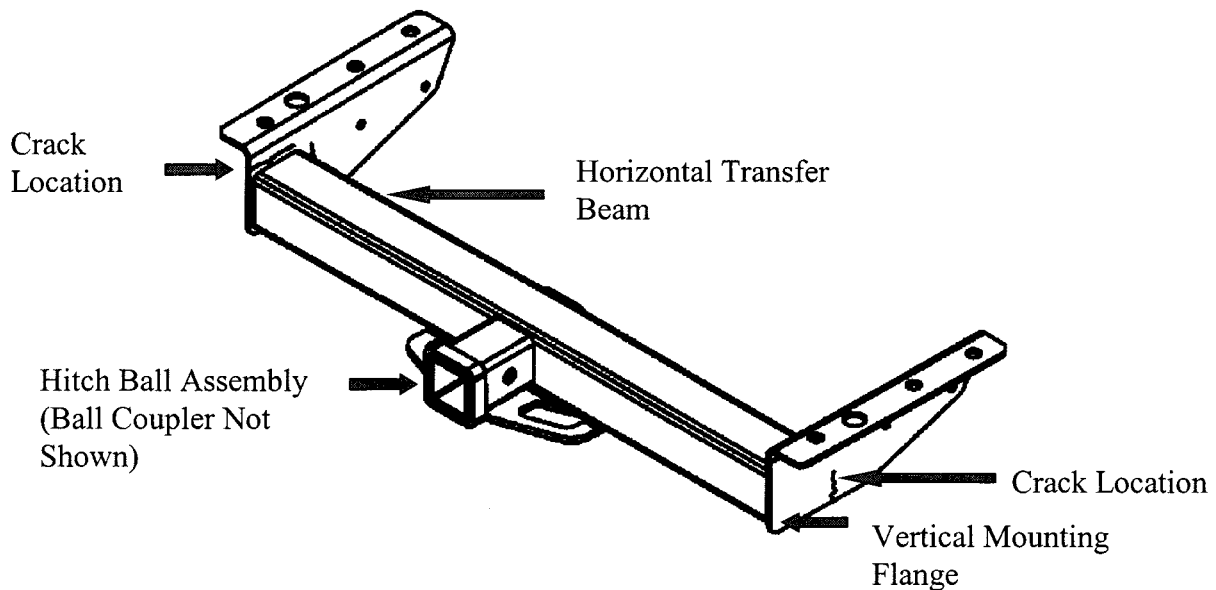
Figure 1. Typical Class III/IV towing Hitch Receiver

Figure 1 shows a diagram of a typical frame mounted Class III/IV type hitch receiver.

and (3) the vertical mounting flanges for attachment to the vehicle frame. Note that the diagram also shows the typical crack patterns found as reported by the petitioner.
