[Docket No. FAA-2008-1311; Directorate Identifier 2007-NE-48-AD; Amendment 39-15976; AD 2009-15-13]

#### Airworthiness Directives; Honeywell International Inc., T5313 and T5317 Series Turboshaft Engines

**SUMMARY:** The FAA is adopting a new airworthiness directive (AD) for Honeywell International Inc., T5313 and T5317 series turboshaft engines. This AD requires initial and repetitive visual inspections and initial and repetitive ultrasonic inspections of combustion chamber housings (CCHs) for cracks. This AD results from eight instances of cracks in CCHs. Two of the instances resulted in an engine shutdown during flight. We are issuing this AD to detect cracks in the CCH, which could result in rupture of the CCH, leading to loss of engine power and damage to the helicopter.

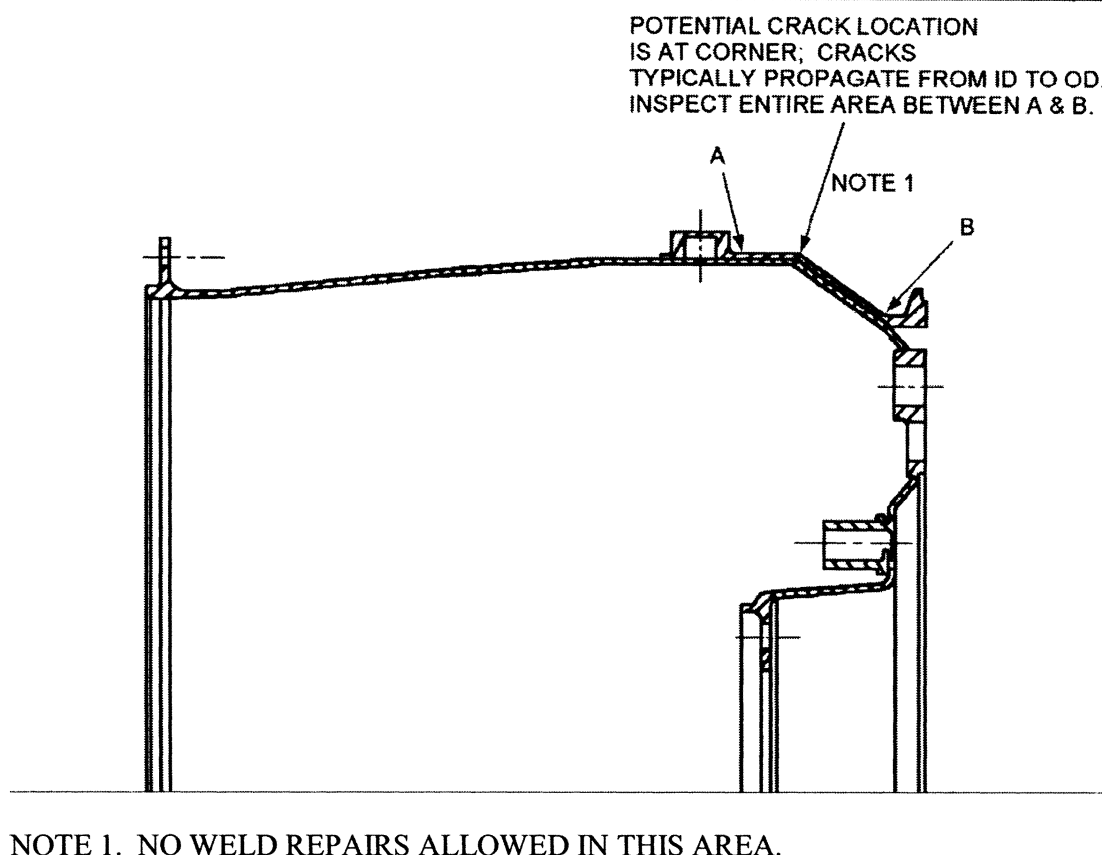
Figure 1. Visual Inspection of CCH

(d) This AD results from eight instances of cracks in CCHs. Two of the instances resulted in an engine shutdown during flight. We are issuing this AD to detect cracks in the CCH, which could result in rupture of the CCH, leading to loss of engine power and damage to the helicopter.

(f) For CCH, P/N 1-130-610-05 and 1-130-610-12, within 50 hours time-in-service (TIS) after the effective date of this AD, inspect the area between points A and B around the entire housing circumference in Figure 1 of this AD for weld repairs and cracks.

(g) For CCH, P/N 1-130-610-05 and 1-130-610-12, inspect the area between points A and B around the entire housing circumference in Figure 1 of this AD for cracks within every 50 hours time-since-last inspection. Honeywell International Inc. Standard Practices Manual 70-20-02, SP 1302, contains additional guidance on visual inspection.

(1) If you find any cracks, replace the CCH before further flight. Honeywell International Inc. Alert Service Bulletin (ASB) T53-A0142, Revision 1, dated September 14, 2006, contains additional guidance on replacing the CCH.

(2) If you find any weld repairs, replace the CCH within 100 hours TIS after the visual inspection. Honeywell International Inc. ASB T53-A0142, Revision 1, dated September 14, 2006, contains additional guidance on replacing the CCH.

(h) If you find any cracks, replace the CCH before further flight. Honeywell International Inc. ASB T53-A0142, Revision 1, dated September 14, 2006, contains additional guidance on replacing the CCH.
