[Docket No. FAA-2021-0189; Project Identifier AD-2020-00645-R]

Airworthiness Directives; Various Restricted Category Helicopters

ACTION: Notice of proposed rulemaking (NPRM).

SUMMARY: The FAA proposes to adopt a new airworthiness directive (AD) for type certificated Model UH-1H restricted category helicopters. This proposed AD was prompted by multiple reports of failure of the main driveshaft. This proposed AD would require establishing a life limit for certain main driveshafts, and a one-time and repetitive inspections of the main driveshafts. The FAA is proposing this AD to address the unsafe condition on these products.

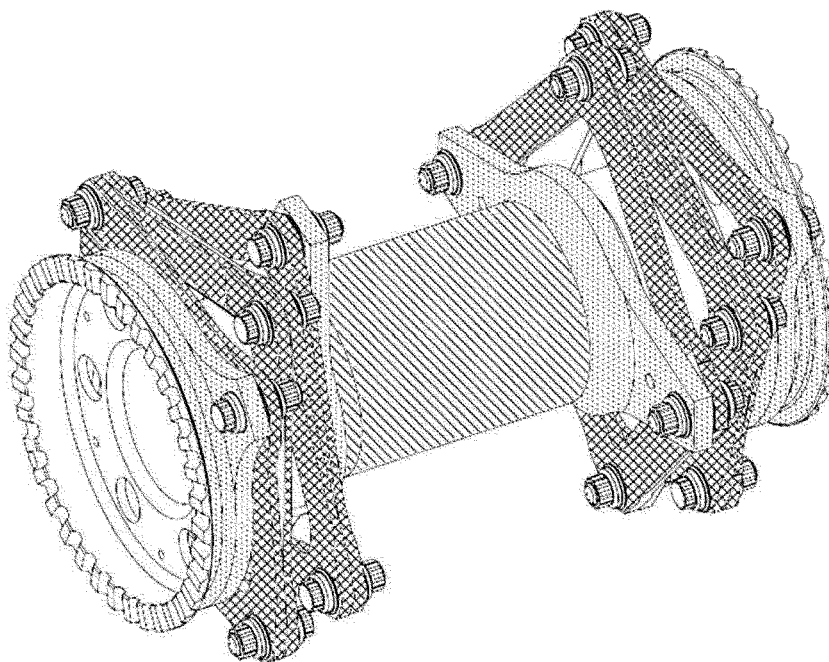
Figure 1 to Paragraph (g)(3)(iv) – Damage Limits

(iv) Inspect the main driveshaft for mechanical damage, corrosion, an edge dent, and nick as shown in Figure 1 to paragraph (g)(3)(iv) of this AD. For the purposes of this inspection, mechanical damage may be indicated by a crack, scratch, or wear; and corrosion may be indicated by corrosion or pitting. If there is a scratch, wear, corrosion, pitting, an edge dent, or a nick within allowable limits, before further flight, repair the main driveshaft in accordance with FAA-approved procedures. If there is a crack, or a scratch, wear, corrosion, pitting, an edge dent, or a nick that exceeds allowable limits, before further flight, replace the driveshaft.

MECHANICAL	0.001" before and after repair	0.005" before and after repair	0.005" before and after repair	0.015" before and after repair
CORROSION	Surface, no pits	0.005" before and after repair	0.005" before and after repair	0.010" before and after repair
MAXIMUM AREA PER FULL DEPTH REPAIR	0.05 in ²	0.10 in ²	0.25 in ²	0.25 in ²
NUMBER OF REPAIRS	One per leg			
EDGE DENTS, NICKS	0.001 in	0.010 in	0.010 in	0.025 in

1. No cracks are permitted
2. Repairs must be no less than 1.000 inch apart.
3. Repairs not to be within 0.500 inches of bolt hole.
4. Faying surfaces must be free of any raised metal areas.
5. All repairs to be smooth at maximum depth and smoothly blended with surrounding surface.
6. Exposed bare metal may be touched up with Sermetel Product 1122 or 196. Zinc Chromate, primer color T, even though it does not blend cosmetically with Sermetel coating, can be used if Sermetel touch-up products are unavailable.
