[Docket No. FAA-2013-0822; Directorate Identifier 2013-SW-004-AD; Amendment 39-17783; AD 2014-05-10]

#### **Airworthiness Directives; Airbus Helicopters (Type Certificate Previously Held by Eurocopter France) (Airbus Helicopters)**

**2014–05–10 Airbus Helicopters (Type Certificate Previously Held By Eurocopter France):** Amendment 39–17783; Docket No. FAA–2013–0822; Directorate Identifier 2013–SW–004–AD.

This AD defines the unsafe condition as severe vibrations due to failure of laminated half-bearings (bearings). This condition could result in failure of the tail rotor and subsequent loss of control of the helicopter.

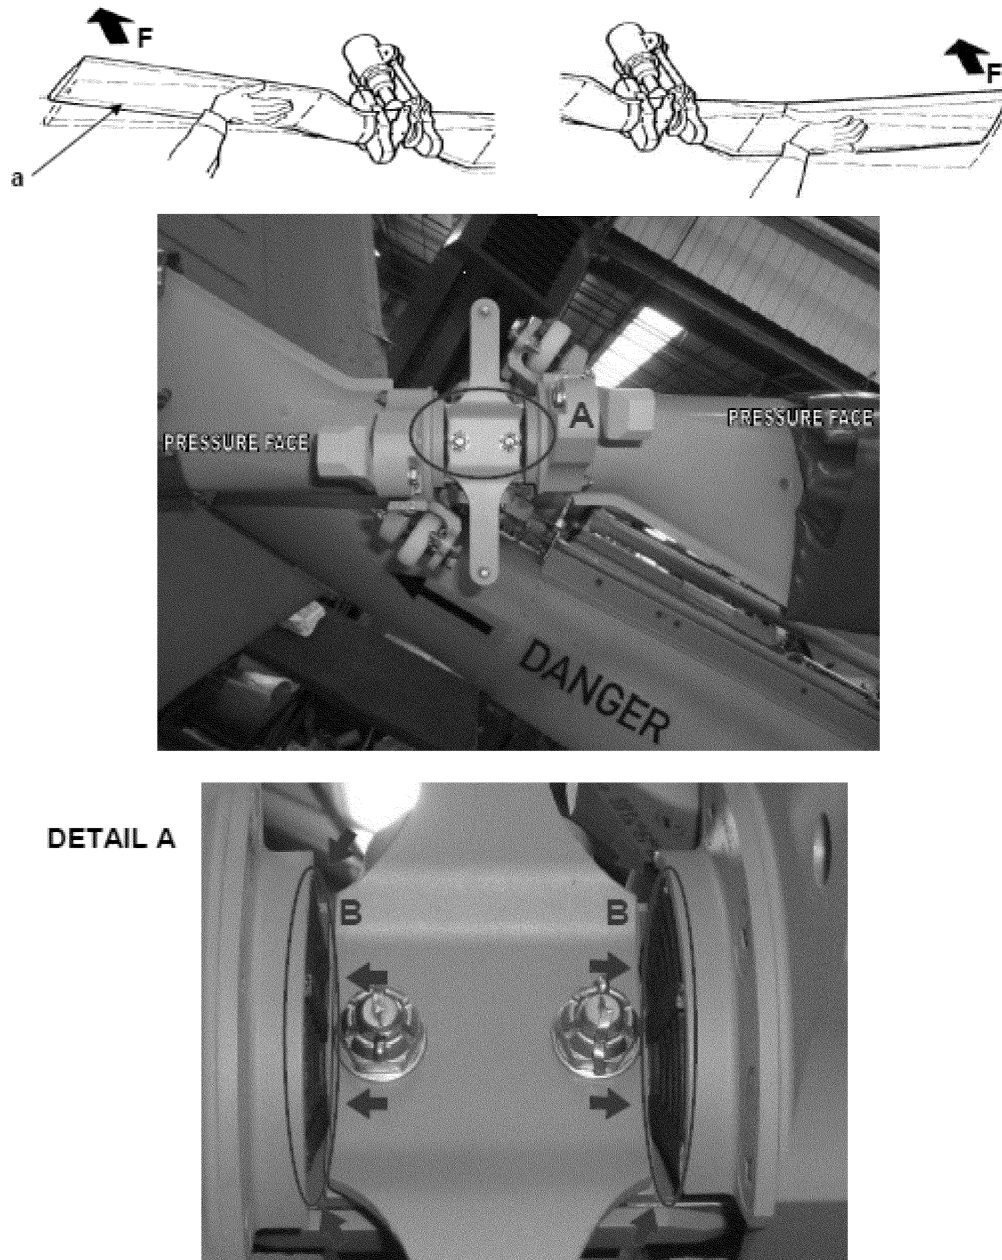
(C) While maintaining the load, check all the visible faces of the bearings (front and side faces) in area B of DETAIL A of Figure 3 to paragraph (f) of this AD for separation between the elastomer and metal parts, a crack in the elastomer, or an extrusion (see example in Figure 4 to paragraph (f) of this AD). A flashlight may be used to enhance the check.

(v) If there is an extrusion on any bearing, before further flight, replace the four bearings with airworthy bearings.

(vi) If there is a separation or a crack on the pressure side bearing, measure the separation or the crack. If the separation or crack is greater than 5 millimeters (.196 inches) as indicated by dimension “L” in Figure 6 to paragraph (f) of this AD, before further flight, replace the four bearings with airworthy bearings.

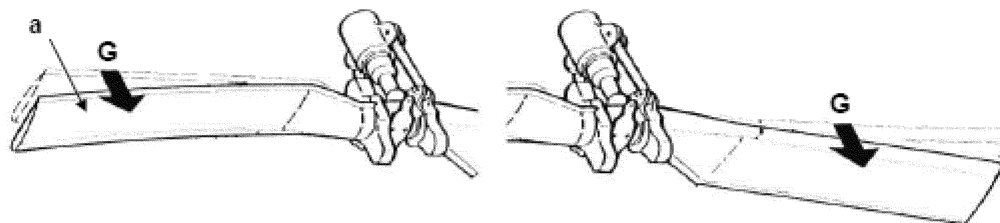
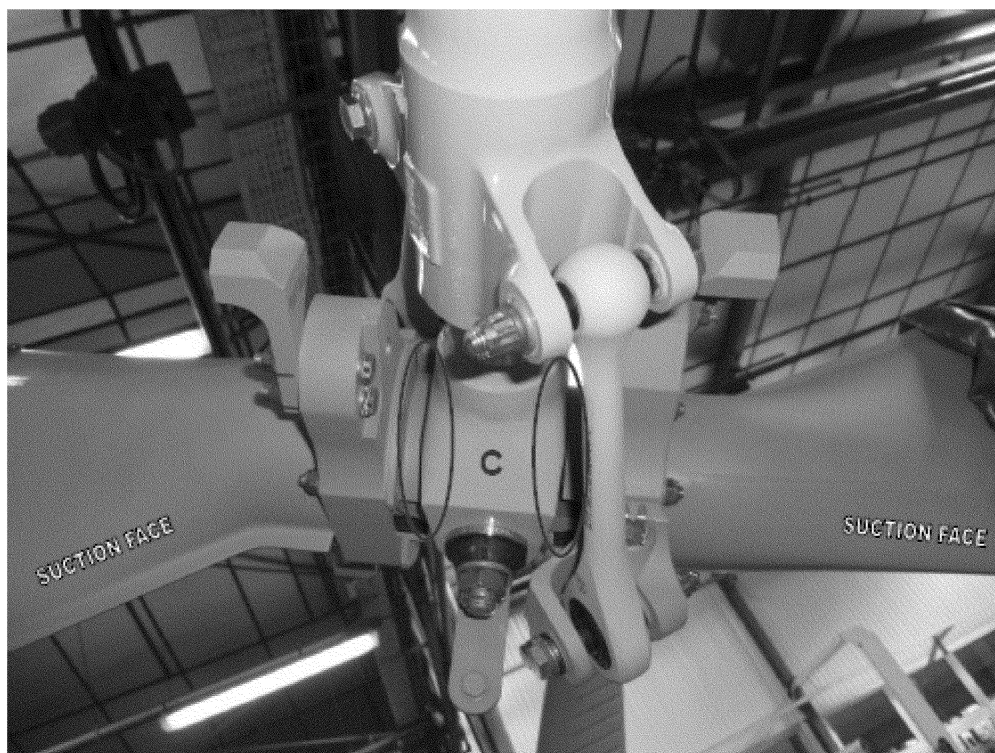
(F) While maintaining the load, check visible faces of Area C as shown in Figure 5 to paragraph (f) of this AD for any extrusion. A flashlight may be used to enhance the check.
