[Docket No. FAA-2012-0807; Directorate Identifier 2011-NM-191-AD; Amendment 39-17888; AD 2014-13-12]

#### Airworthiness Directives; Airbus Airplanes

**ACTION:** Final rule.

**SUMMARY:** We are adopting a new airworthiness directive (AD) for all Airbus Model A318, A319, A320, and A321 series airplanes. This AD was prompted by reports of silicon particles inside the oxygen generator manifolds, which had chafed from the mask hoses during installation onto the generator outlets. This AD requires identifying the part number and serial number of each passenger oxygen container, replacing the oxygen generator manifold of any affected oxygen container with a serviceable manifold, and performing an operational check of the manual mask release, and corrective actions if necessary. We are issuing this AD to detect and correct non-serviceable oxygen generator manifolds, which could reduce or block the oxygen supply and result in injury to passengers when oxygen supply is needed.

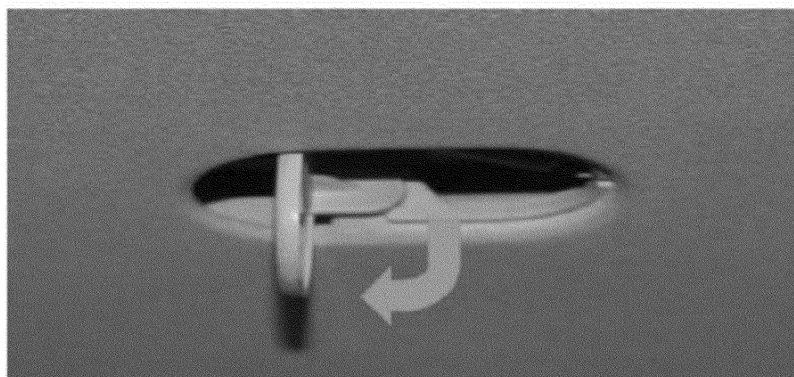
Figure 1 to paragraph (i)(7) of this AD – Design A of the Passenger Oxygen Containers Affected by this AD

(7) The requirements of paragraphs (g) and (h) of this AD apply only to passenger oxygen containers that are Design A, as defined in figure 1 to paragraph (i)(7) of this AD.

**Design A:** The placard on the passenger oxygen container test button is as described in Picture A of Appendix 1 of this AD. The Mask configuration ("ZZ" in Picture A) is a number and the test button is as shown in Picture B.
