[Docket No. FAA–2015–7527; Directorate Identifier 2015–NM–094–AD; Amendment 39–18686; AD 2016–21–05]

**Airworthiness Directives; The Boeing Company Airplanes**

#### 2016–21–05 The Boeing Company:

#### (e) Unsafe Condition

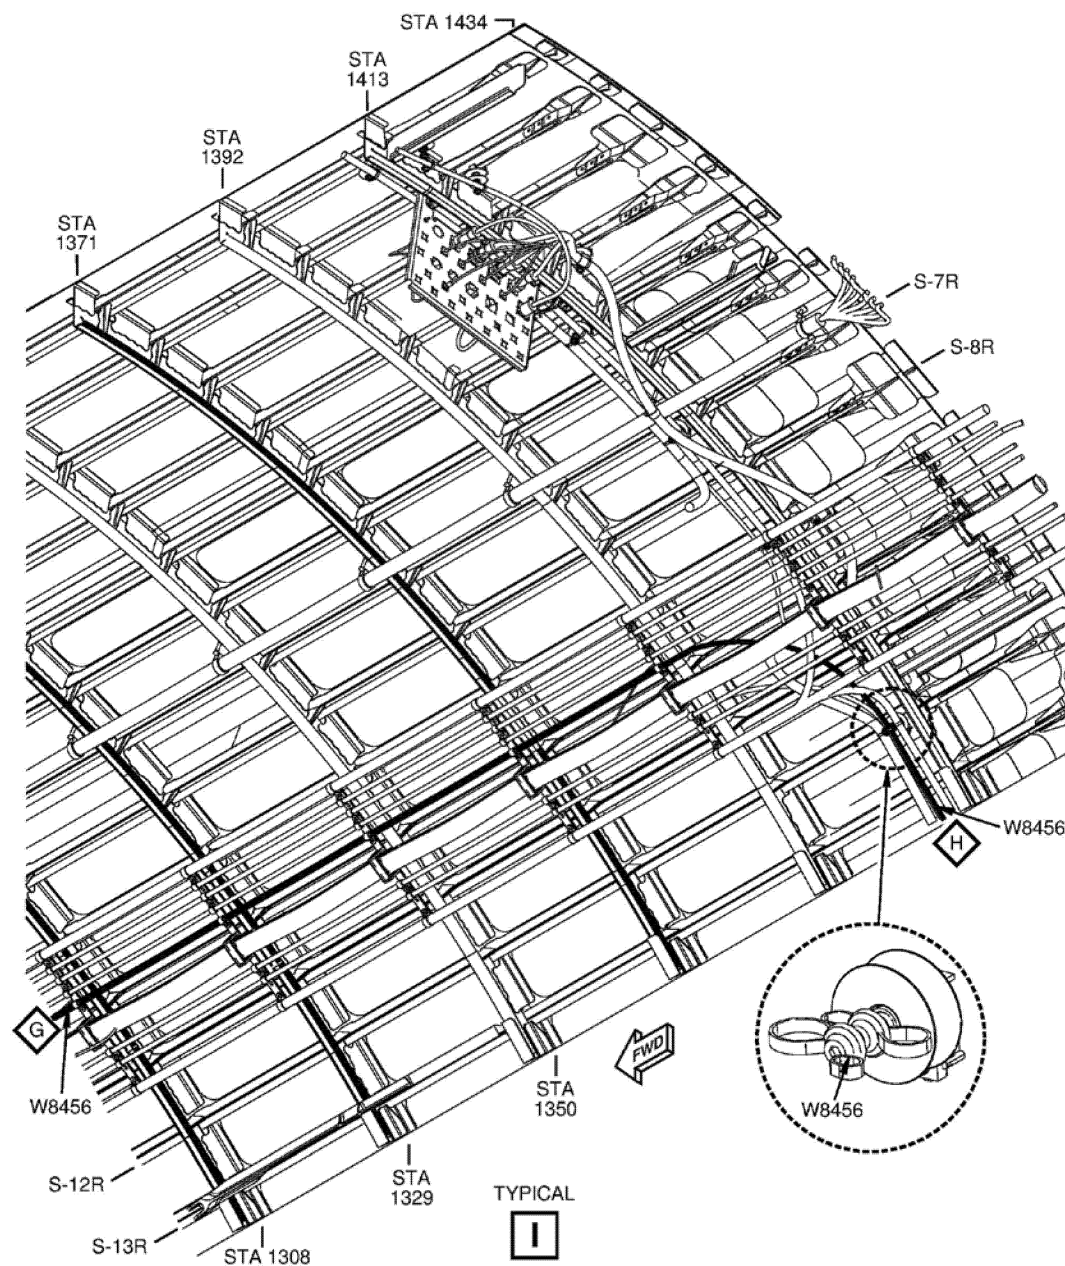
**Figure 1 to paragraph (h) of this AD: Wiring Installation - Right Engine Fuel Spar Valve**

appropriate source of service information in this AD because it is not an FAA-approved document. However, we acknowledge that for certain airplanes, Figure 22, Sheet 9, of Boeing Special Attention Service Bulletin 777–28–0061, Revision 2, dated May 4, 2015, includes an editorial error, which shows incorrect wire routing. Boeing Service Bulletin Information Notice 777–28–0061, IN 03, dated November 16, 2015, allows for a modification of Group 2 airplanes that meets the requirements of the AD without an additional burden to operators. We have included a corrected figure in paragraph (h) of this AD to address this issue.

(1) Where Boeing Special Attention Service Bulletin 777–28–0061, Revision 2, dated May 4, 2015, specifies to use Figure 22, Sheet 9, for the wiring installation of the right engine fuel spar valve, this AD requires using figure 1 to paragraph (h) of this AD.

Within 60 months after the effective date of this AD, modify the wiring and install new relay brackets in new locations to allow installation of new relays for the left and right engine fuel spar valves, in accordance with the Accomplishment Instructions of Boeing Special Attention Service Bulletin 777–28–0061, Revision 2, dated May 4, 2015, except as required by paragraph (h) of this AD.
