[Docket No. 2004–SW–09–AD; Amendment 39–13651; AD 2004–06–51]

#### Airworthiness Directives; Boeing Defense and Space Group Model 234 Helicopters

**2004-06-51 Boeing Defense and Space Group:** Amendment 39-13651. Docket No. 2004-SW-09-AD.

**Applicability:** Model 234 helicopters, with aft vertical shaft assembly, part number (P/N) 234D3300, serial number-181 or lower with a prefix of A, installed, certificated in any category.

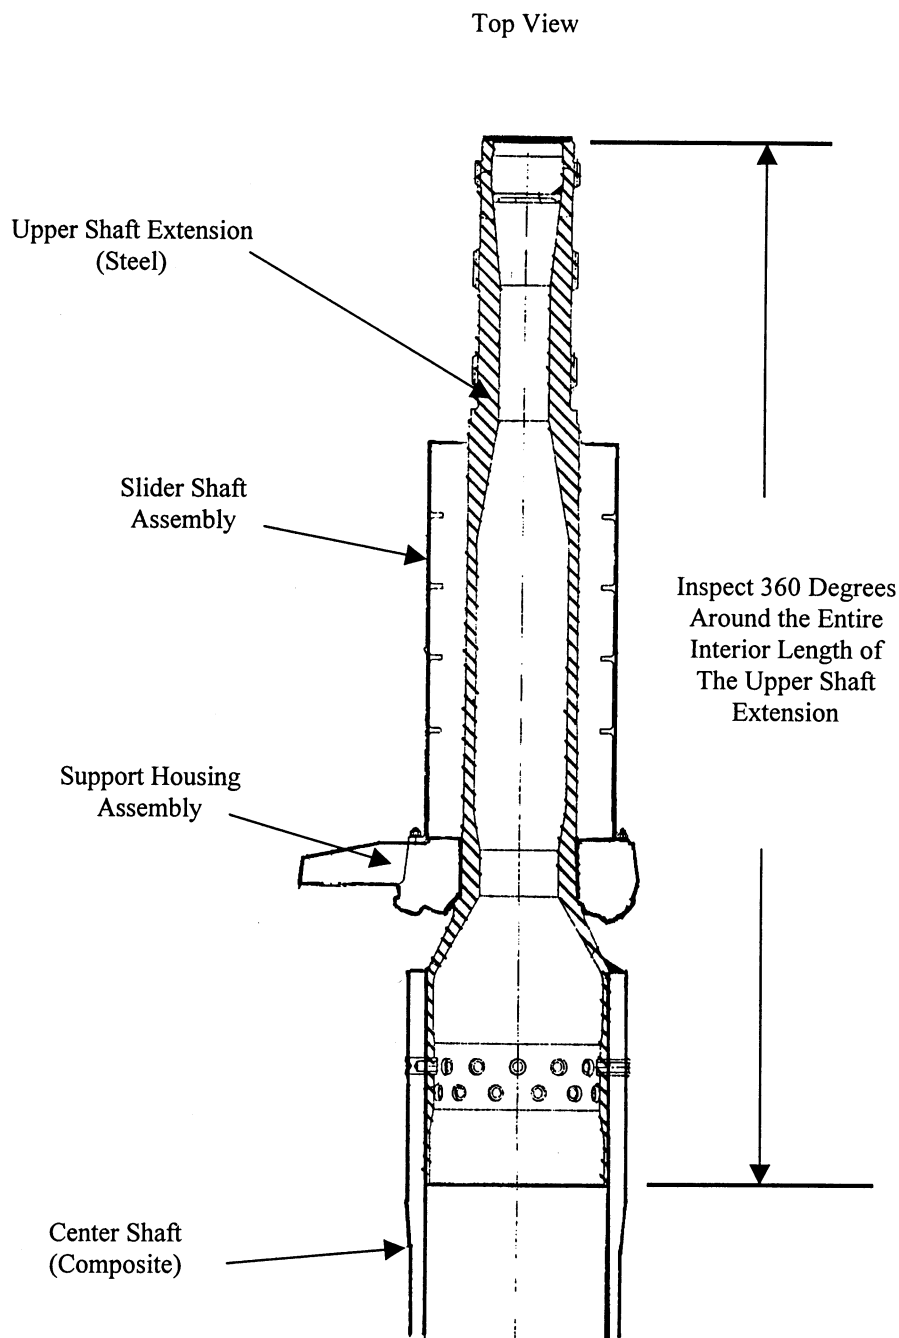
Aft Vertical Shaft  
Assembly Inspection Area  
Figure 1

To detect a crack in the upper shaft extension, which could result in catastrophic failure of the aft vertical shaft assembly and subsequent loss of control of the helicopter, accomplish the following:

(5) Inspect the upper shaft extension, P/N 114D3248, using a borescope or other lighted device that provides direct visual observation of the interior of the aft rotor shaft. Inspect 360 degrees around the entire interior length of the upper shaft extension. If any crack is found, replace the aft vertical shaft assembly, P/N 234D3300, with an airworthy assembly before further flight. See the following Figure 1 of this AD for the area to inspect:

(3) Inspect the upper shaft extension, P/N 114D3248, using a borescope or other lighted device that provides direct visual observation of the interior of the aft rotor shaft. Inspect 360 degrees around the entire interior length of the upper shaft extension (see Figure 1 of this AD). If any crack is found, replace the aft vertical shaft assembly, P/N 234D3300,

with an airworthy assembly before further flight.
