Federal Register

Wednesday, February 9, 2005

[Docket No. FAA-2004-19960; Directorate Identifier 2004-CE-47-AD]

#### Airworthiness Directives; The New Piper Aircraft, Inc. PA-34 Series Airplanes

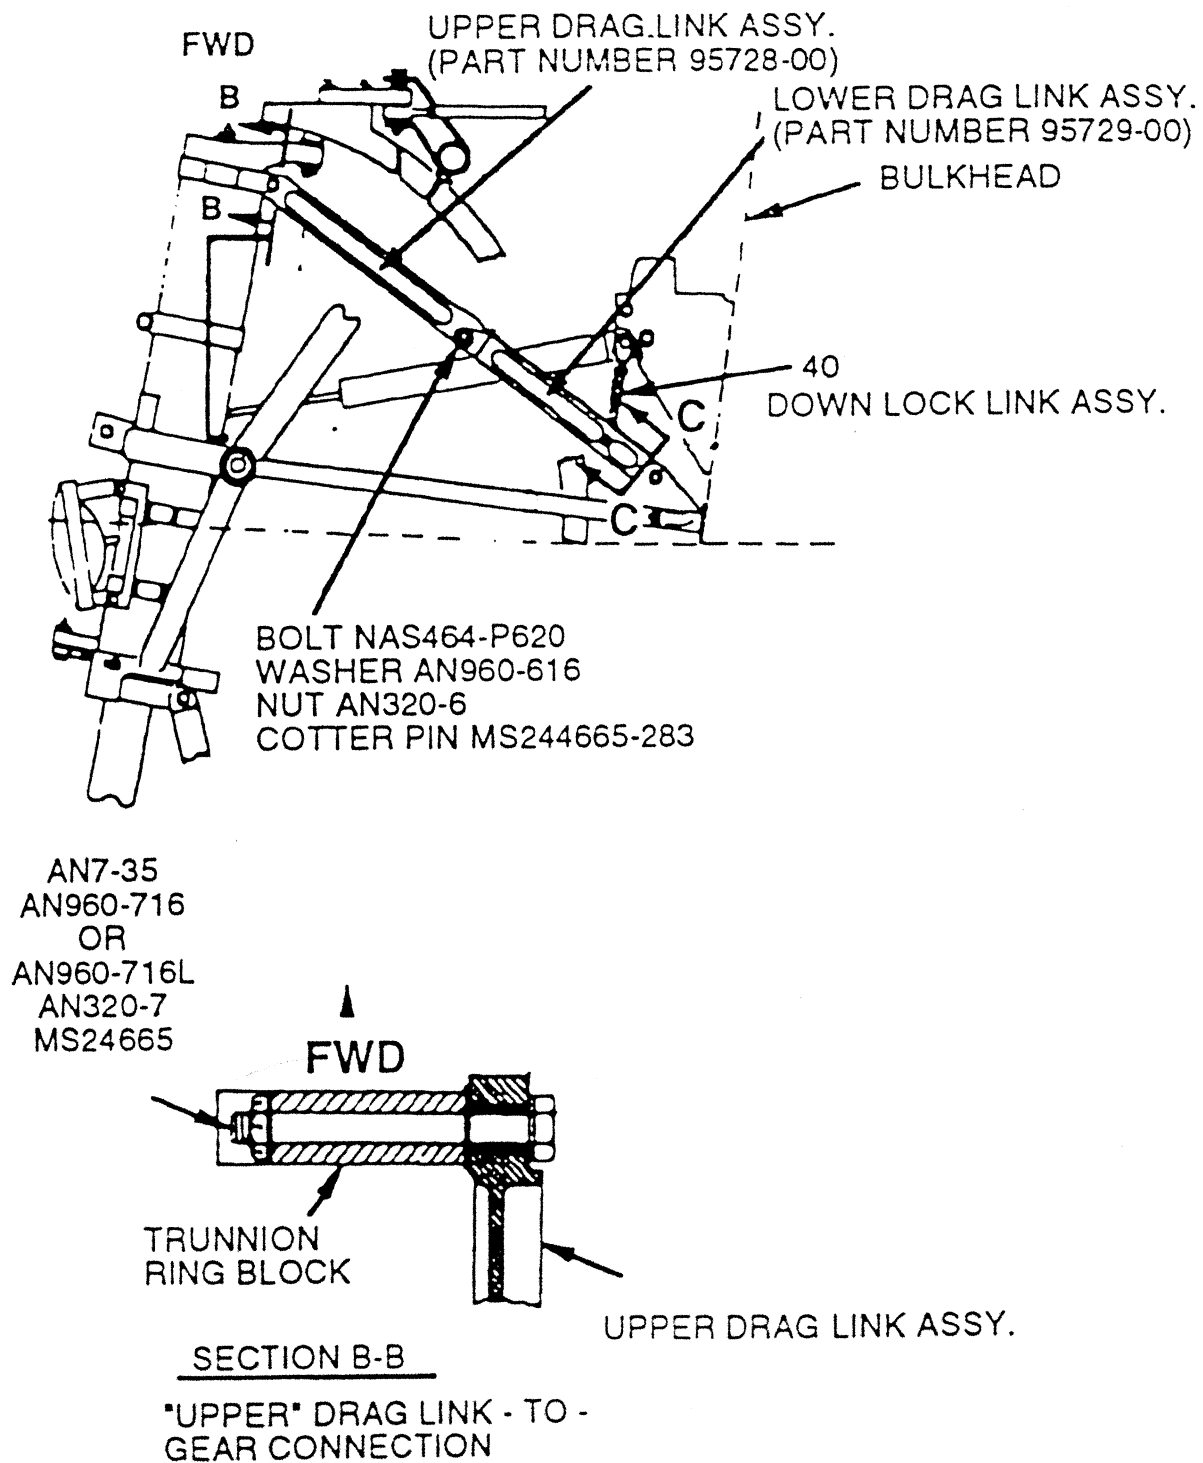
- (d) This AD is the result of service difficulty reports related to the collapse or inadvertent retraction of the nose landing gear (NLG). The actions specified in this AD are intended to detect, correct, and prevent future failure in certain components of the NLG, lack of cleanliness of the NLG due to inadequate maintenance, or lack of lubricant in the NLG or NLG components. This failure of the NLG could lead to loss of control of the airplane during take-off, landing, or taxiing operations.

| Actions | Compliance | Procedures |
|---|---|---|
| (1) Replace the bolt and stack up that connects the upper drag link to the nose gear trunnion with new parts of the following:<br>(i) Piper part number (P/N) 400 274 (AN7-35) bolt;<br>(ii) Piper P/N 407 591 (AN960-716L) washer, as applicable;<br>(iii) Piper P/N 407 568 (AN960-716);<br>(iv) Piper P/N 404 396 (AN320-7) nut; and<br>(v) Piper P/N 424 085 cotter pin. | Within the next 100 hours time-in-service (TIS) after January 28, 1994 (the effective date of AD 93-24-14), unless already done within the last 400 hours TIS before January 28, 1994 (compliance with AD 93-24-14). Repetitively replace thereafter at intervals not to exceed 500 hours TIS. Continue to repetitively replace until the actions in paragraph (e)(2) and (e)(3) of this AD begin. | Follow Figure 1 of this AD. |
