DEPARTMENT OF TRANSPORTATION**Federal Aviation Administration****14 CFR Part 39****[Docket No. 2002–SW–25–AD]****RIN 2120–AA64****Airworthiness Directives; Schweizer Aircraft Corporation Model 269A, 269A–1, 269B, 269C, and TH–55A Helicopters****AGENCY:** Federal Aviation Administration, DOT.**ACTION:** Notice of proposed rulemaking (NPRM).

Schweizer Aircraft Corporation: Docket No. 2002-SW-25-AD. Supersedes AD 2001-25-52, Amendment 39-12726, Docket No. 2001-SW-58-AD.

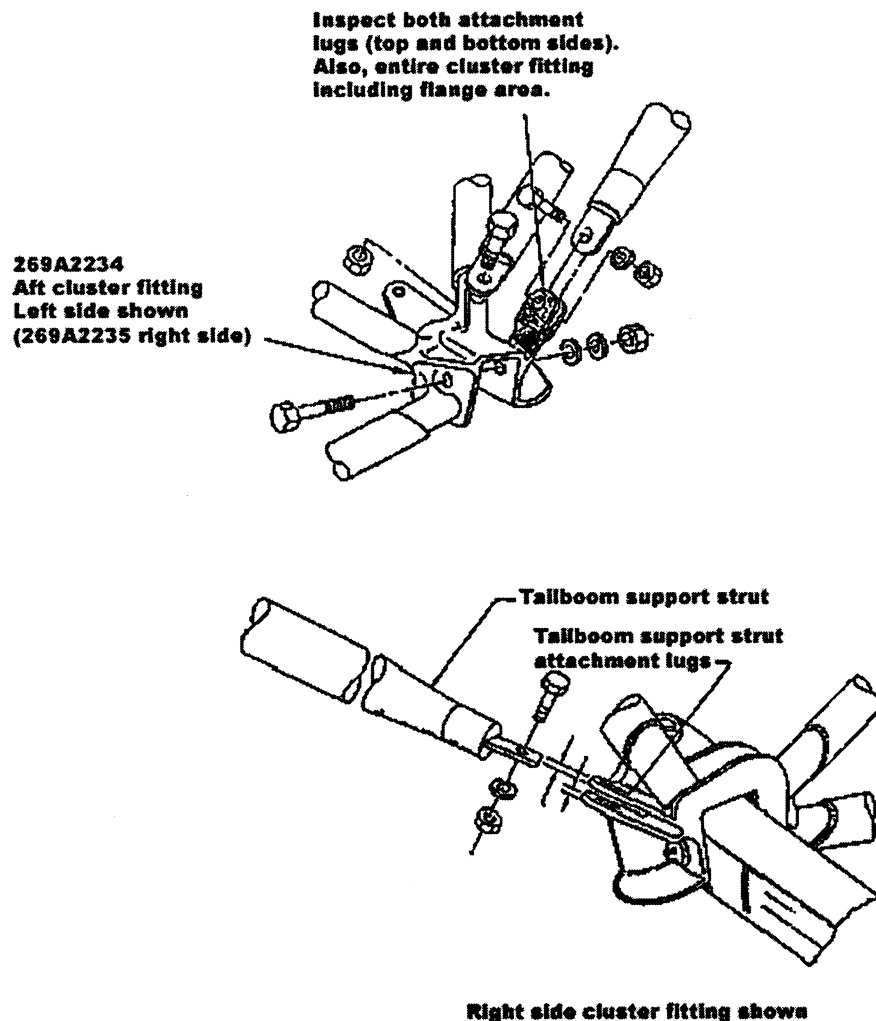
**Figure 1****BILLING CODE 4910-13-C**

(1) Using paint remover, remove paint from the lugs on each cluster fitting. Wash with water and dry. The tailboom support strut must be removed prior to the paint stripping.

(2) Dye-penetrant inspect the lugs on each cluster fitting. See the following Figure 1:

(3) If a crack is found, before further flight, replace the cracked cluster fitting with an airworthy cluster fitting.
