[Docket No. FAA–2024–0237; Project Identifier AD–2023–00491–R; Amendment 39–22853; AD 2024–19–11]

**Airworthiness Directives; Robinson Helicopter Company Helicopters**

**2024-19-11 Robinson Helicopter Company:**  
Amendment 39-22853; Docket No.  
FAA-2024-0237; Project Identifier AD-  
2023-00491-R.

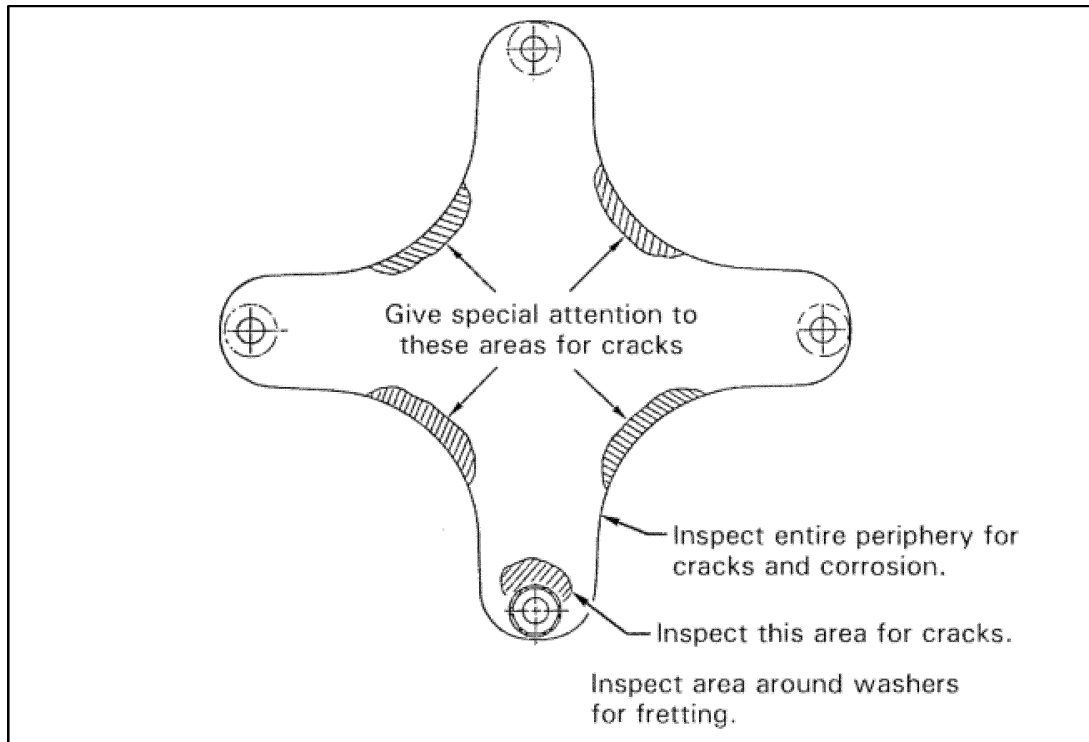
Figure 1 to Paragraph (g)(1)(i)—Flex Plate Inspection

(i) Visually inspect forward flex plate assembly (flex plate) part number (P/N) C947-1 for any loose fasteners, cracks, fretting, corrosion, wear, and to ensure that the washers are bonded to both sides of each flex plate arm, in the areas depicted in Figure 1 to paragraph (g)(1)(i) of this AD. If there is any loose fastener (can be moved by hand), crack, fretting, corrosion, or wear that consists of the washers not securely bonded to both sides of each flex plate arm, before further flight, remove the flex plate from service and replace with an airworthy flex plate.
