[Docket No. FAA–2018–0893; Product Identifier 2018–SW–032–AD; Amendment 39–21319; AD 2020–23–03]

Airworthiness Directives; Airbus Helicopters

2020–23–03 Airbus Helicopters:

This AD defines the unsafe condition as failure of a rear upper screw fitting on the emergency flotation gear. This condition, if not detected and corrected, could result in failure of the emergency flotation system and subsequent capsizing of the helicopter.

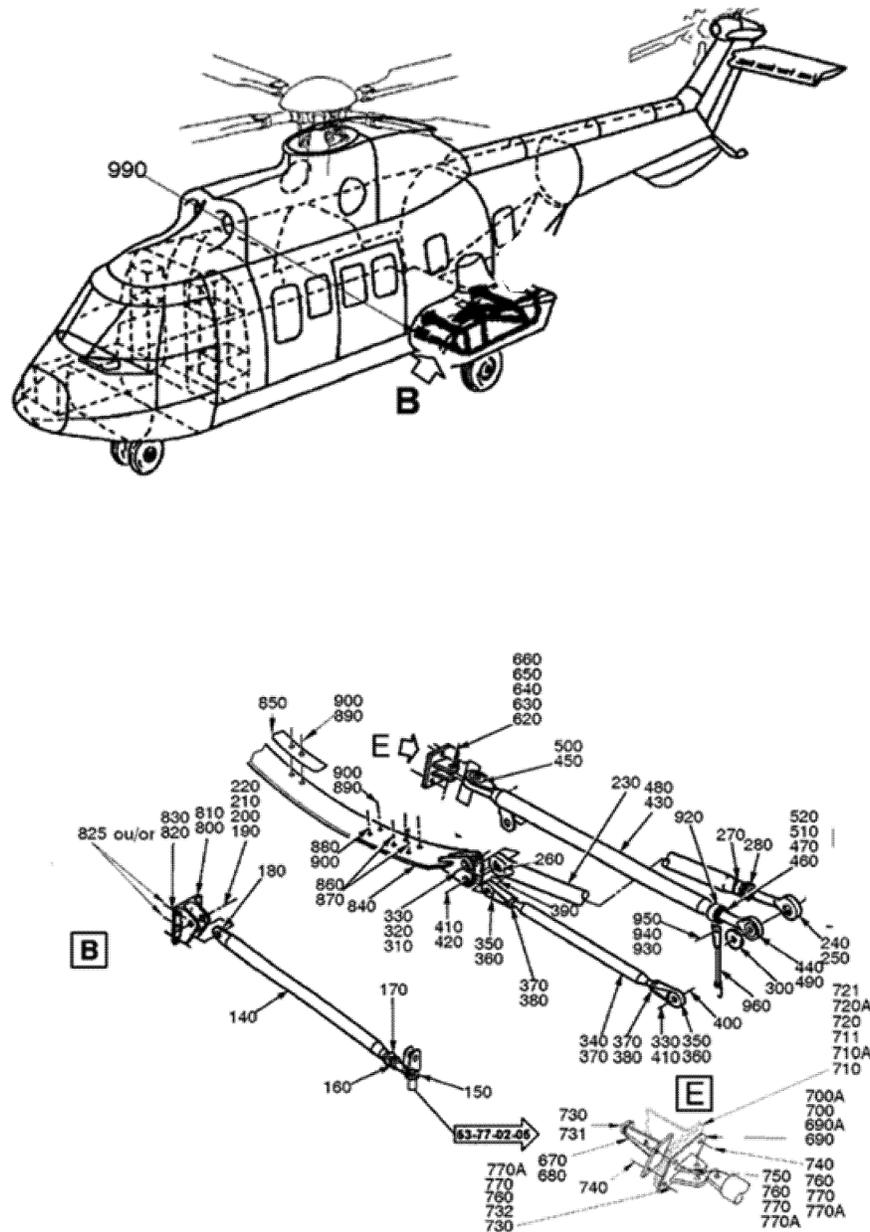
Figure 1 to Paragraph (f)(1)

After the FAA issued AD 2017-09-05, Airbus Helicopters identified the root cause of the screw rupture as a tapering gap under the fitting attachment screw heads creating excessive stress loads. Consequently, EASA issued AD No. 2018-0090, dated April 20, 2018 (EASA AD 2018-0090), to supersede EASA AD 2015-0239-E. EASA AD 2018-0090 retains the repetitive inspection requirements in EASA AD 2015-0239-E and also requires the installation of Airbus Helicopters MOD 0728456 as a terminating action for the repetitive inspections. MOD 0728456 involves the installation of spherical washers and longer screws on the rear upper fittings of the flotation gear to remove the stress applied to the screw heads.

(1) Within 15 hours time-in-service (TIS), and before each flight over water thereafter, visually check each emergency flotation gear left hand (LH) and right hand (RH) rear upper fitting to determine whether the heads of the lower screws are present. Figure 1 to paragraph (f)(1) of this AD depicts where the lower three screws (noted as B and E) are located. Check each screw for looseness by determining whether it can be rotated by hand. These actions may be performed by the owner/operator (pilot) holding at least a private pilot certificate and must be entered into the aircraft records showing compliance with this AD in accordance with 14 CFR 43.9(a)(1) through (4) and 14 CFR 91.417(a)(2)(v). The record must be maintained as required by 14 CFR 91.417, 121.380, or 135.439.

(2) If a screw head is missing, or if a screw is loose, before further flight over water, install MOD 0728456 by completing paragraph (f)(3) of this AD.

(3) Within 300 hours TIS, unless required before further flight over water by paragraph (f)(2) of this AD, install MOD 0728456 by doing the following:
