[Docket No. 2000-SW-12-AD]

#### Airworthiness Directives; Eurocopter France Model AS350B, B1, B2, B3, BA, C, D, D1, and AS355E, F, F1, F2, and N Helicopters

**ACTION:** Supplemental notice of proposed rulemaking; reopening of comment period.

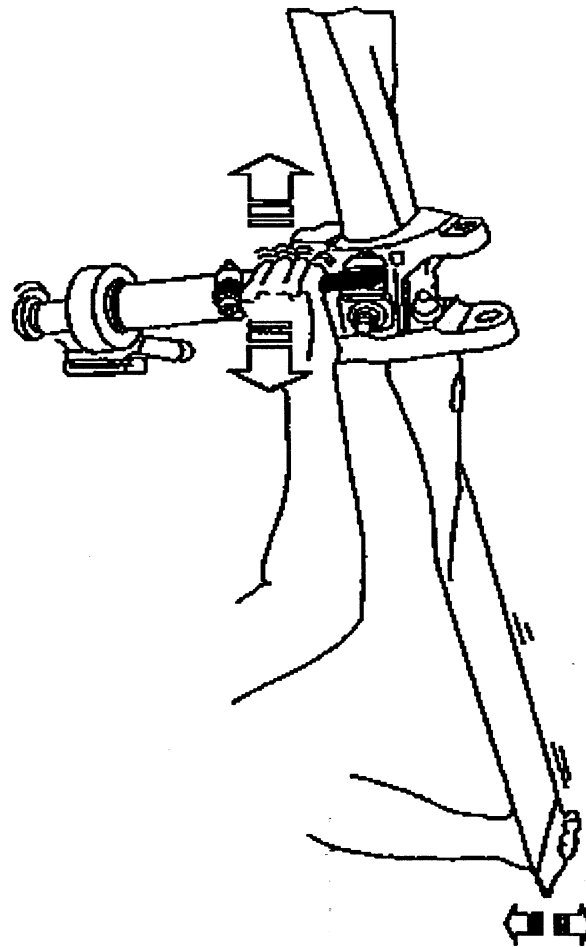
Figure 1: Manual Check for Play of the Tail Rotor Pitch Control Rod

(a) Before the first flight of each day, place the tail rotor pedals in the neutral position. If the helicopter is fitted with a tail rotor load compensator, discharge the accumulator as described in the rotorcraft flight manual. Check the bearing for play on the helicopter, by observation and feel, by slightly moving the tail rotor blade in the flapping axis while monitoring the bearing for movement. See the following Figure 1 of this AD:

(1) If the Teflon cloth is coming out of its normal position within the bearing, totally or partially, or if there is discoloration or scoring on the bearing, the bearing is unairworthy.

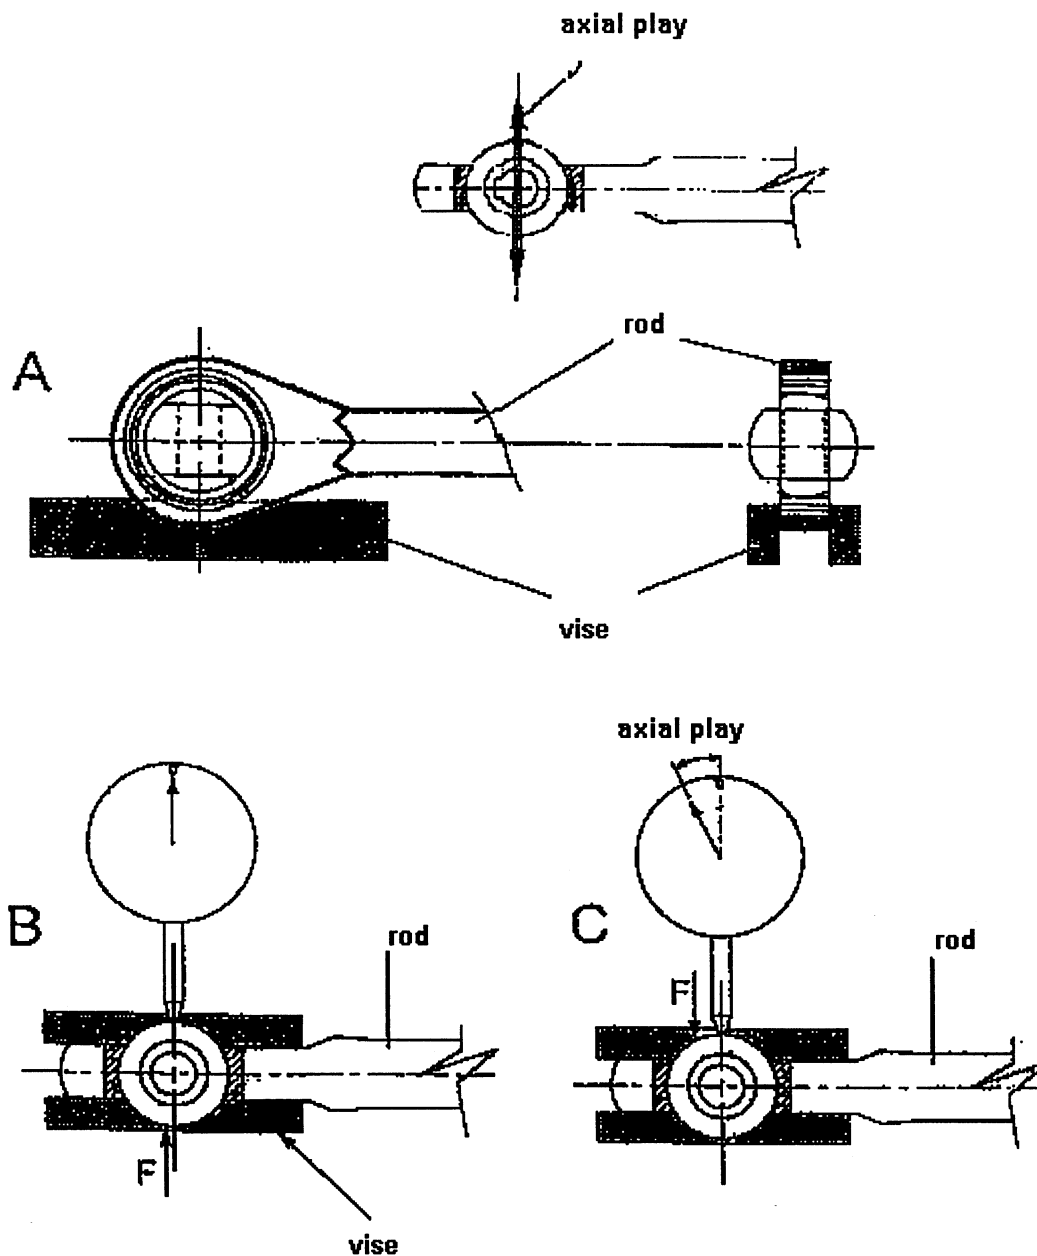
Figure 2: Measurement of the Axial Play (A) of the Bearing

(b) If a pilot or mechanic detects play, a mechanic must remove the control rod from the helicopter, and using a dial indicator, measure the bearing wear according to the following and as shown in Figures 2 and 3 of this AD:

(2) Mount the control rod in a vise as shown in Figure 2 of this AD.

(3) Using a dial indicator, take axial play readings by moving the spherical bearing in the direction F (up and down) as shown in Figure 2 of this AD.

(8) If the radial play exceeds 0.008 inch or axial play exceeds 0.016 inch, replace the

control rod with an airworthy control rod before further flight.
