DEPARTMENT OF TRANSPORTATION**Federal Aviation Administration****14 CFR Part 39**

[Docket No. 2003-NE-52-AD Amendment 39-13410; AD 2003-24-12R1]

Airworthiness Directives; Pratt & Whitney JT9D-3A, -7, -7A, -7F, -7H, -7AH, and -7J Turbofan Engines

ACTION: Final rule; request for comments.

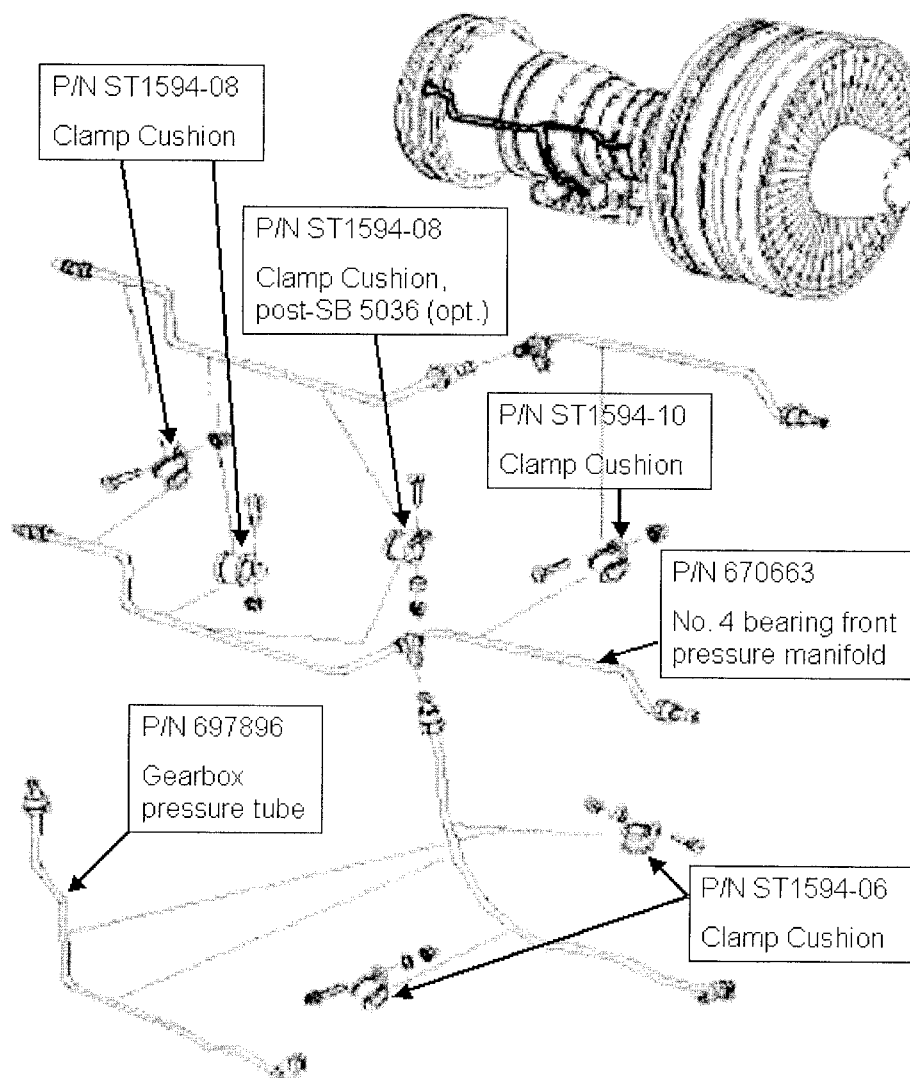
(f) Visually inspect the clamp assemblies, P/Ns ST1594-06, ST1594-08, and ST1594-10, (see Figure 1 of this AD) that attach the gearbox pressure tube and the No. 4 bearing front pressure manifold to the engine. Replace clamp assemblies before further flight that are rejected by any of the following rejection criteria:

(1) Cracks, wear, or distortion in clamp metal.

(2) Clamp cushions that are worn, compacted, cracked, coming apart in chunks, deteriorated, or missing. A reddish powder found around the clamp is an indication of deterioration.

(g) If one or more clamp assemblies are rejected as described in paragraph (f) of this AD, or out of position or missing (see Figure 1 of this AD), clean any debris and oil from the outer surface of the gearbox pressure tube and No. 4 bearing front pressure manifold and visually inspect the tube and manifold. Repair or replace the affected tube or manifold before further flight if it is rejected by any of the following rejection criteria:

- (1) Nicks, chafing, scratches, and or pitting 0.003 inch or greater in depth.
- (2) Dents within 0.25 inch of the ferrules or will not permit free passage of a ball having a minimum diameter of 80% of the tubing inner diameter.
- (3) Corrosion that is unable to be removed by a light polishing.
- (4) Tube or manifold is leaking oil.

(h) Ensure that the gearbox pressure tube, No. 4 bearing front pressure manifold, and clamp assemblies are properly positioned, before further flight, as shown in Figure 1 of this AD.
