Airworthiness Directives; GE Aviation Czech s.r.o. (Type Certificate Previously Held by WALTER Engines a.s., Walter a.s., and MOTORLET a.s.) Turboprop Engines

ACTION: Notice of proposed rulemaking (NPRM).

Figure 1 to Paragraph (g)(1) – Visual Inspection of the Centrifugal Compressor Case

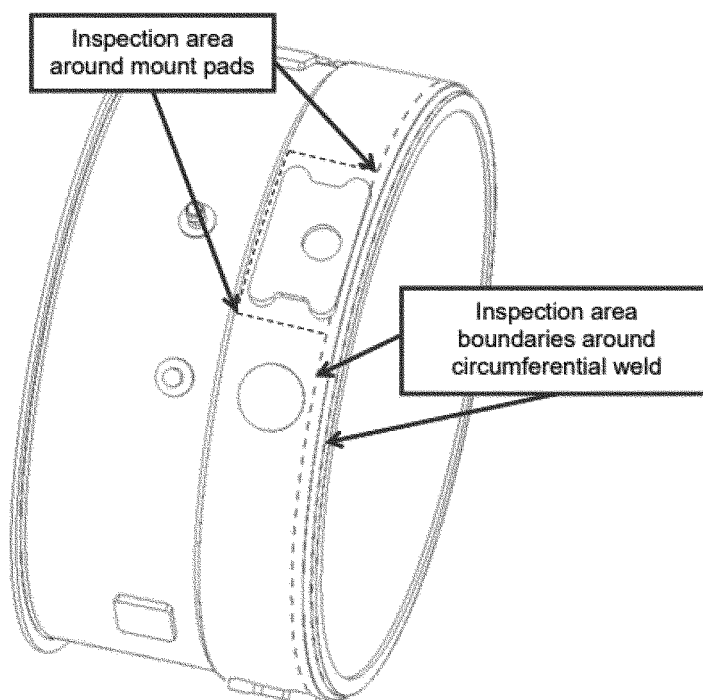
Figure 1. Centrifugal Compressor Case

engine maintenance manual (EMM) to include a visual inspection of the centrifugal compressor case for cracks. The FAA is issuing this AD to prevent failure of the centrifugal compressor case. The unsafe condition, if not addressed, could result in failure of the centrifugal compressor case, engine separation, and loss of the airplane.

Do a visual inspection of the compressor case in the specified areas, shown in Figure 1, for every 100±10 Flight Hours. Use magnifying lens 10x for inspection. No visible cracks are allowed.

(1) Within 90 days after the effective date of this AD, revise the ALS of the existing EMM by incorporating Figure 1 to paragraph (g)(1) of this AD.
