**DEPARTMENT OF TRANSPORTATION**

**Federal Aviation Administration**

[Docket No. 2001-SW-39-AD; Amendment 39-12751; AD 2002-10-05]

**Airworthiness Directives; MD Helicopters Inc. Model MD-900 Helicopters**

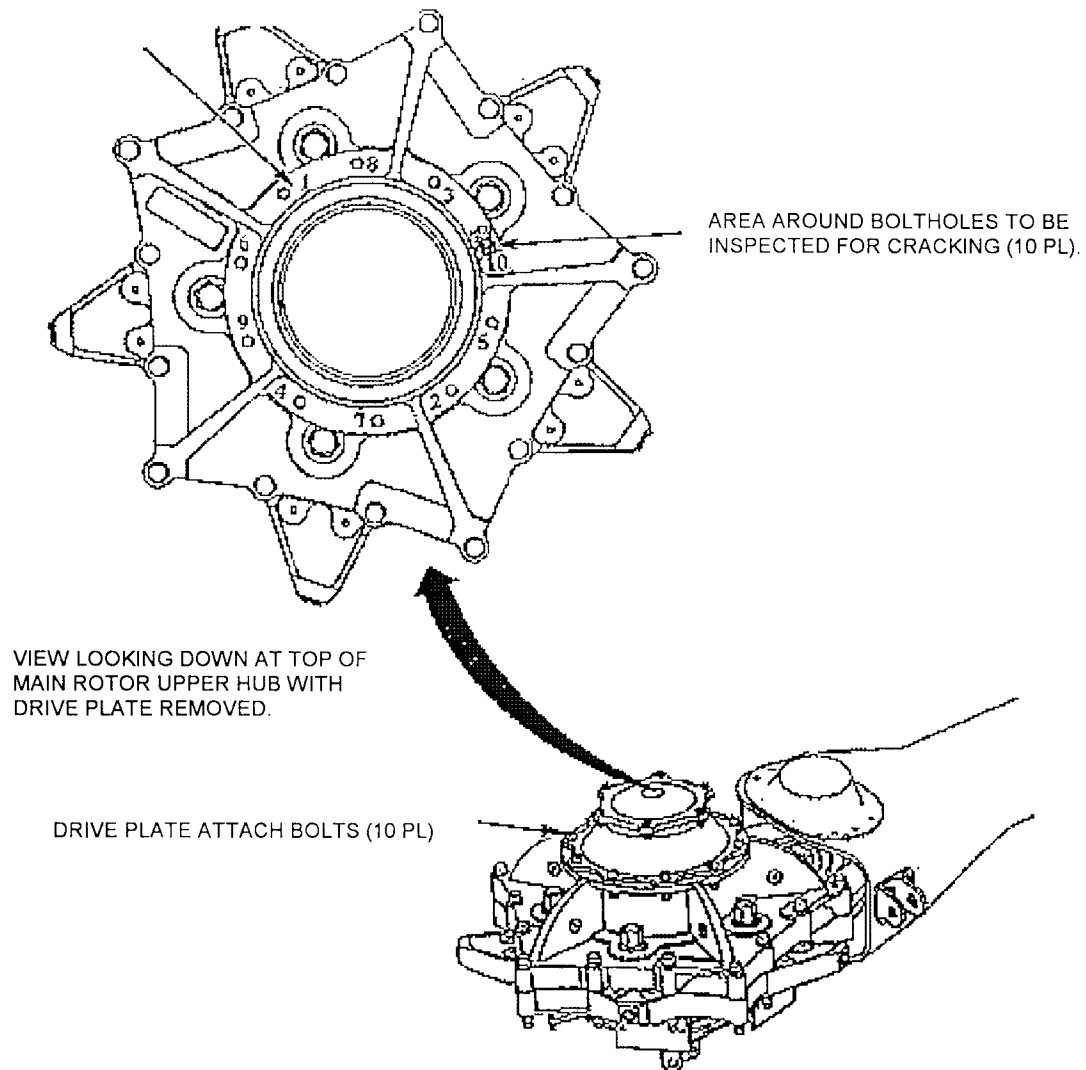
**Figure 1. Main Rotor Upper Hub Assembly Inspection**

surface of the flange at specified intervals, removing the drive plate and visually inspecting the flange for a crack at specified intervals, and replacing any unairworthy hub assembly. This amendment is prompted by reports that cracks starting at the drive plate attachment holes were found in the hub. The actions specified by this AD are intended to detect a crack in the flange and to prevent failure of the hub assembly, loss of drive to the main rotor, and subsequent loss of control of the helicopter.

1. MAIN ROTOR DRIVE PLATE ATTACHMENT HARDWARE TORQUE SEQUENCE.
2. NUMBERING MAY START AT ANY HOLE.
3. TORQUE NUTS TO 1/2 TOTAL TORQUE, THEN FULL TORQUE.

(ii) Mark the main rotor hub holes to correspond with the drive plate hole numbers (see Figure 1 of this AD).

(v) Using paint stripper (Consumable Item List C313 or equivalent) and cleaning solvent (C420 or equivalent), remove the paint from the upper mating surface of the hub assembly to enable an accurate visual inspection of each drive plate attachment bolt hole (bolt hole) area for cracking (Figure 1). Ensure the paint stripper and solvent DO NOT contaminate the upper bearing and upper grease seal areas.

(vi) Using a 10x or higher magnifying glass and light, inspect the mating surface area and the area around and inside the 10 bolt holes of the hub assembly for a crack. If a crack is found, before further flight, replace the hub assembly with an airworthy hub assembly.

(viii) Reinstall the main rotor drive plate using 10 new sets of replacement attachment hardware. Torque the nuts to 160 inch pounds above locknut locking/run-on torque in the sequence shown (Figure 1). Record in the rotorcraft logbook, or equivalent record, the locknut locking/run-on torque for each nut.
