Federal Register

Thursday, June 24, 2004

[Docket No. 2004-SW-04-AD]

#### Airworthiness Directives; Bell Helicopter Textron Canada Model 222, 222B, 222U, and 230 Helicopters

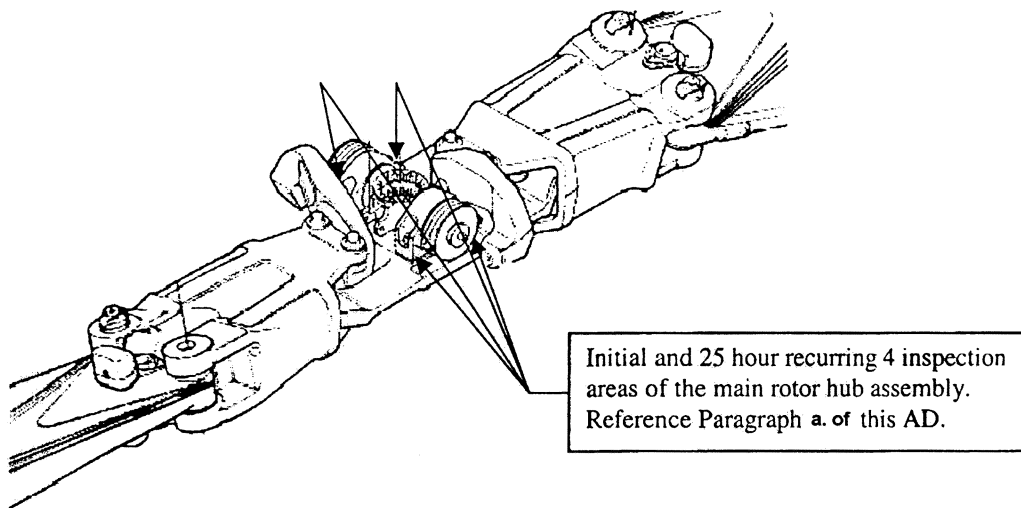
**Figure 1. Main Rotor Hub Assembly**

- (a) Within 50 hours time-in-service (TIS) or by the next scheduled inspection for the hub assembly, whichever occurs first, and thereafter at intervals not to exceed 25 hours TIS, using a 10X or higher magnifying glass, visually inspect the main rotor yoke (yoke)

for a crack, fretting or buffer deterioration in the four areas around the flapping bearing attachment bushings as shown in the following Figure 1 of this AD:  
**BILLING CODE 4910–13–P**

(1) If a crack is found, before further flight, replace the yoke with an airworthy yoke.

(2) If fretting or buffer deterioration is found on the yoke in the areas shown in Figure 1 of this AD, before further flight, disassemble the hub assembly and further inspect the yoke with a 10X or higher magnifying glass in the four areas shown in Figures 2 and 3 of this AD.
